**ADDENDUM 2**  
**Questions for Request for Proposal**  
**RFP 03-2026 BEAVER ROAD EAST AND WEST BRIDGES - ENGINEERING CONSULTING**  
**SERVICES FOR DESIGN PROCESS**

## Municipality of Central Manitoulin – 2024 OSIM Inspections

October 2024  
TULLOCH Project #: 22-0983

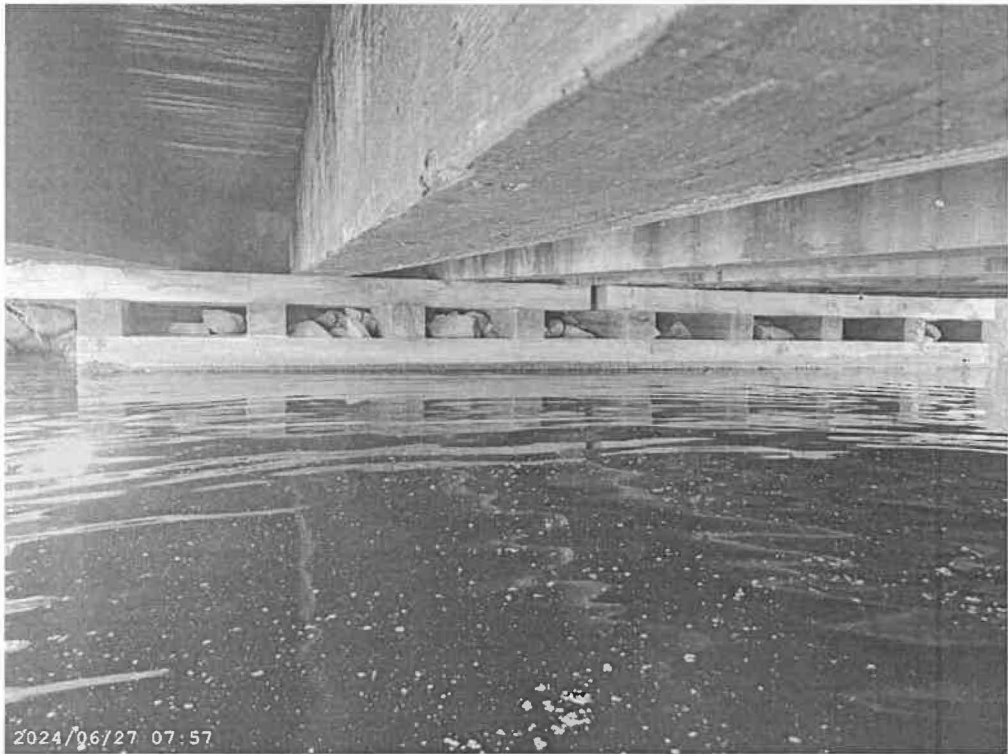
| Timber cribbing to be replaced and undermining repaired. | | | Clean debris from and trim vegetation near bearing seats. | | | |

East abutment general arrangement

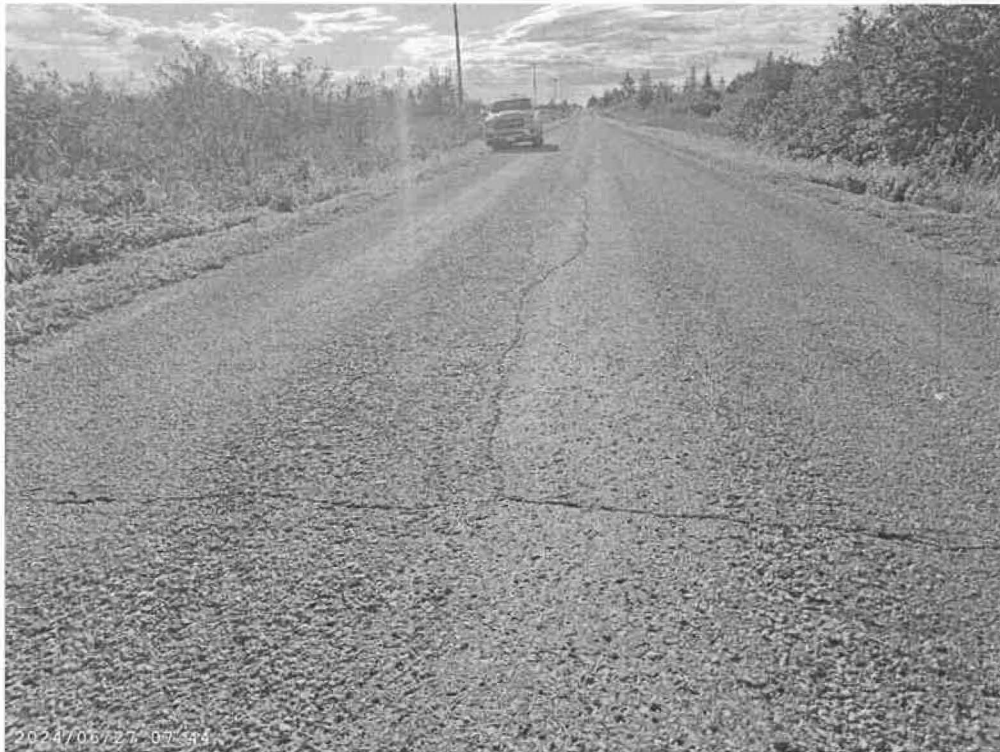
Transverse and longitudinal crack in East approach

| | | | Seal approach cracks | | | |

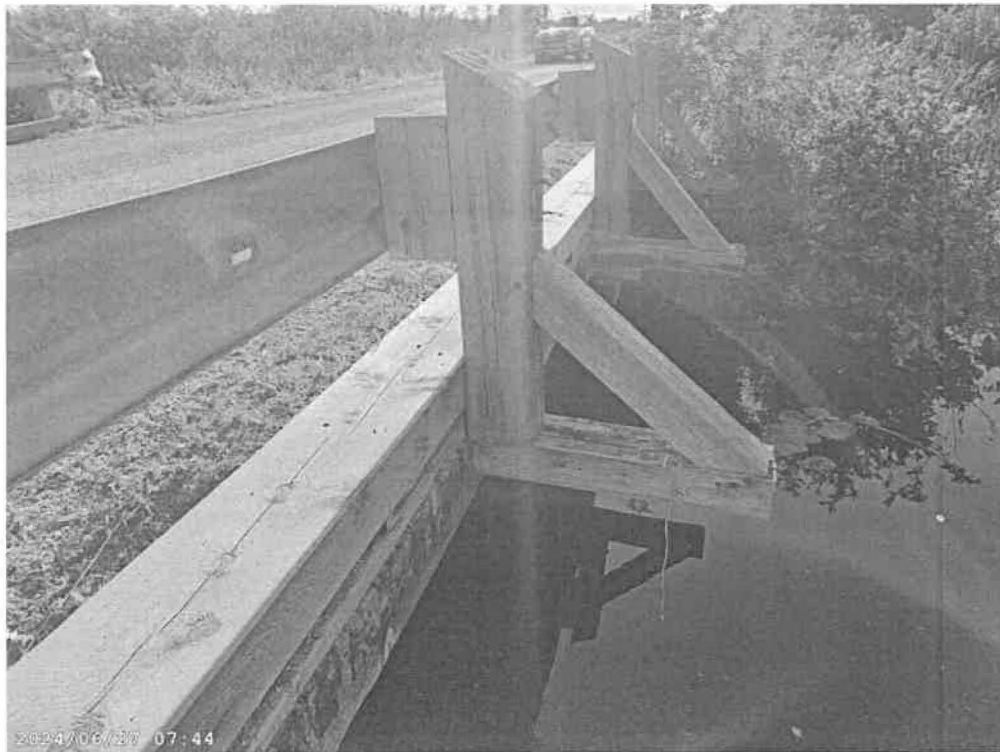
| <b>Comments:</b><br>Posts are rolling and have been impacted. Posts have a spacing of 2.3-2.5m and are supported off a 3-ply 2x4 outrigger. | | | | | | |

Typical railing posts and supports

| <b>Recommended Work:</b><br><input type="checkbox"/> Rehab <input checked="" type="checkbox"/> Replace<br><input checked="" type="checkbox"/> 1-5 years <input type="checkbox"/> 6-10 years<br>Replace railing system. | | | <b>Maintenance Needs:</b> 01. N/A<br><input type="checkbox"/> Urgent <input type="checkbox"/> 1 year <input type="checkbox"/> 2 year | | | |

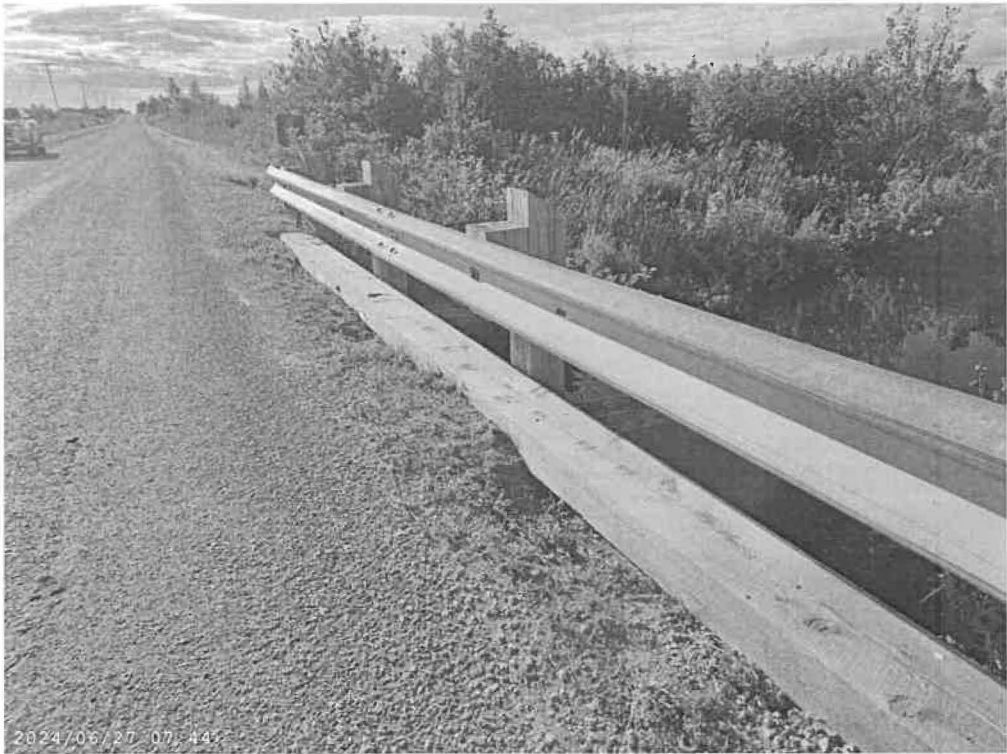
Typical curb and railing system

| Upgrade railing system. | | | | | | |

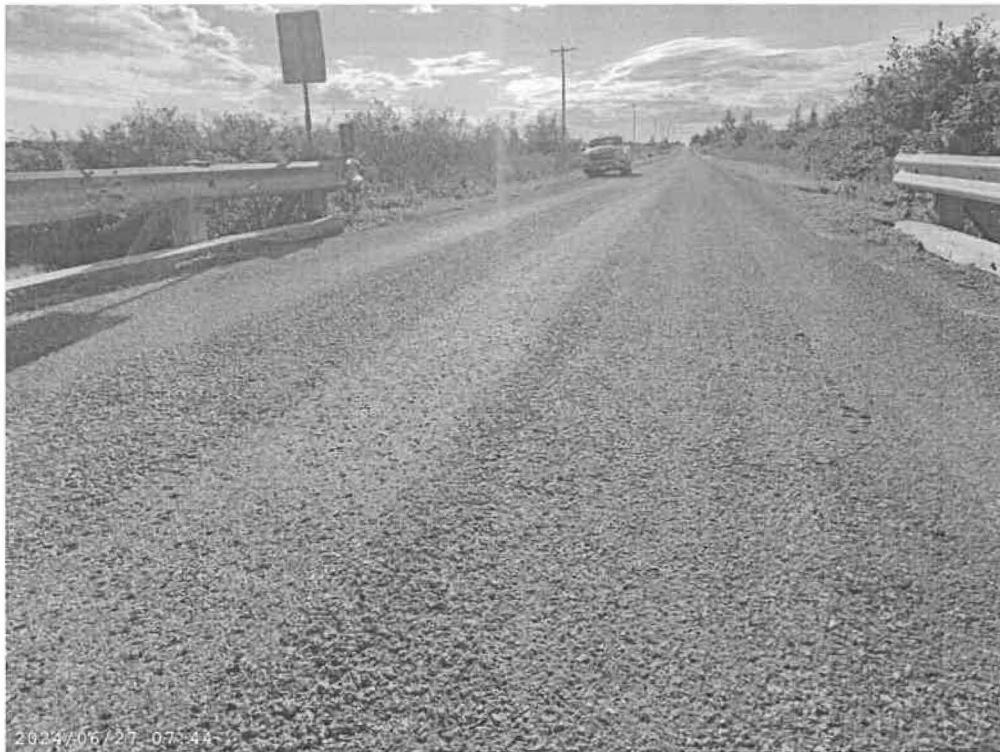
Wearing surface with light raveling, wear and rutting in wheel paths

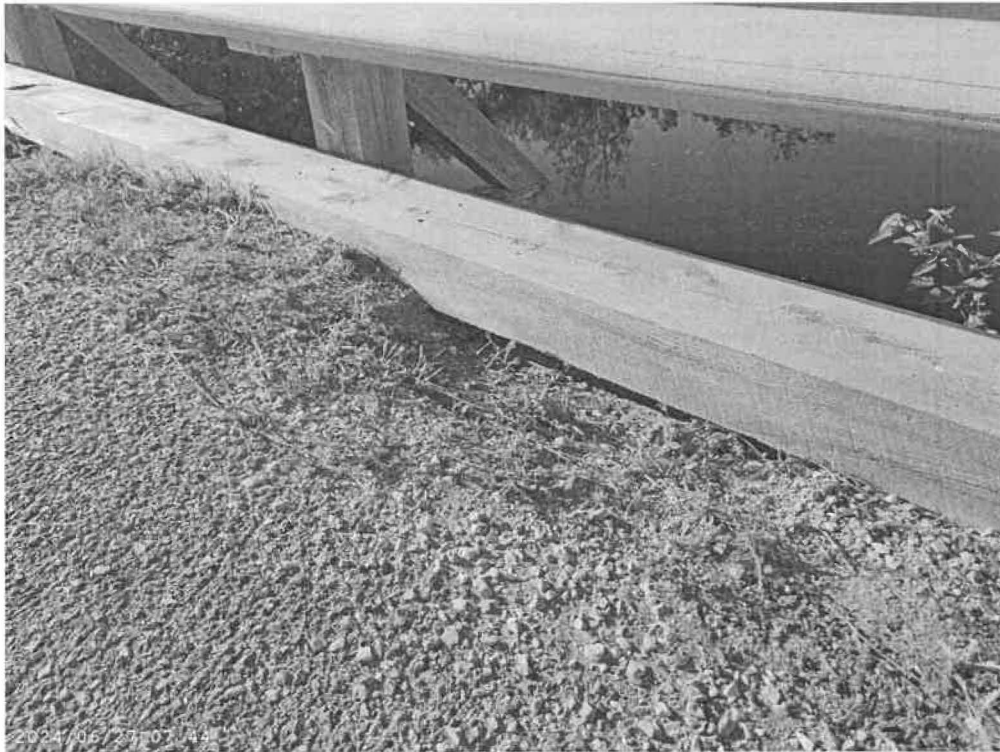
Deck drain to original scupper

| | | | Remove debris from drainage. | | | |

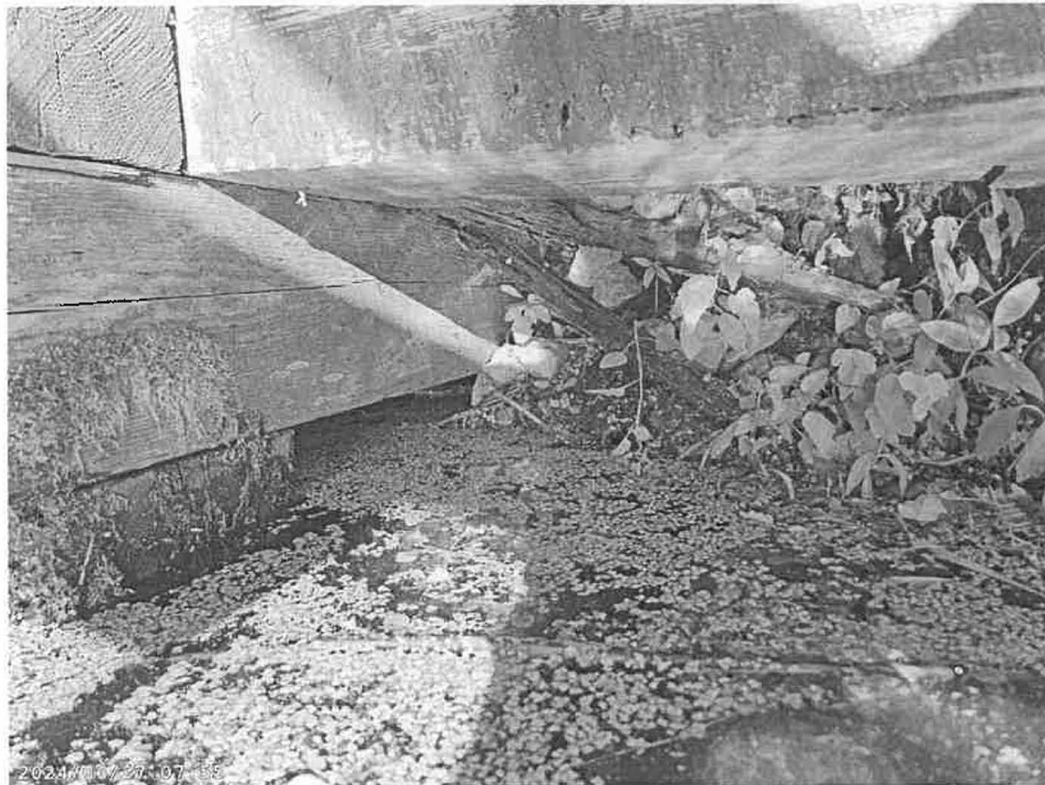
Failed ballast wall

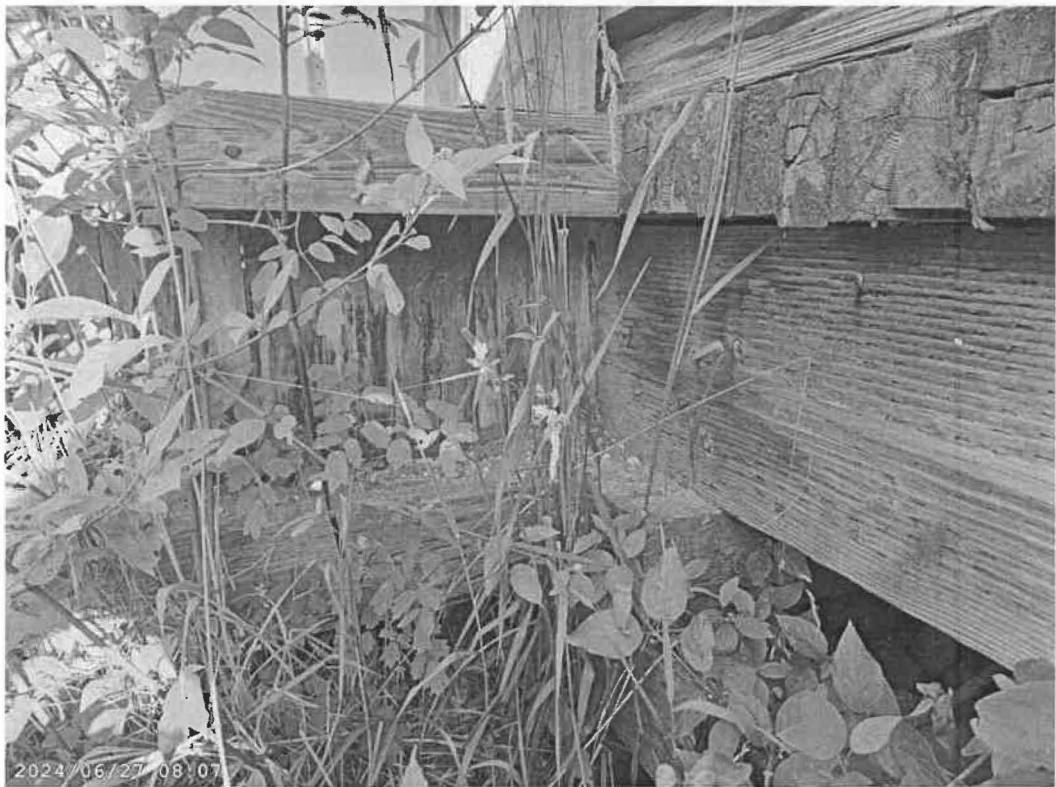
Light debris at bearing

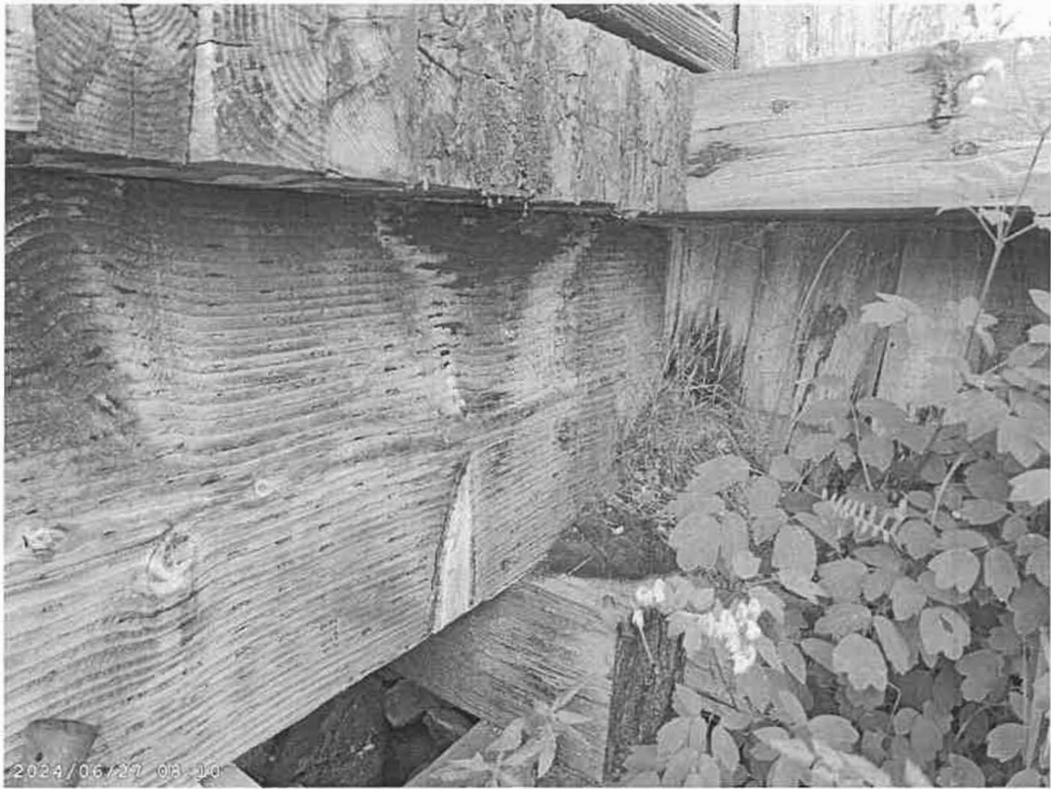
Debris at Southeast corner exterior bearing

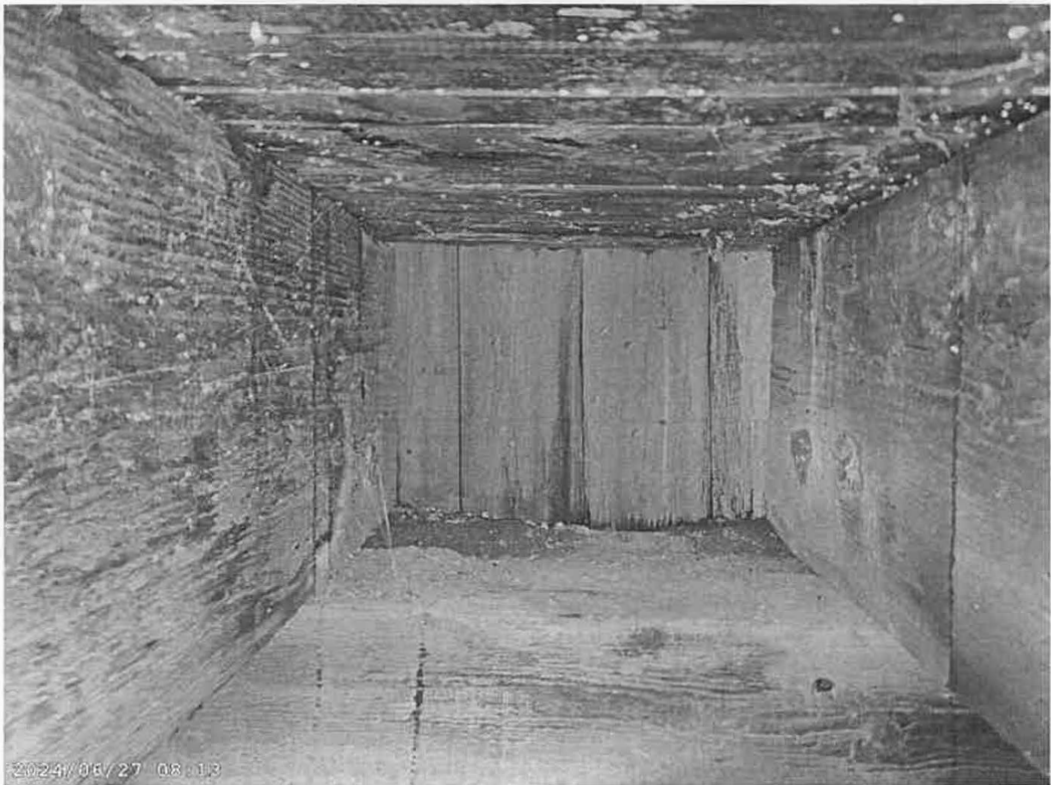
Moderate decay of ballast wall at Northeast corner

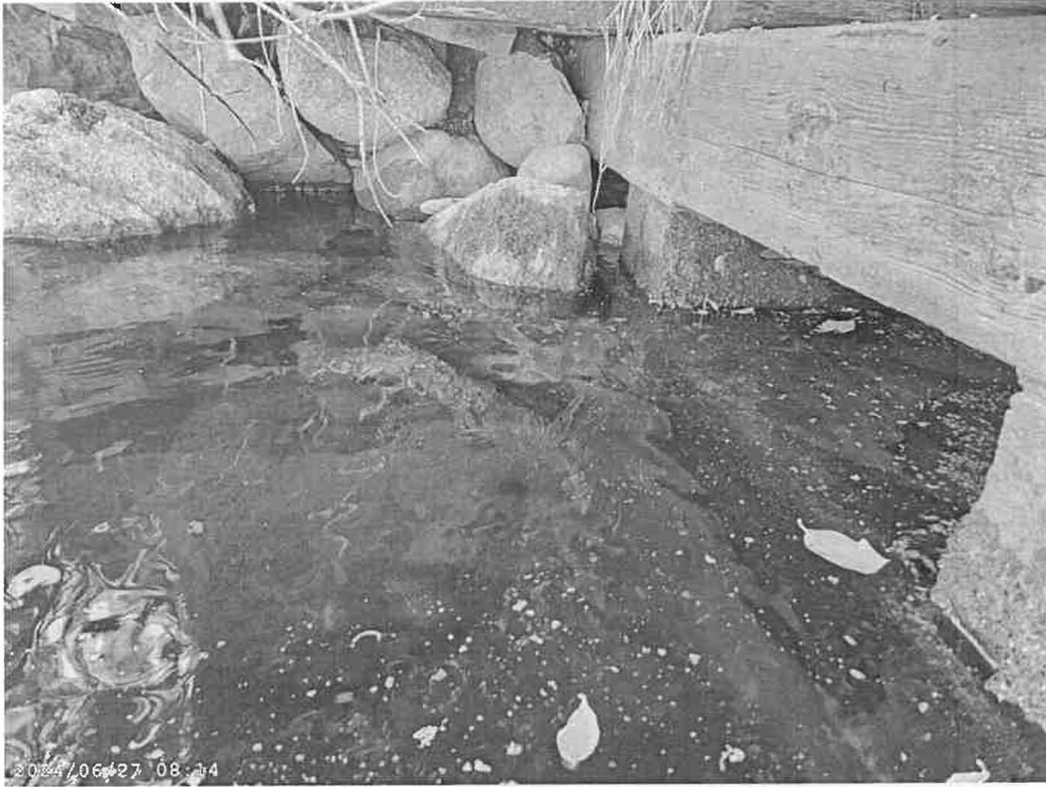
Loss of rock upstream (end of east abutment)

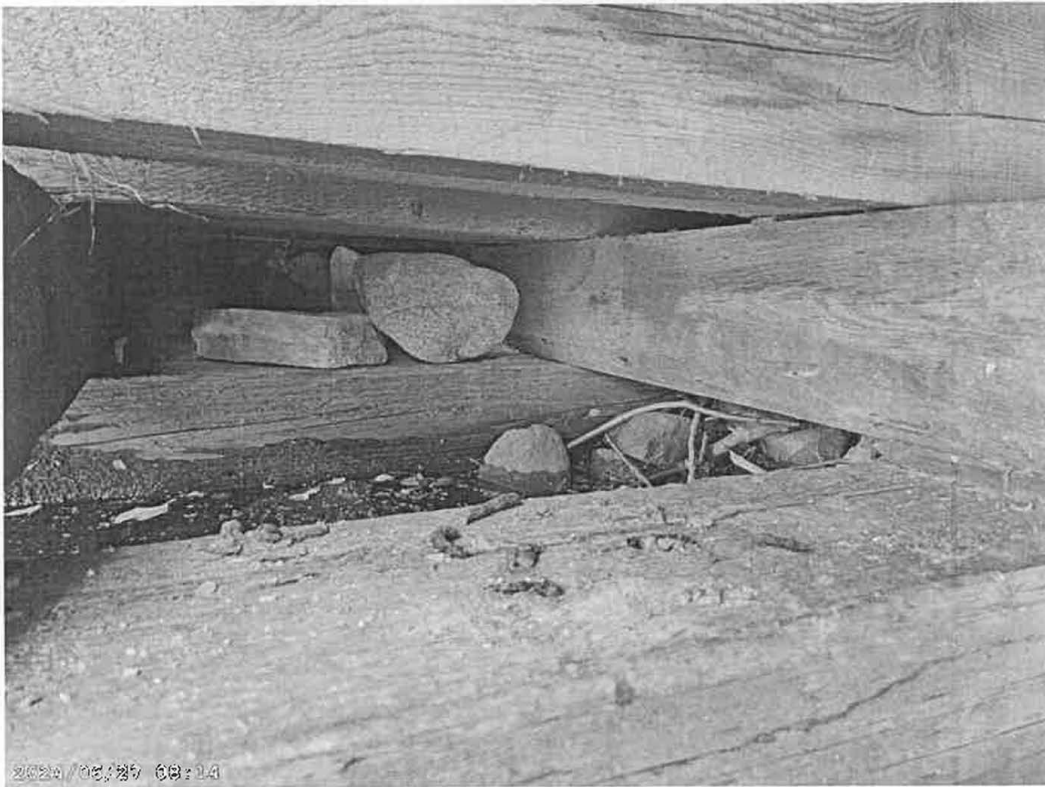
Loss of rock in crib

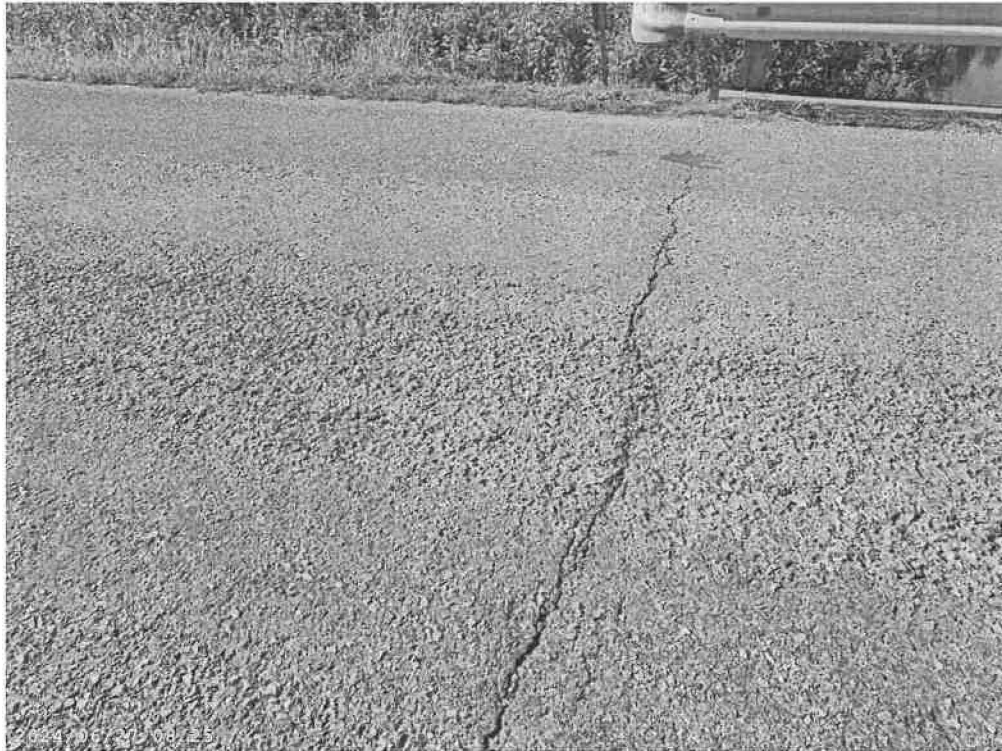
| <b>Comments:</b><br>Center line wide crack in east approach. Wide transverse crack in west approach. Light to medium ravelling and wheel rutting throughout. | | | | | | |

Medium transverse crack at end of deck

| <b>Recommended Work:</b> <input type="checkbox"/> Rehab <input type="checkbox"/> Replace<br><input type="checkbox"/> 1-5 years <input type="checkbox"/> 6-10 years | | | <b>Maintenance Needs:</b> 12. Bridge Surface Repair<br><input type="checkbox"/> Urgent <input checked="" type="checkbox"/> 1 year <input type="checkbox"/> 2 year<br>Seal cracking in bridge deck | | | |

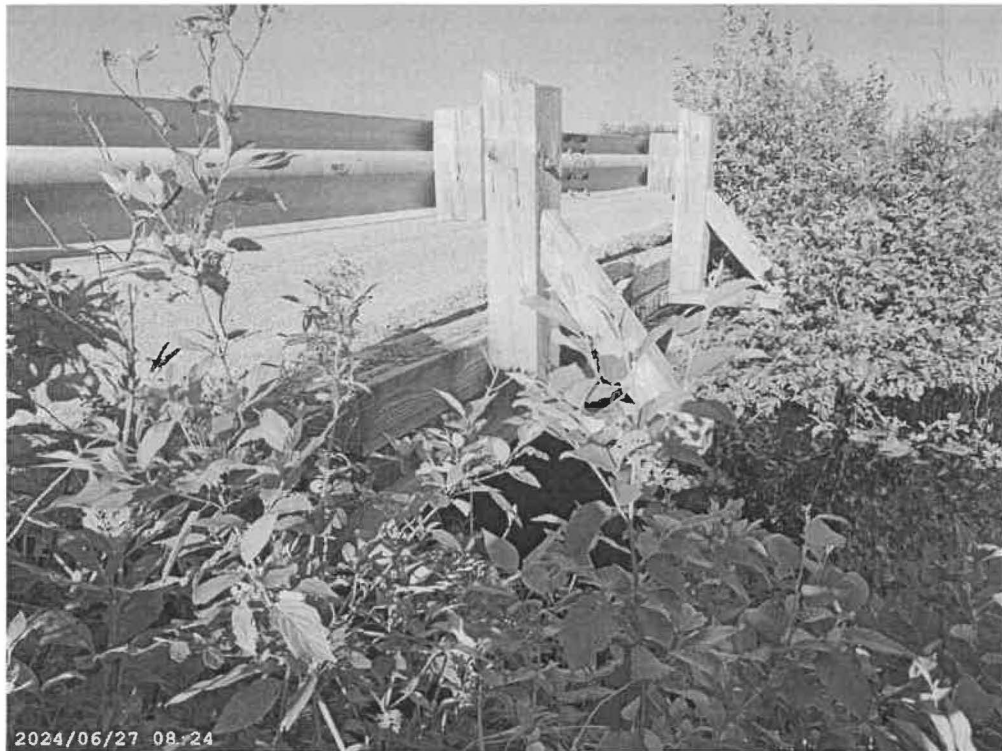
North elevation and railing support

| Replace barrier posts. | | | | | <input type="checkbox"/> Urgent <input type="checkbox"/> 1 year <input type="checkbox"/> 2 year | |

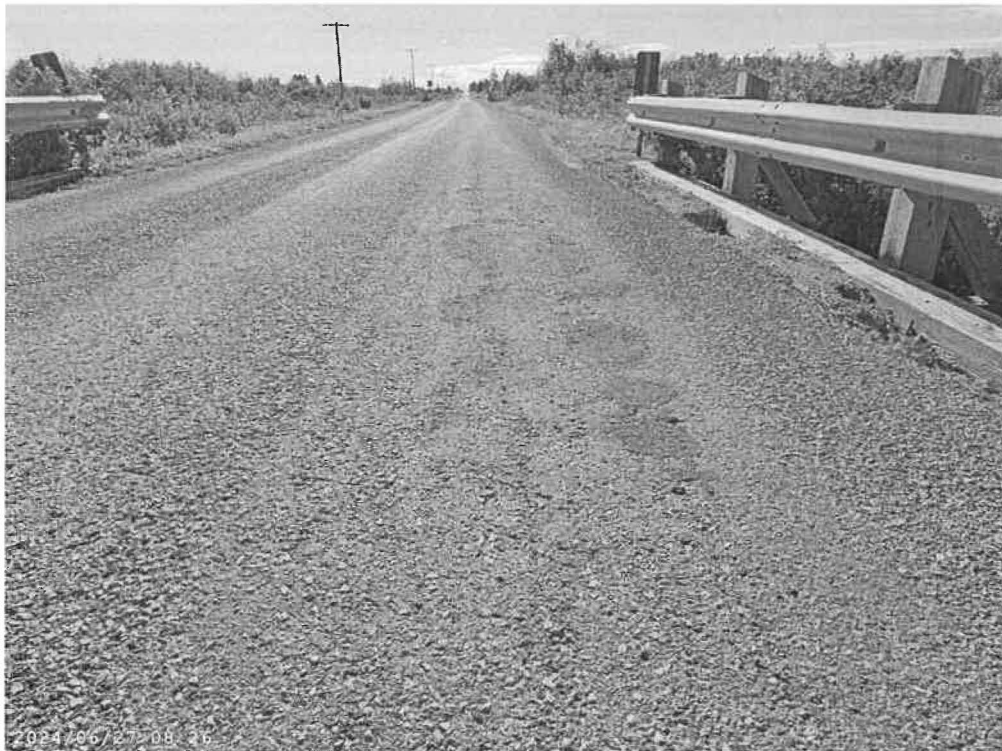
Patching and rutting in wheel path on deck

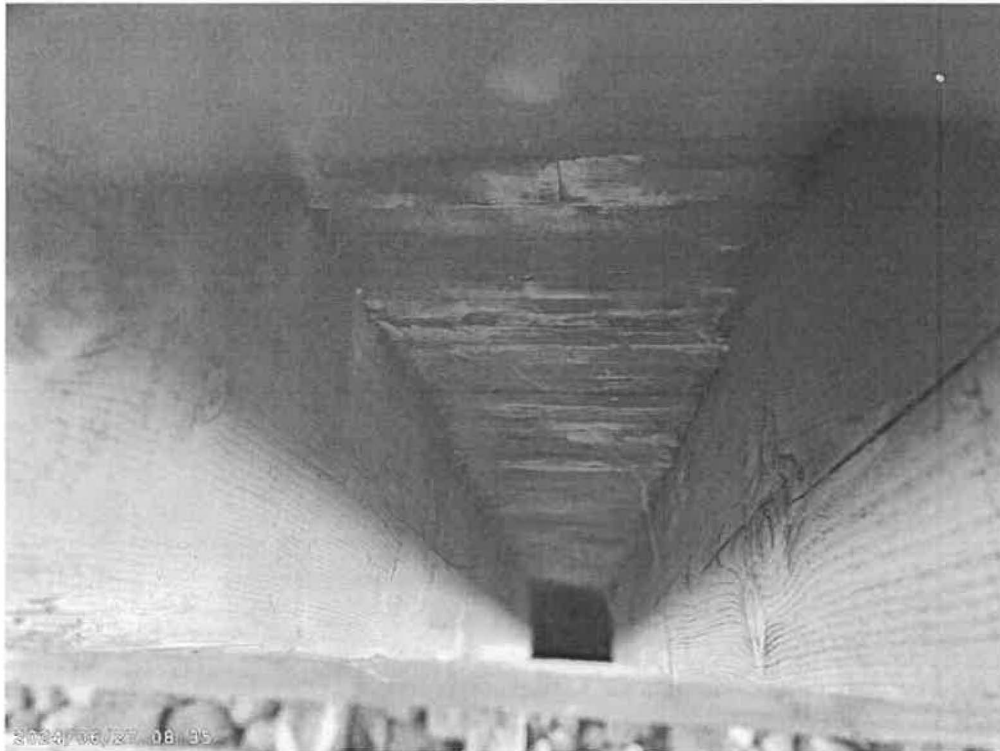
Interior deck soffit

| Replace decking. | | | <input type="checkbox"/> Urgent <input type="checkbox"/> 1 year <input type="checkbox"/> 2 year | | | |

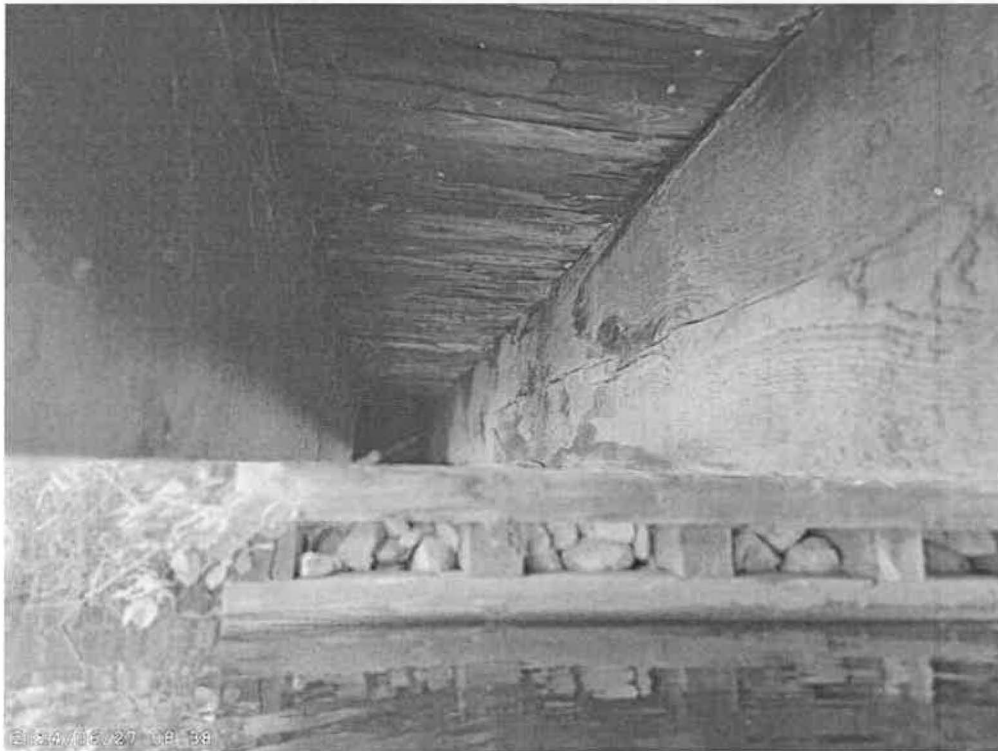
Exterior soffit and water staining on edge of stringer

| Replace decking. | | | <input type="checkbox"/> Urgent <input type="checkbox"/> 1 year <input type="checkbox"/> 2 year | | | |

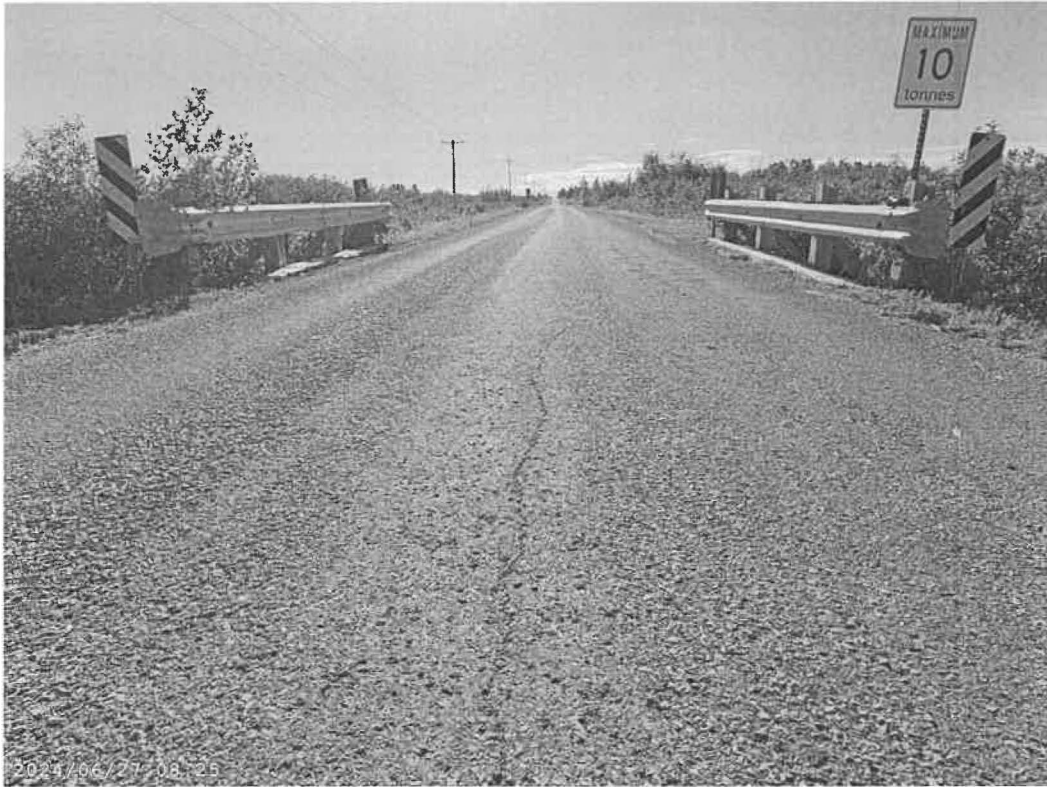
Medium longitudinal crack and typical wearing surface

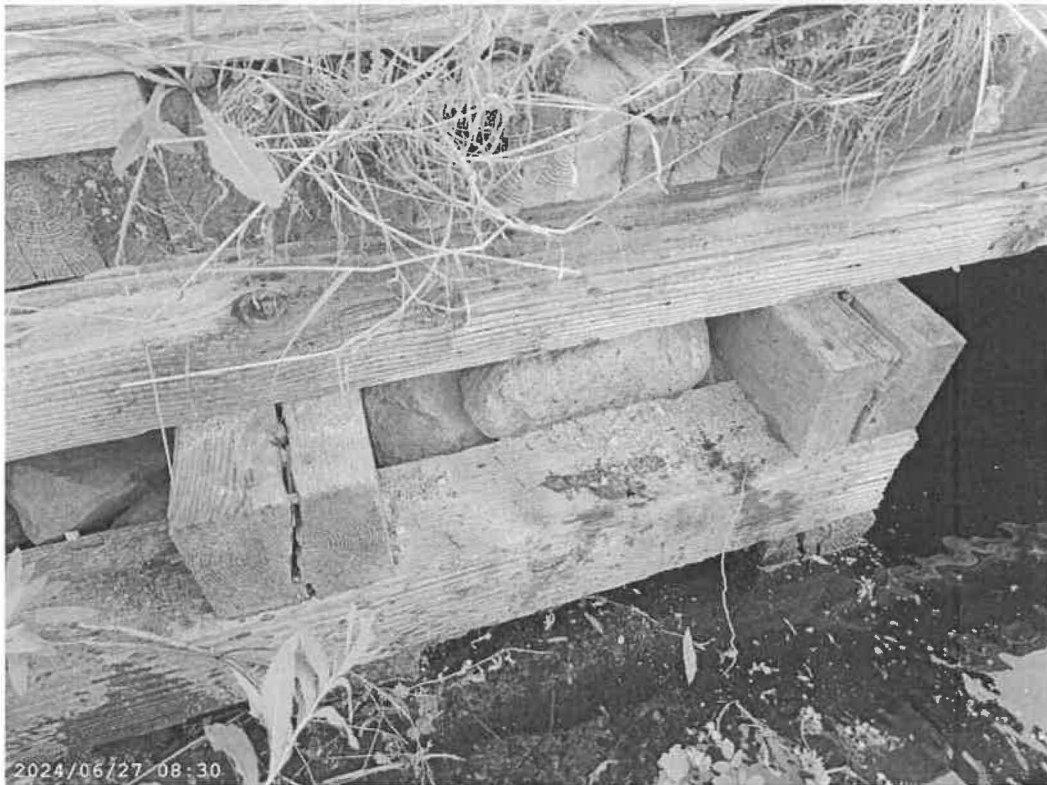
Wide splits in West crib at drift pins

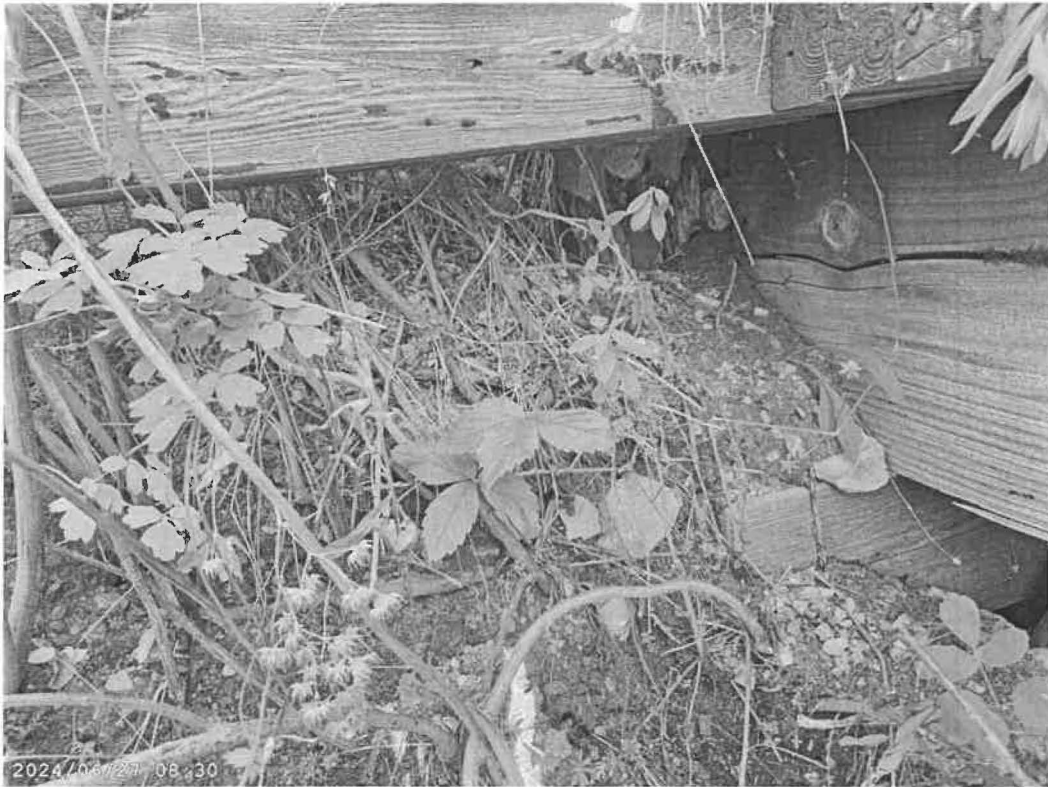
Failed ballast wall corners causing loss of fill onto bearing timber

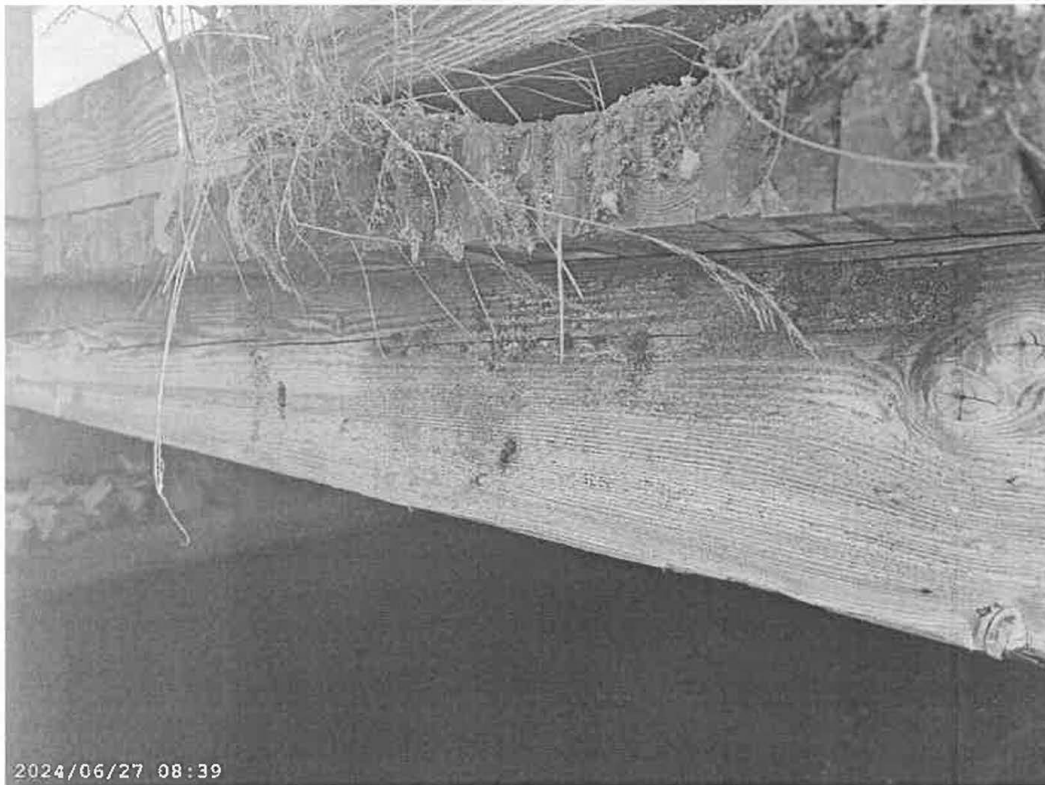
Algae growth on edge of decking

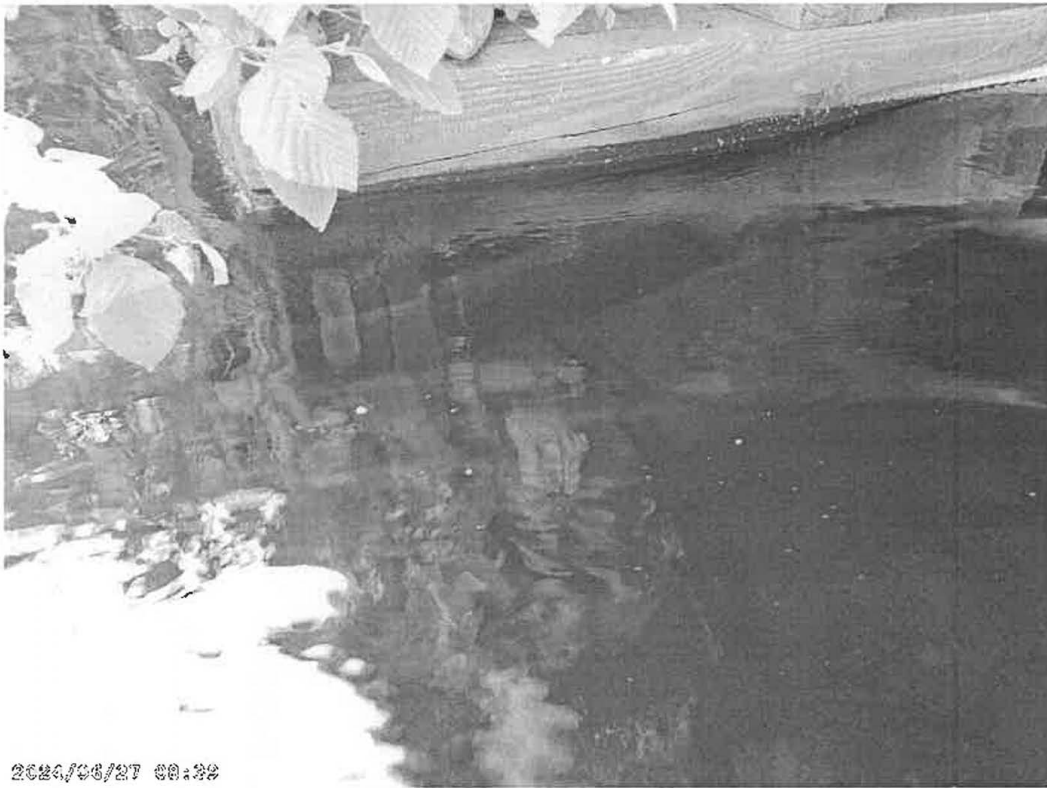
Exposed toe of cribbing bottom course bearing pad

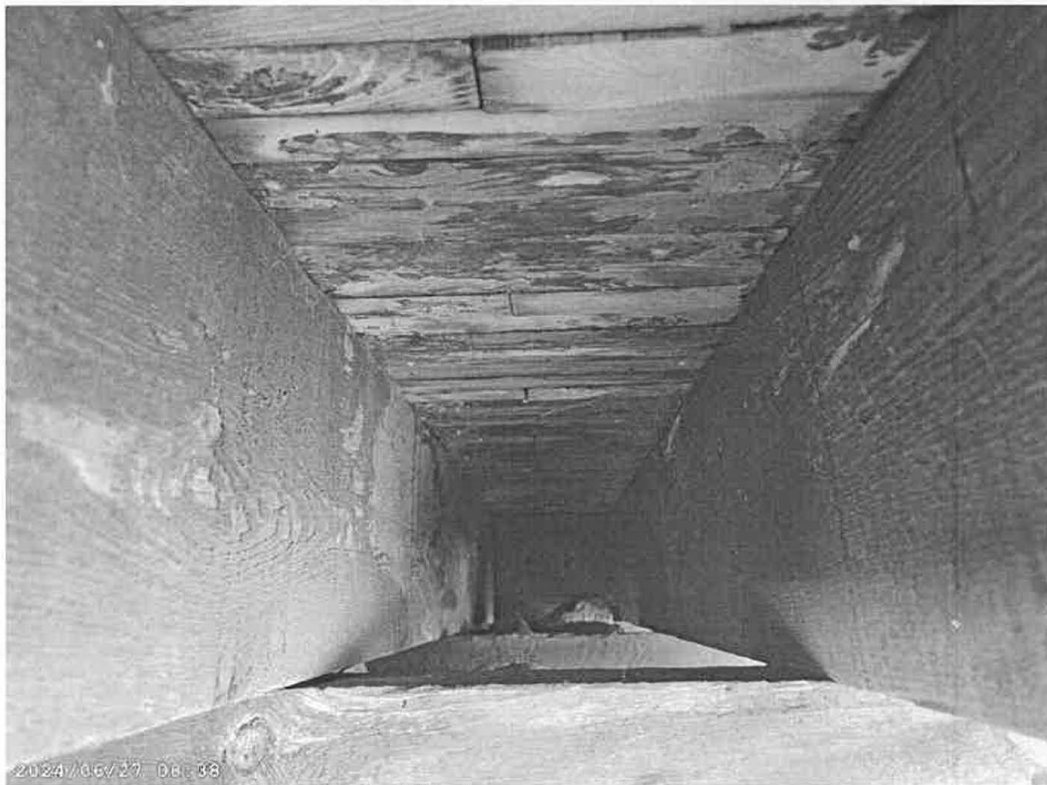
Water staining at edge of deck soffit

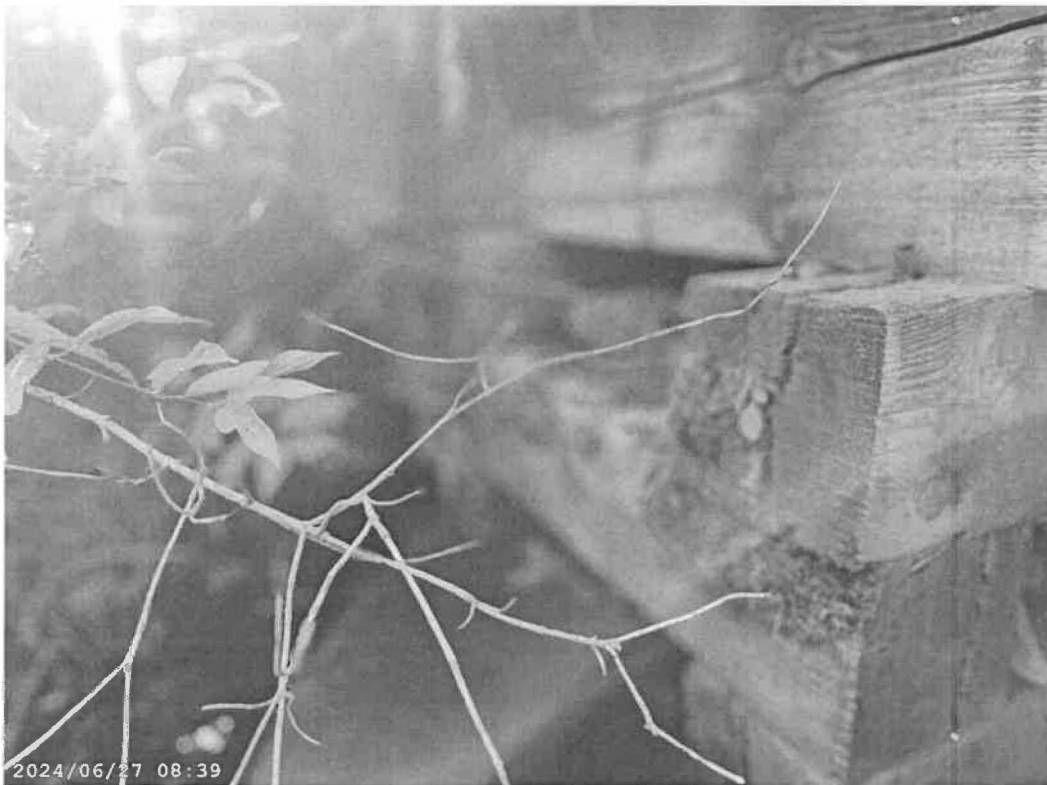
Algae growth on edge of East abutment cribbing
