Addendum A – Proponent’s Questions

**BUILDING CONDITION ASSESSMENT
THE MINDEMOYA CHANGE HOUSE
Mindemoya, Ontario**

**January 2023
TULLOCH Project #: 22-1315**

**Municipality of Central Manitoulin
Mindemoya Lake Pavillion
10 Will-O-Wisp Way
Mindemoya, ON**

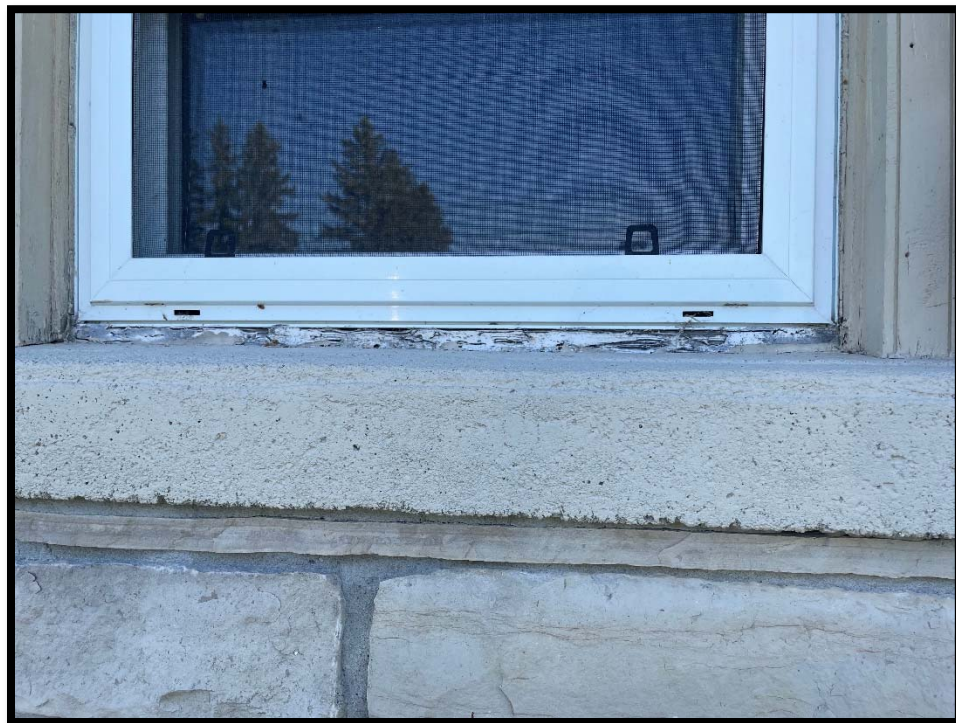
- The building had a prefinished, corrugated screw down metal roof, prefinished vented metal soffit and prefinished metal fascia
- At the servery area, a wood framed plate glass window was provided. Minimal paint was observed on the frame. A cast in place concrete sill was noted at the base of the windows and a painted steel angle lintel was provided over the windows. Mild corrosion of the steel lintels was noted

Photo 6 – Caulking at Exterior Window

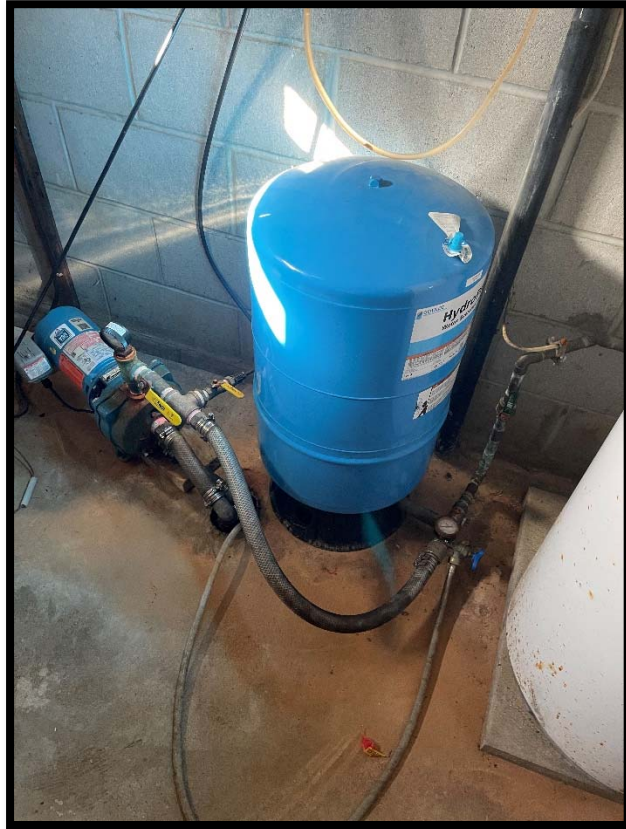
- There was a fused disconnect servicing a water pump
- Observed electrical conductors at the electrical distribution panel were a mix of armoured cable and Romex cabling
- All mechanical and electrical equipment was noted to be contained within a storage room
- Lighting throughout the building was noted to be surface mounted fluorescent fixtures
- Pot lights with fluorescent lamps were provided in the pavilion area
- A non-functioning dual lamp light fixture was noted on the soffit of the pavilion
- One (1) exterior wall pack was noted on the washroom side of the building
- No emergency lighting or exit lighting was noted
- Water distribution piping within the building was noted to be copper
- There was no water filtration/treatment equipment observed within the building
- Domestic hot water was provided by a 40-gallon capacity, electric hot water tank (Cascade)

Photo 7 – Pump in Mechanical Room

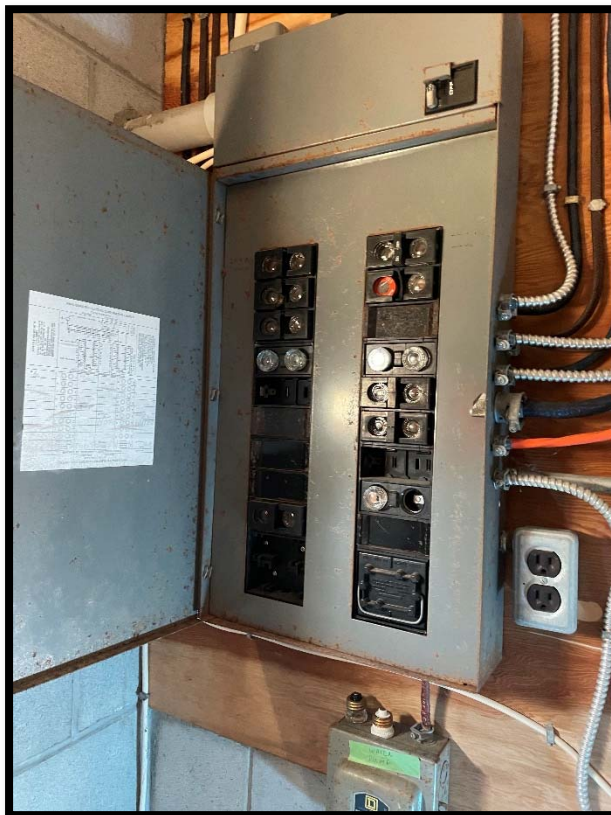
- No heat source is provided in the building. Plumbing systems are drained and winterized seasonally. A dry well is provided on the building exterior to permit draining of the plumbing systems
- Incoming electrical service was noted to be single phase, underground, 200-amp
- The electrical service was a 200-amp fuse panel

Photo 8 – Fused Electrical Panel

It is recommended that all existing fuse style electrical distribution equipment be removed and replaced with breaker style equipment.

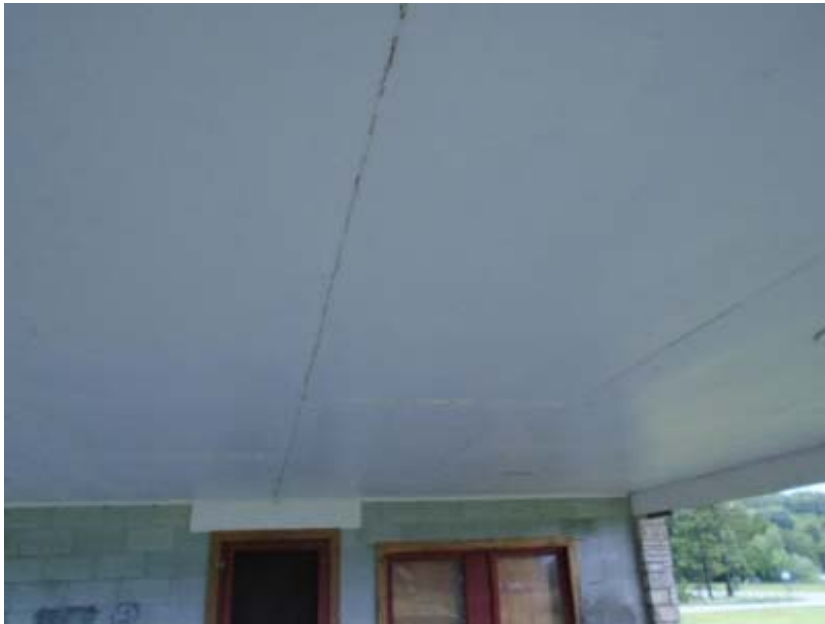
Photo 4: View of Pavillion Ceiling drywall – sample collected

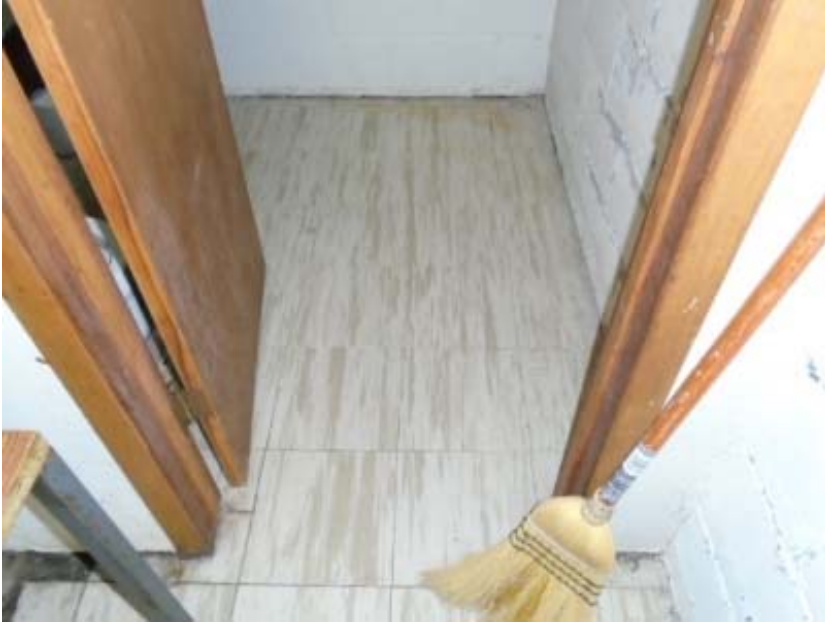
Asbestos was confirmed in the brown and white 12" x 12" floor tiles found in the kitchen area.

Photo 5: View of floor tiles in kitchen area – sample taken
