THE MUNICIPALITY OF CENTRAL MANITOULIN

REQUEST FOR PROPOSALS 03-2026

FOR: Beaver Road East and West Bridges - Engineering Consulting Services for Design process.

Municipality of Central Manitoulin – 2022 OSIM Inspections

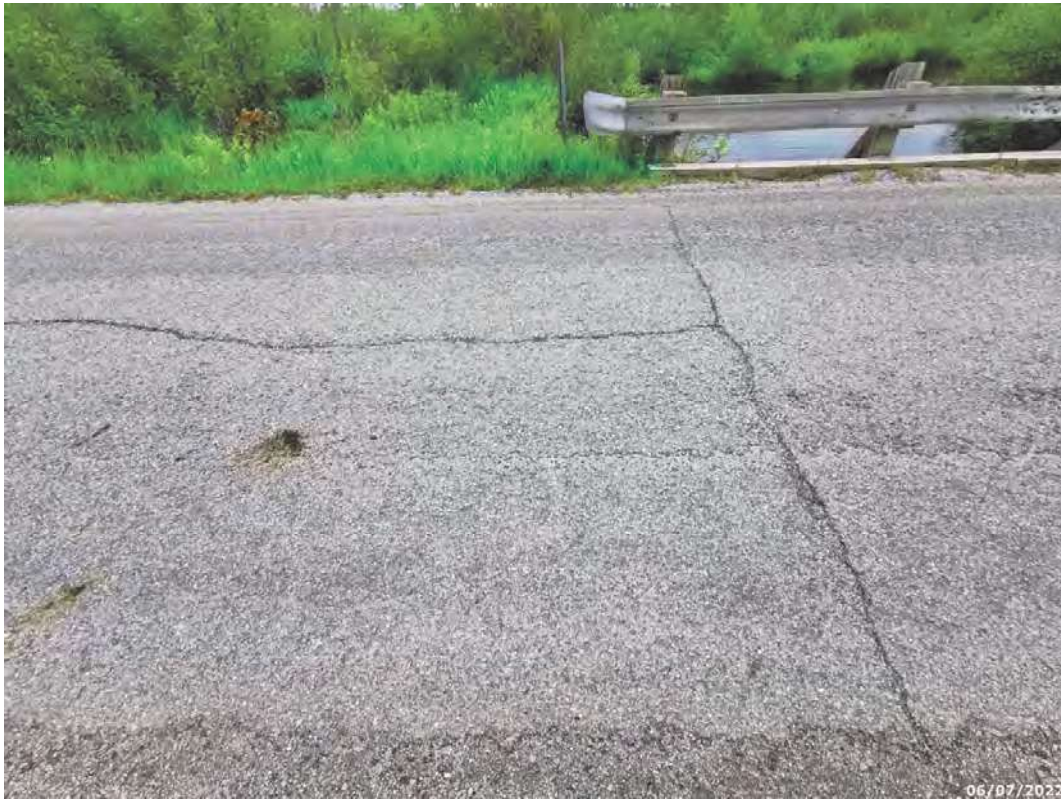
Wide transverse and longitudinal cracks at east approach

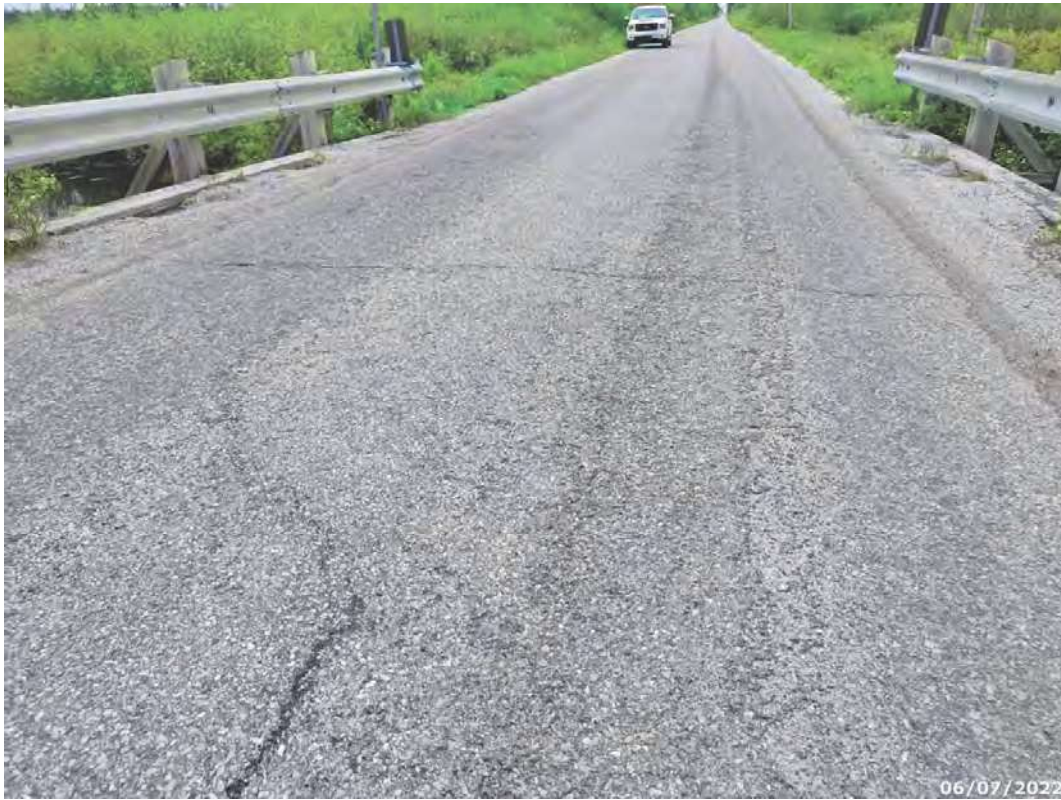
East approach with medium center line crack and wide transverse crack

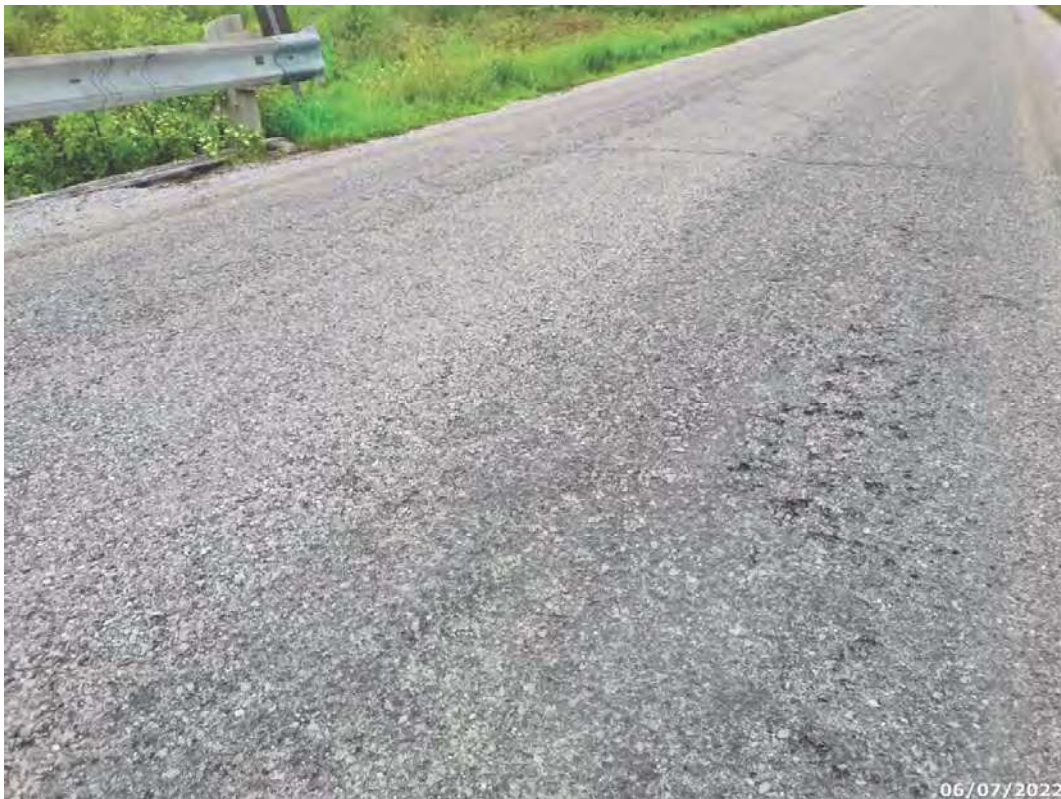
Typical deck wearing surface with localized moderate ravelling and light rutting

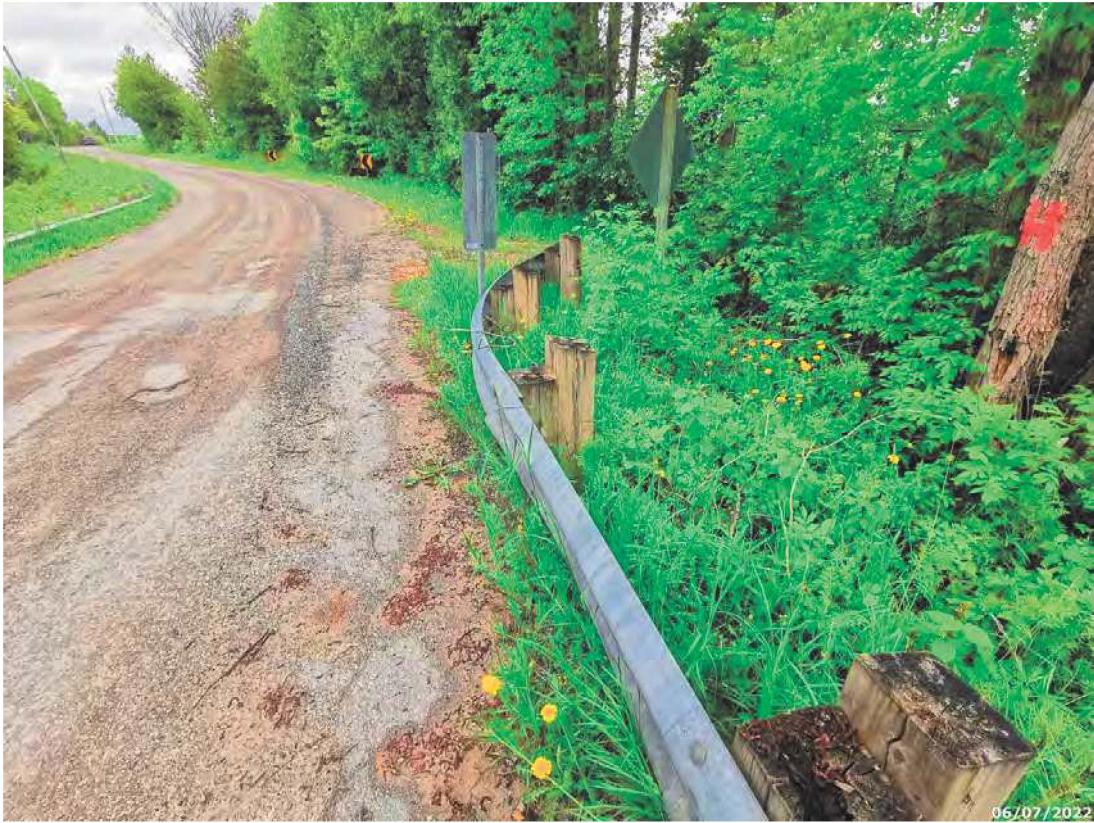
Severe end decay of spacer block

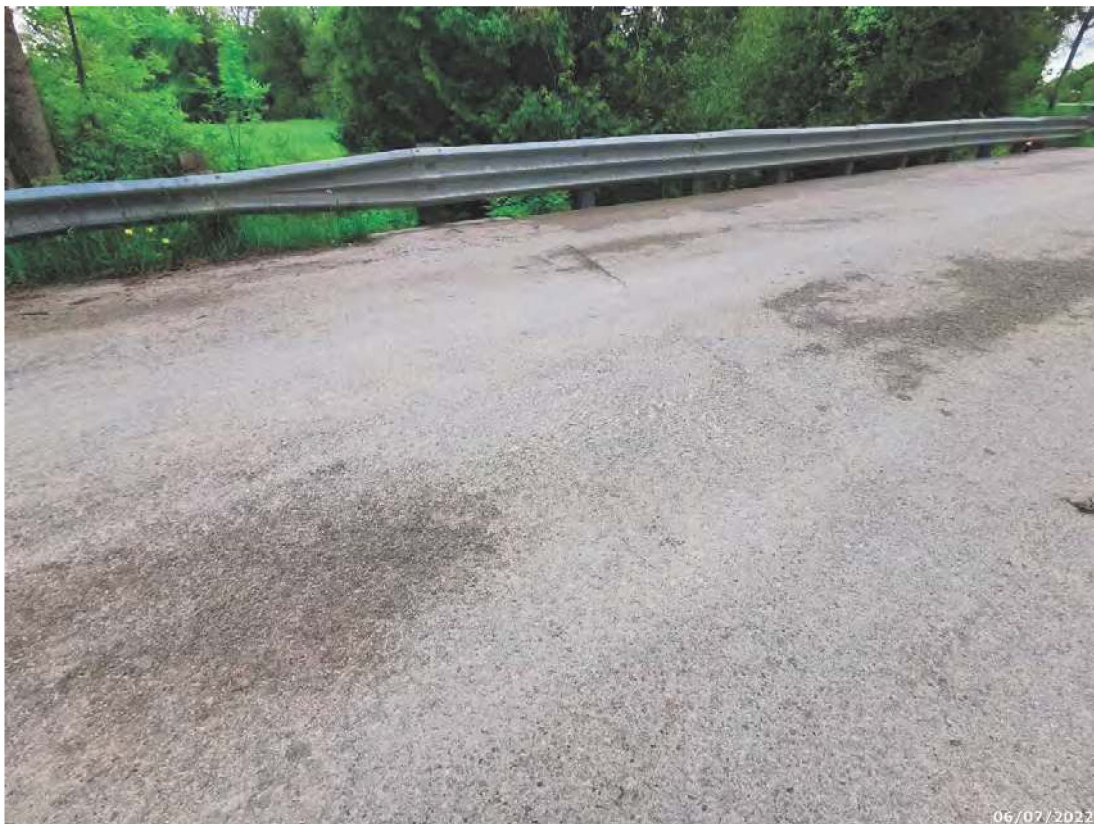
Settlement of east approach

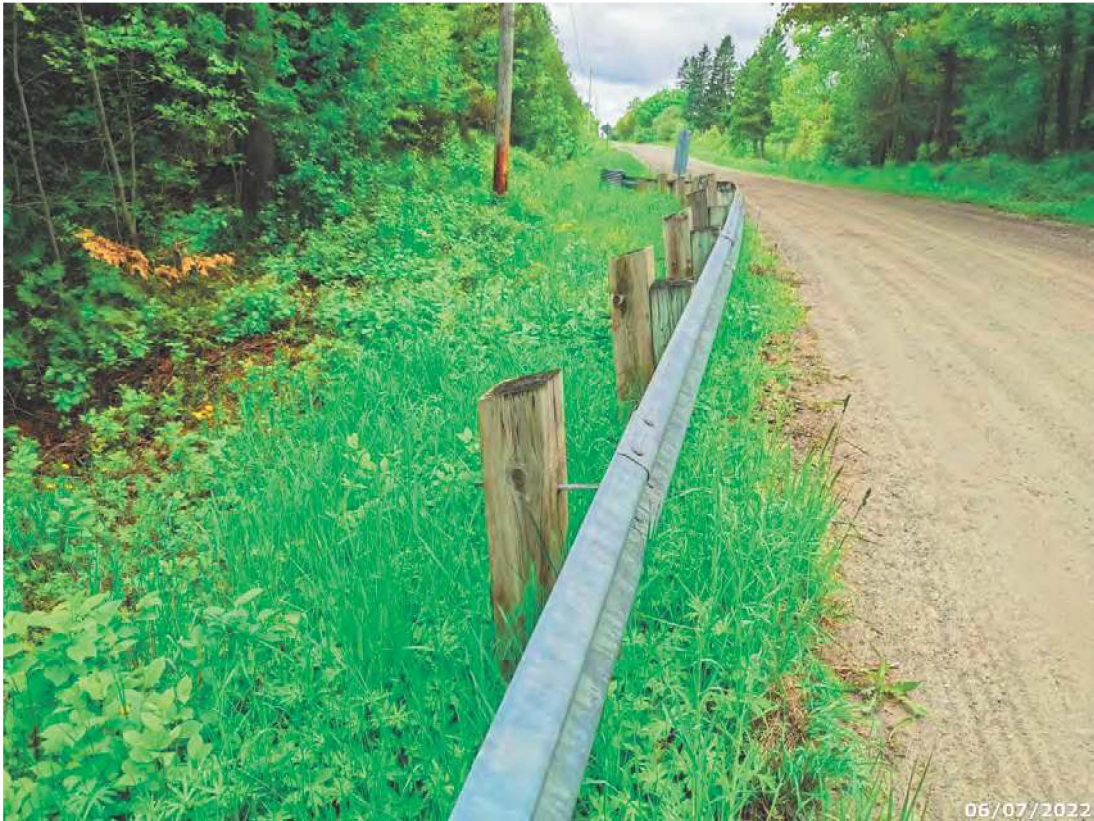
Rotated approach guiderail and missing spacer block, southwest approach

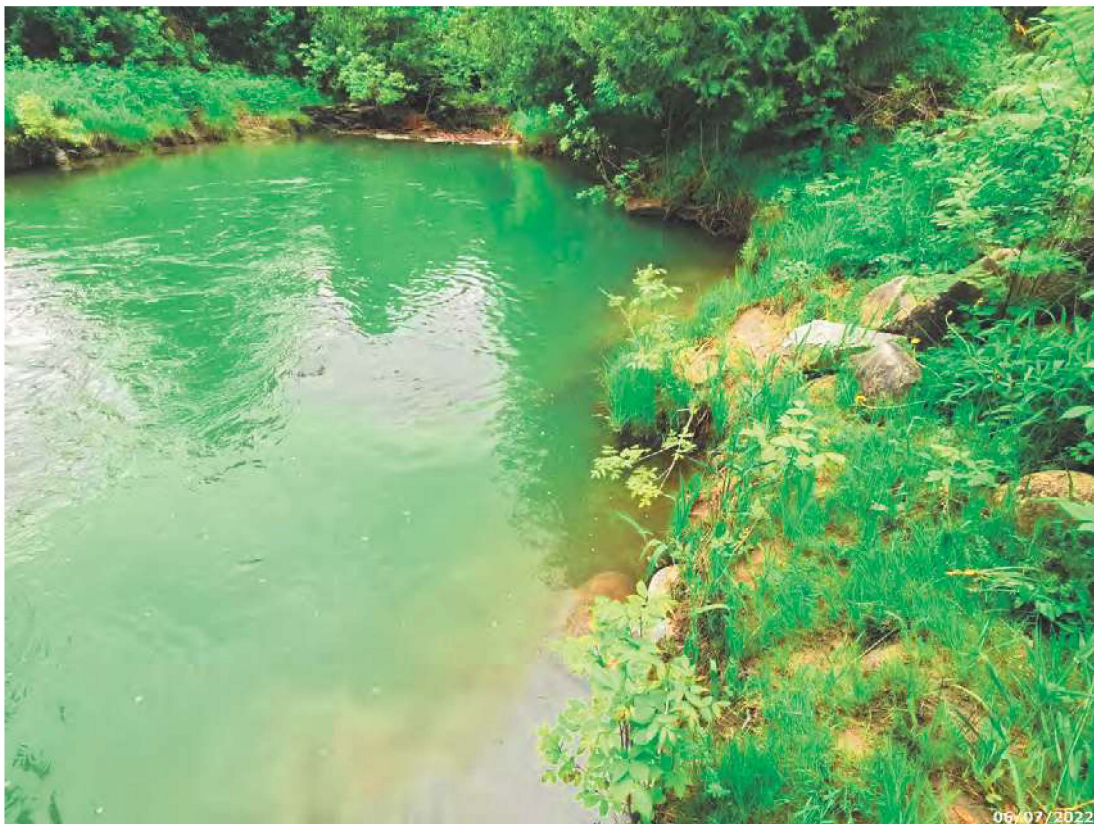
Downstream scour and undermining

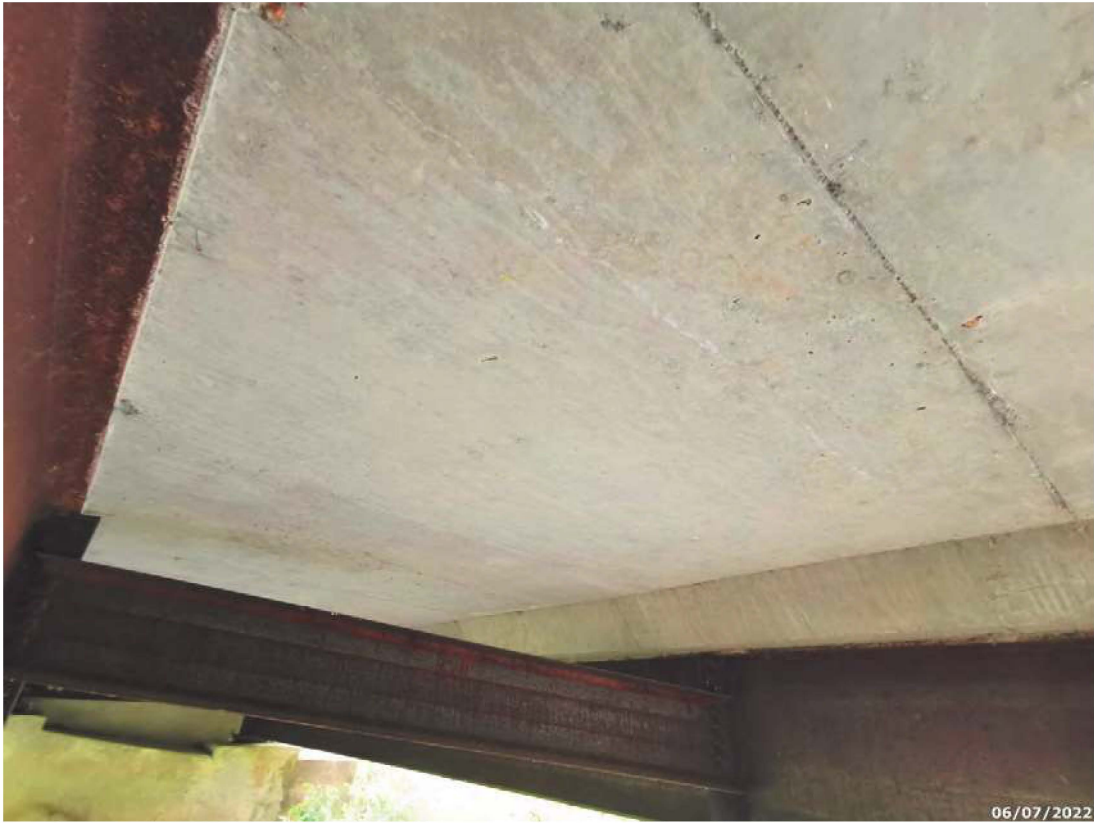
Localized crack with efflorescence

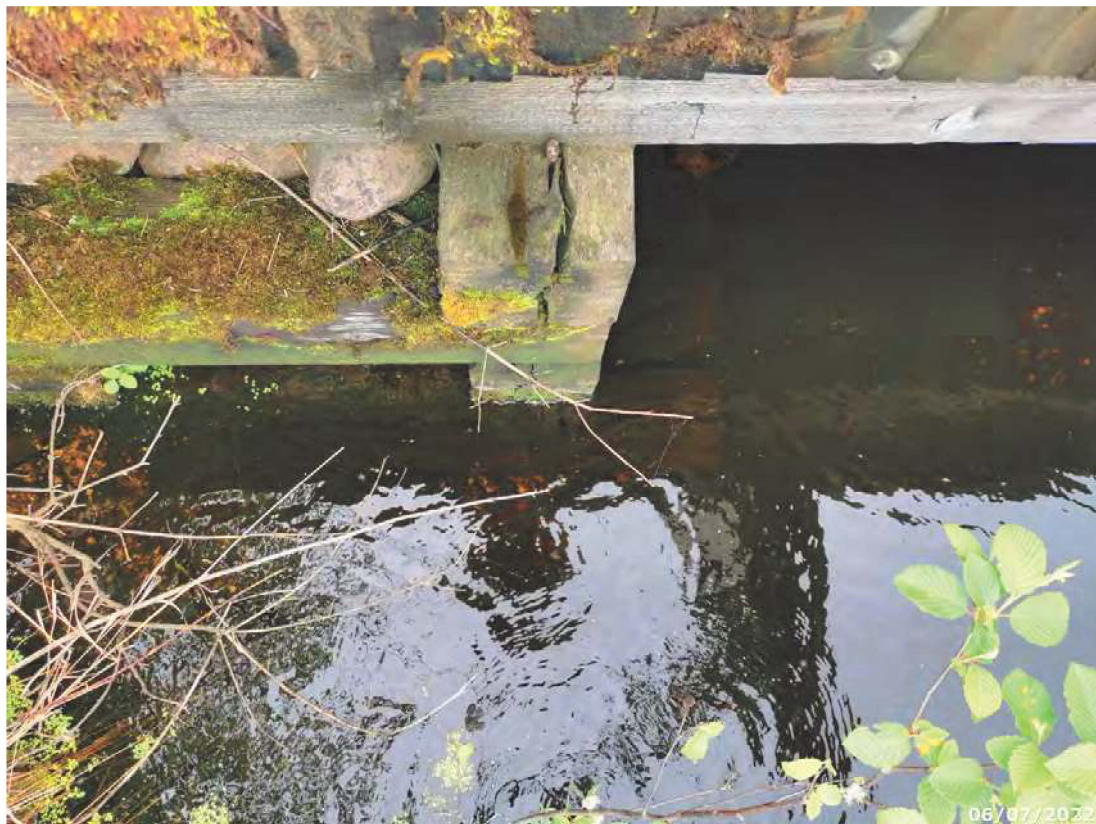
Northeast abutment cribbing with moderate decay, lichen growth and wide split through dowel

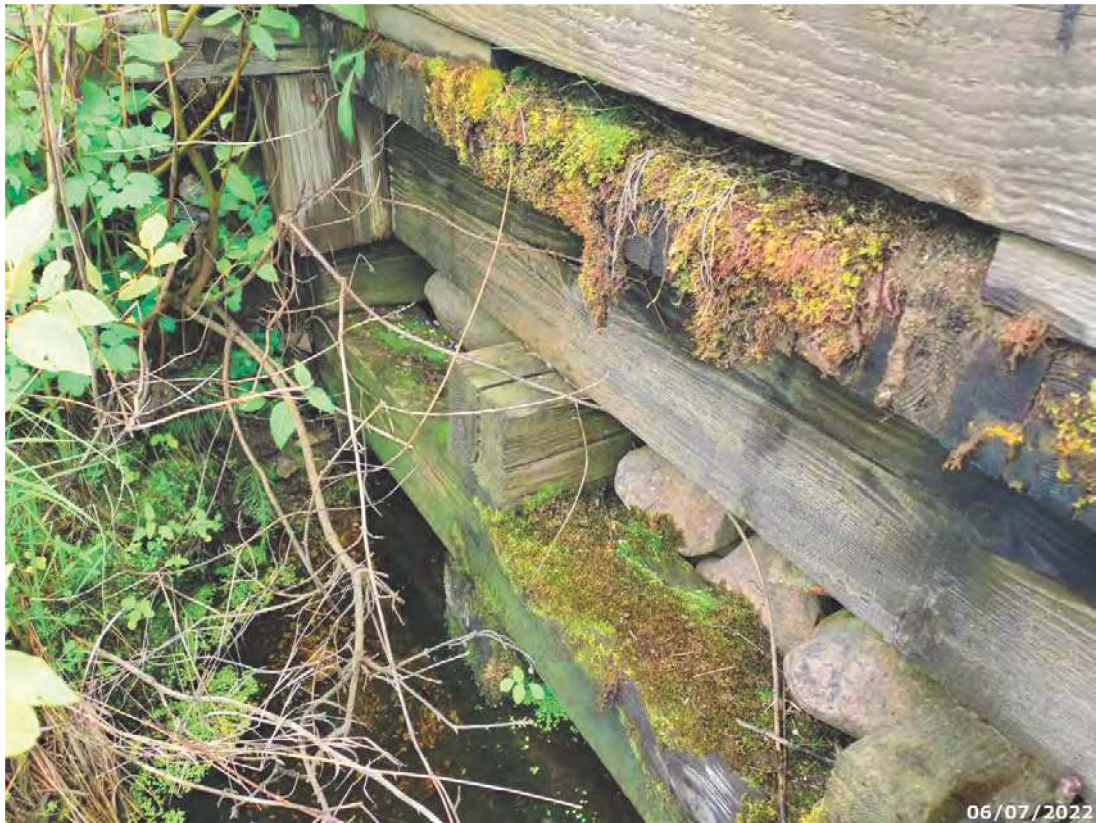
Typical edge of deck with algae and lichen growth

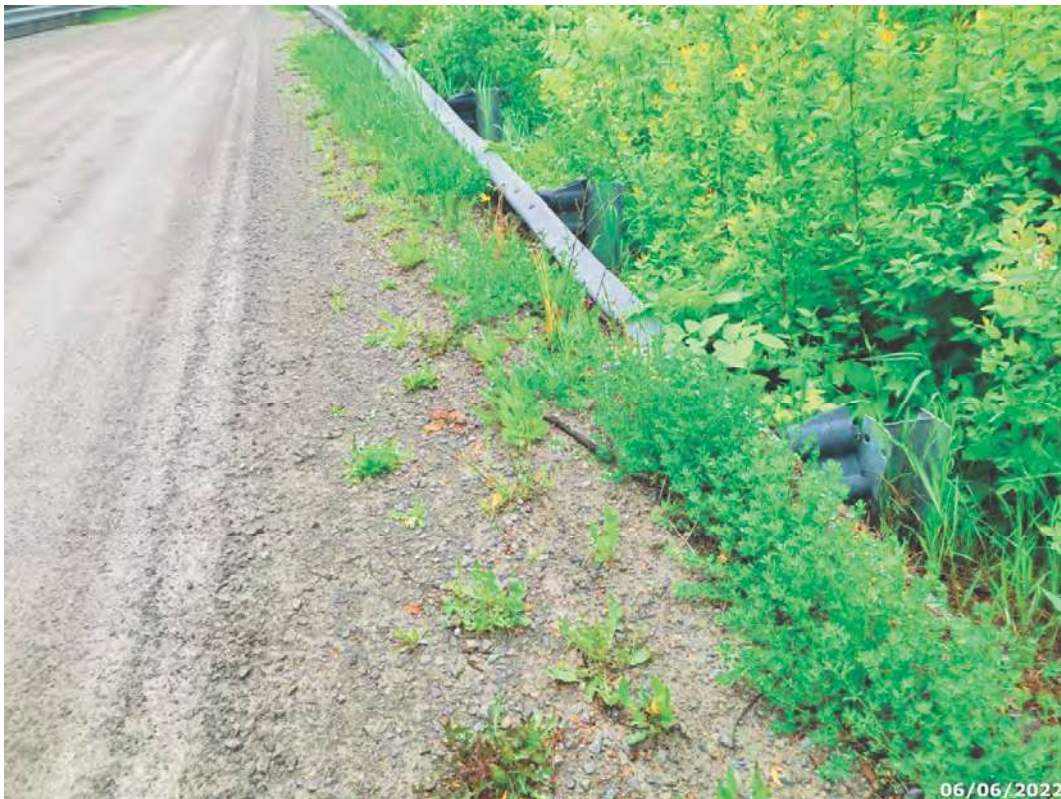
Northeast approach guiderail, broken spacer block, vegetation encroaching

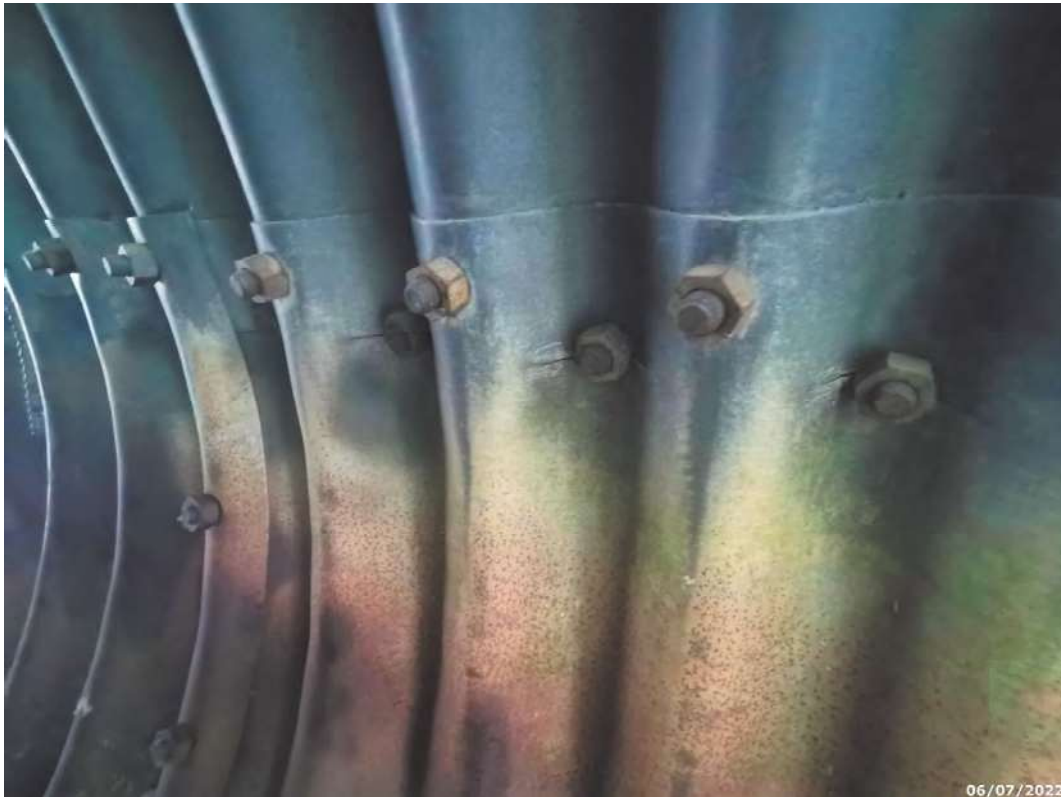
Cracking at Bolt Line Along West Wall

Culvert barrel is generally in good condition but rebar should be welded in at all crack locations to prevent any further cracking. The cable guiderail has several rotten posts that will need to be replaced within 5 years. Guiderail delineators should be installed to assist the snow plow during winter months. Rock protection is required to stop erosion/scour beyond the concrete cutoff walls on the inlet and outlet pool.

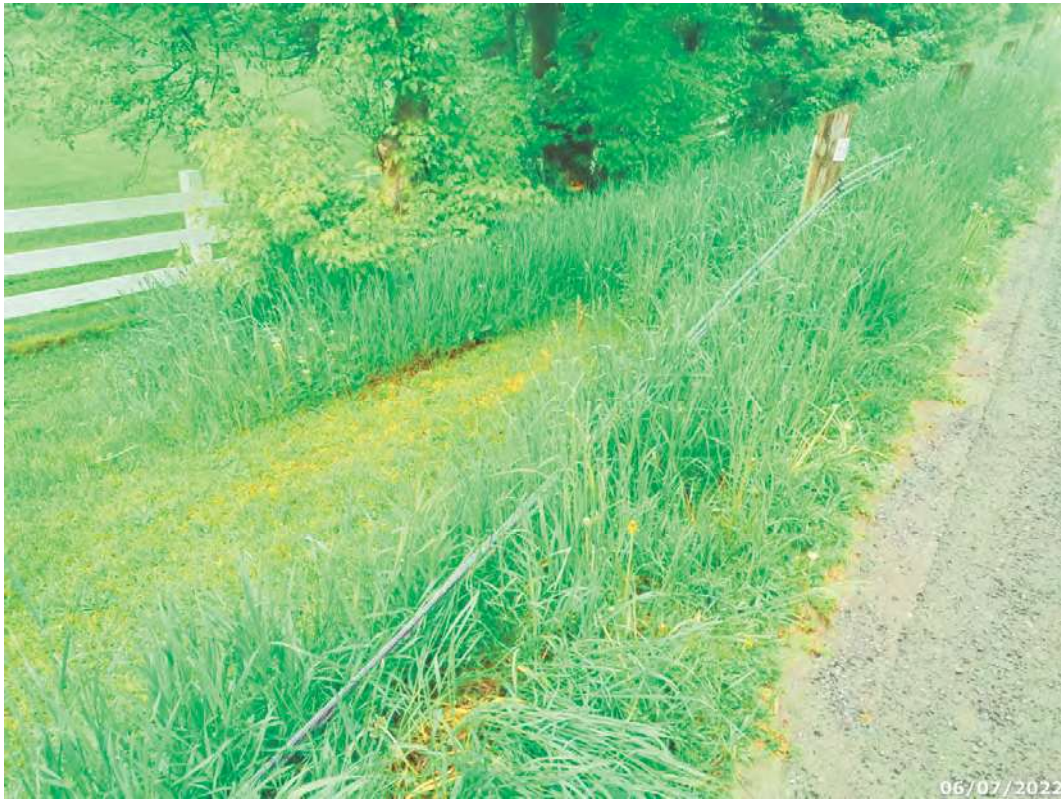
Broken and missing guiderail post in northwest quadrant

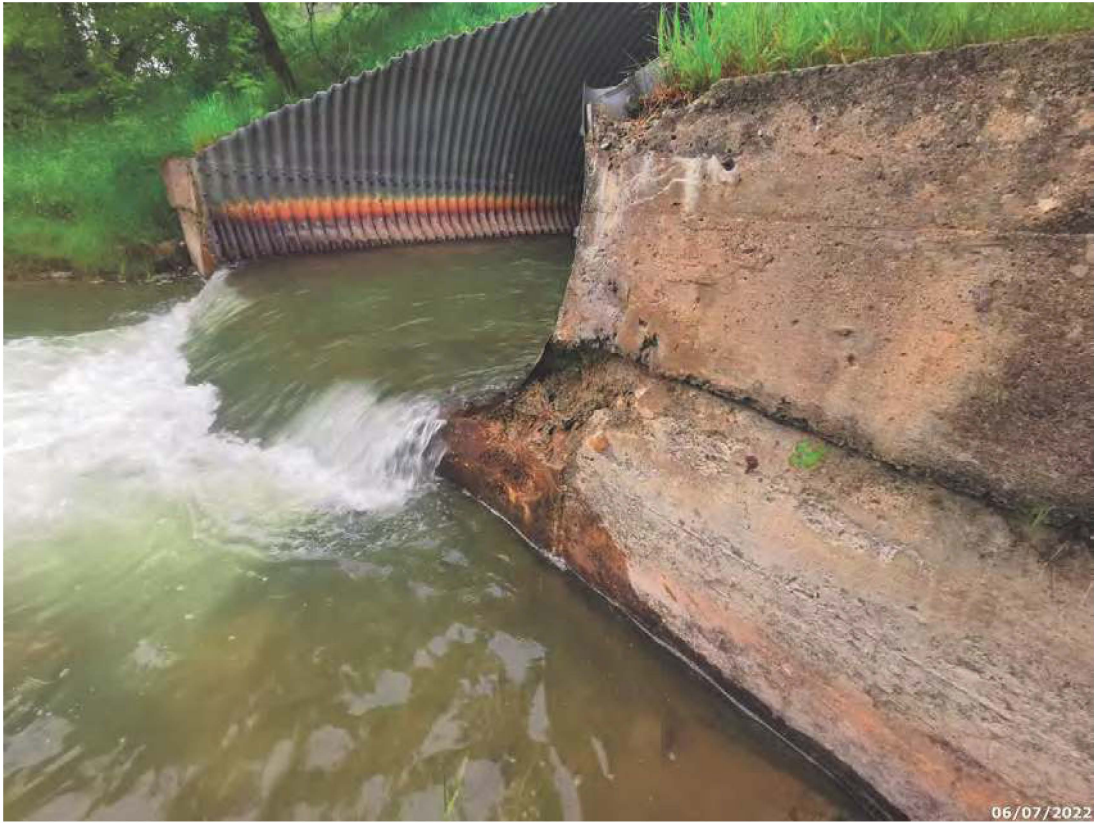
Moderate spall on southeast outlet cutoff wall

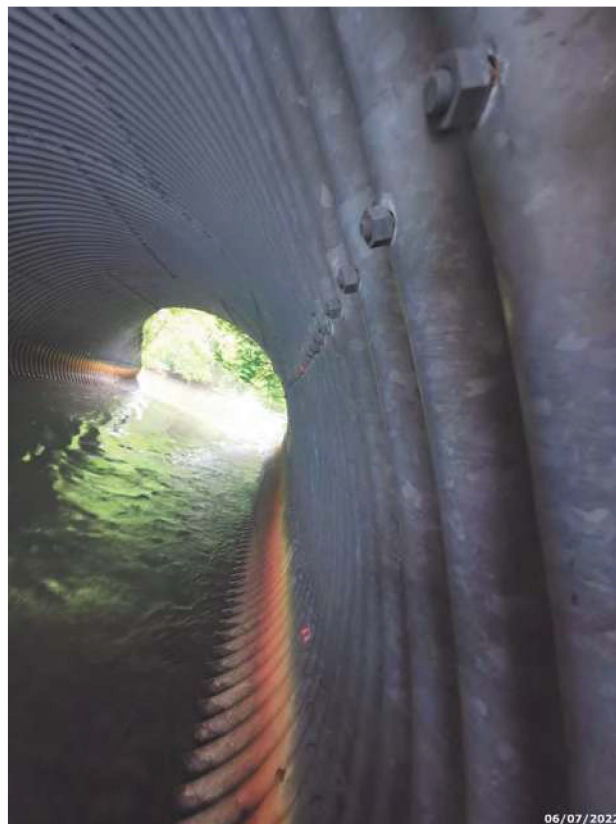
Bulge in east wall at south shoulder

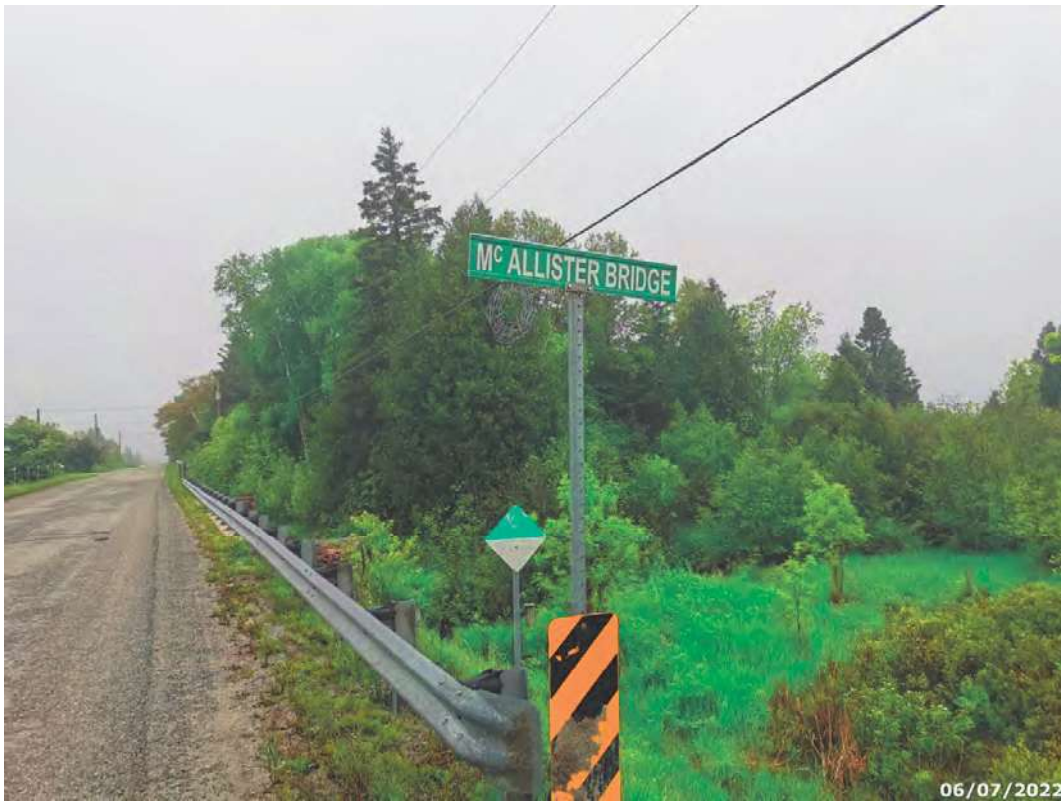
Bridge sign and dirty hazard marker

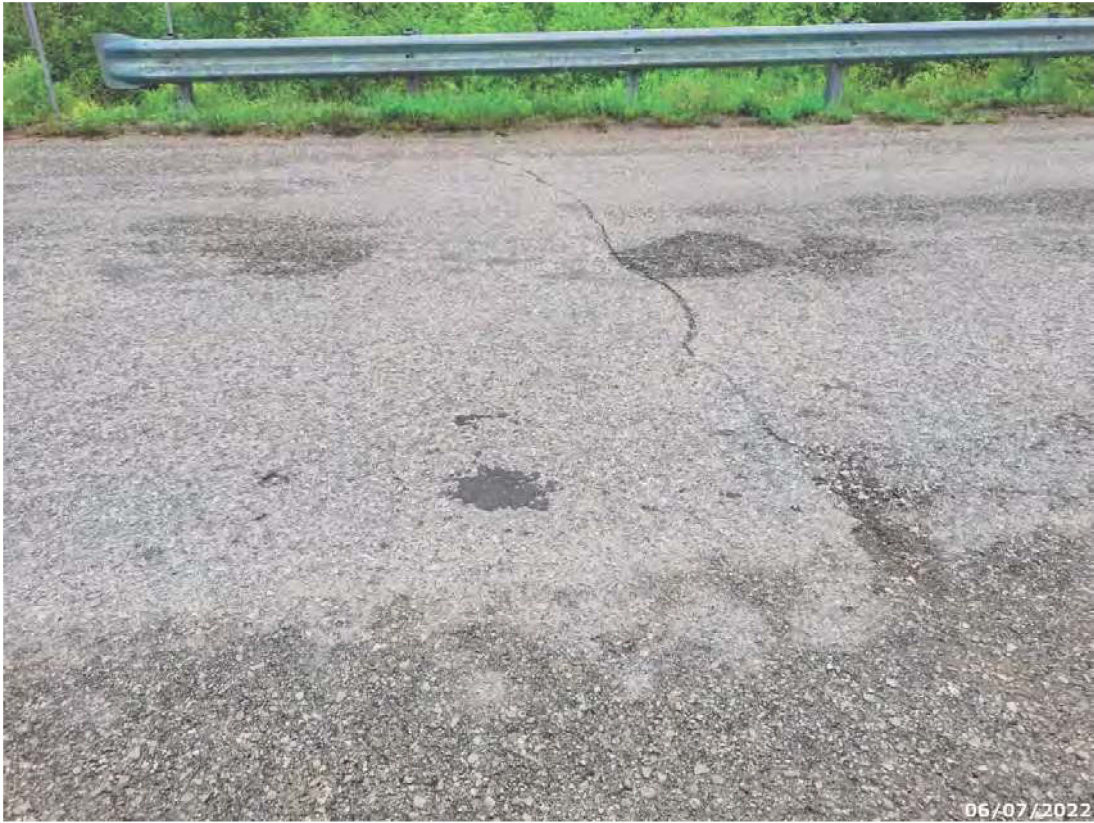
Medium transverse crack in north approach

Monitor efflorescence and water staining at joint between the culverts. Seal cracks in wearing surface to prevent excess water penetration. Remove gravel buildup under the barriers around base plates.

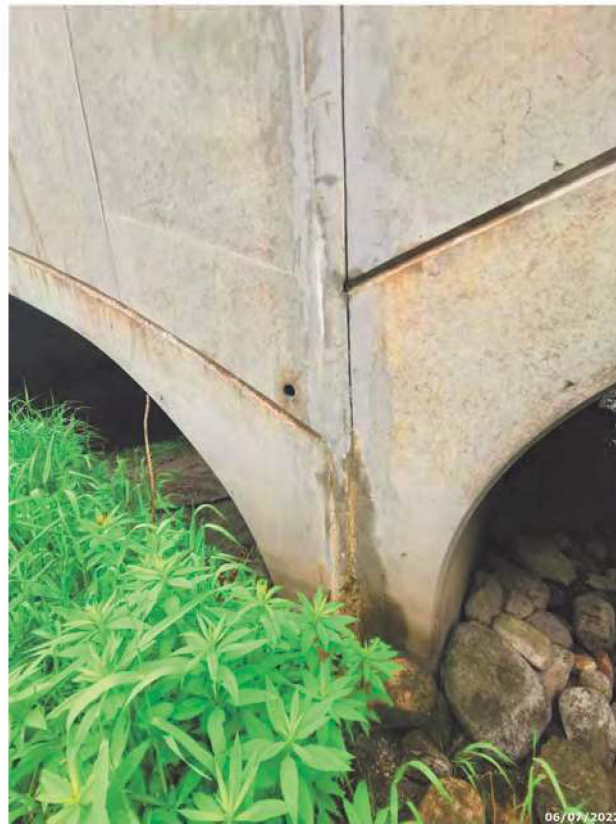
Moisture and wetting of center joint

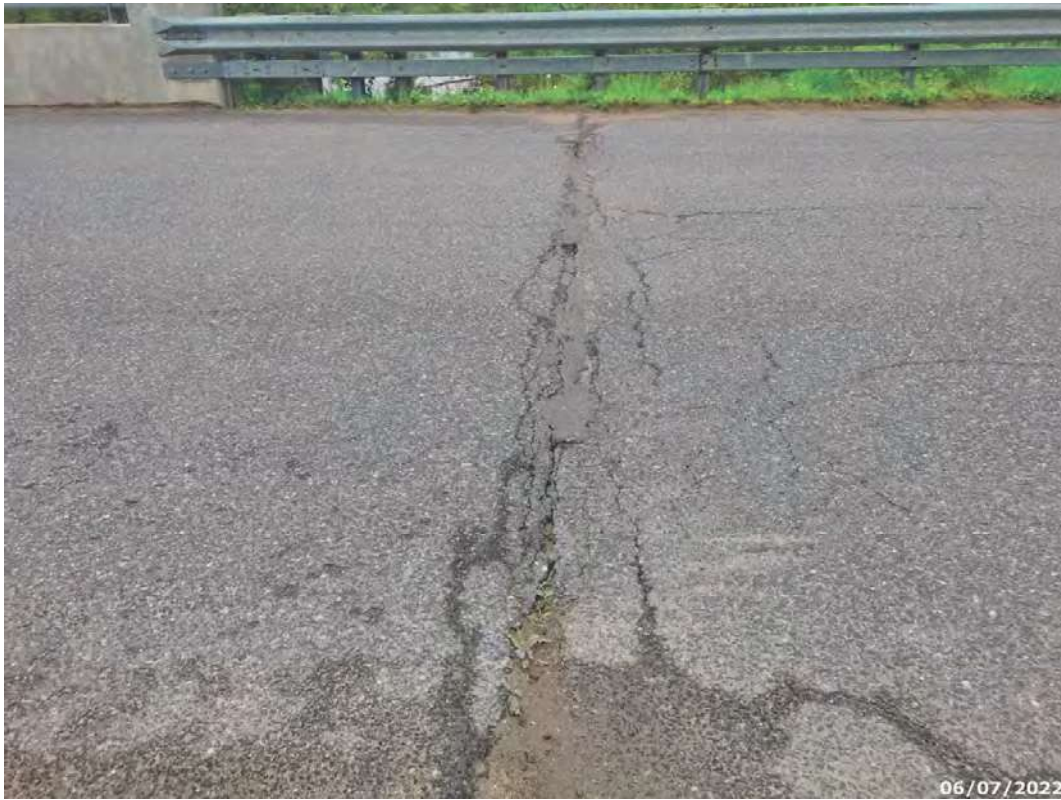
Wide transverse cracking and potholes at end of approach

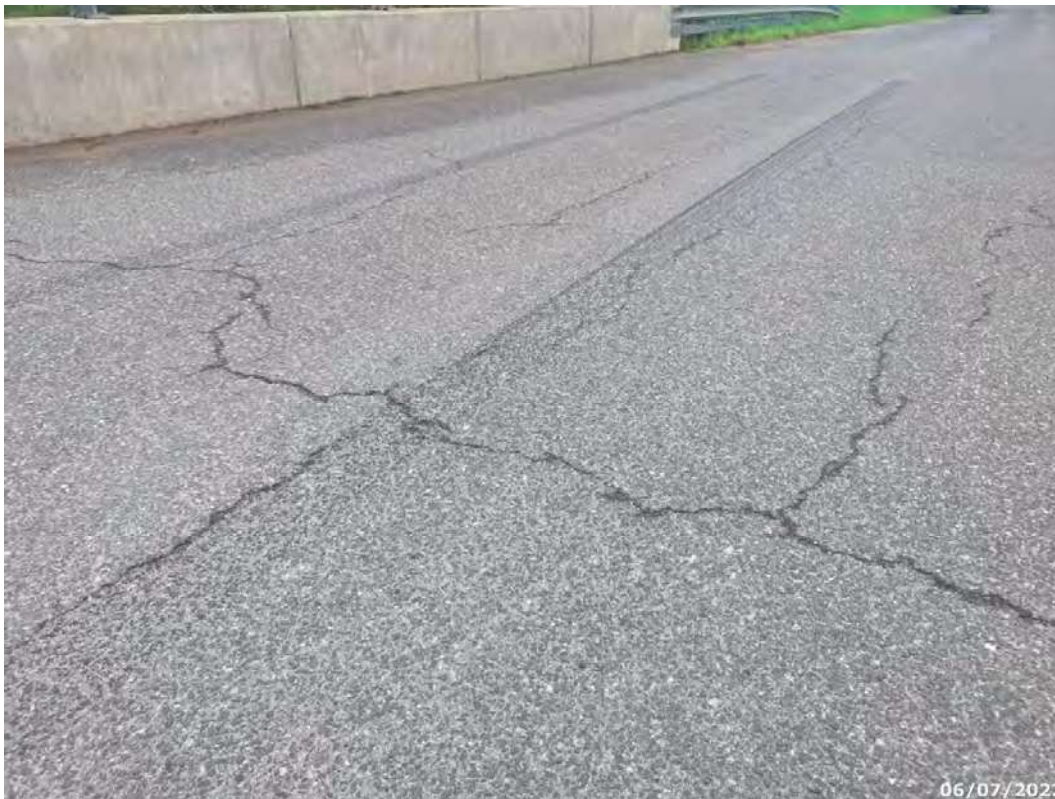
Light to medium map cracking in bridge deck wearing surface

Cracking in asphalt should be rout and sealed as well as the cracking in the concrete sidewalk. Clean bridge deck as a part of yearly maintenance.

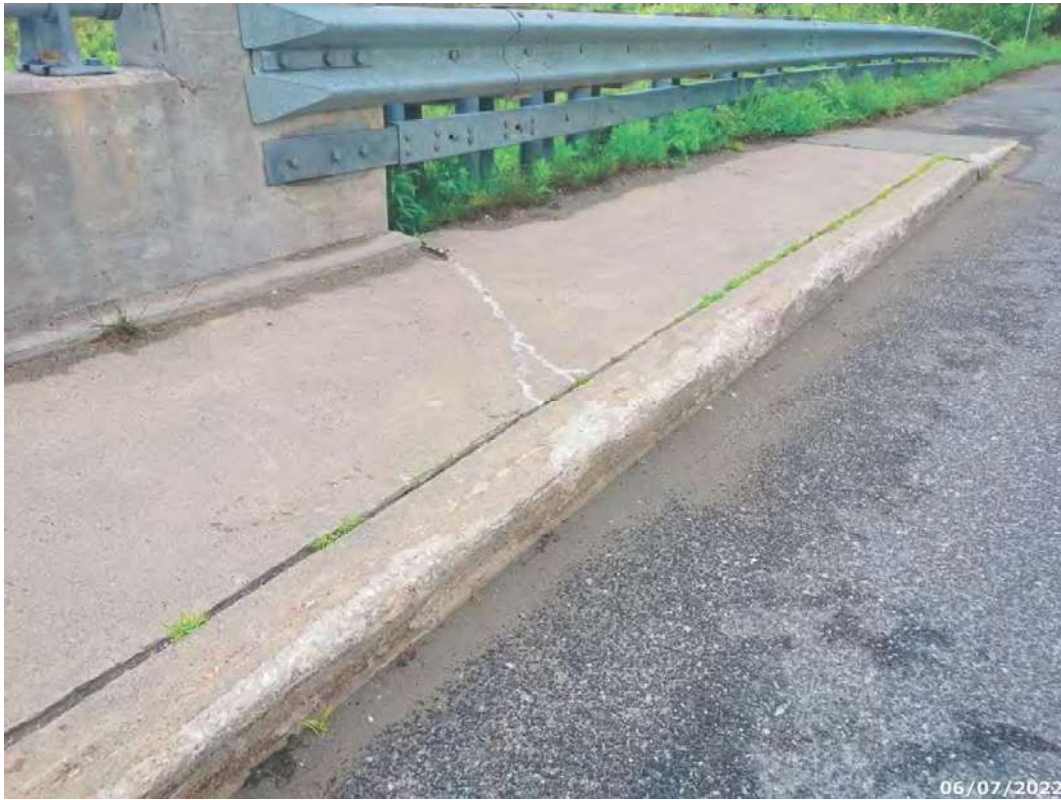
Sealed wide crack in approach sidewalk

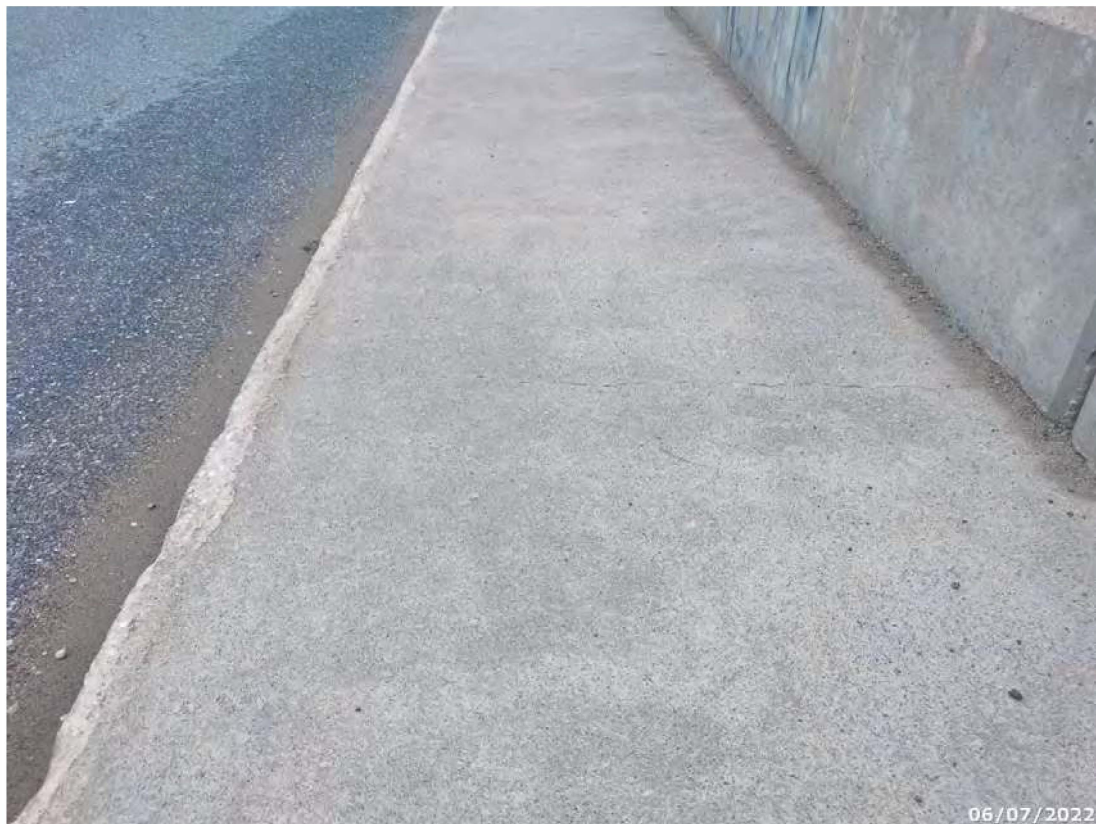
Typical sidewalk condition, localized medium transverse crack

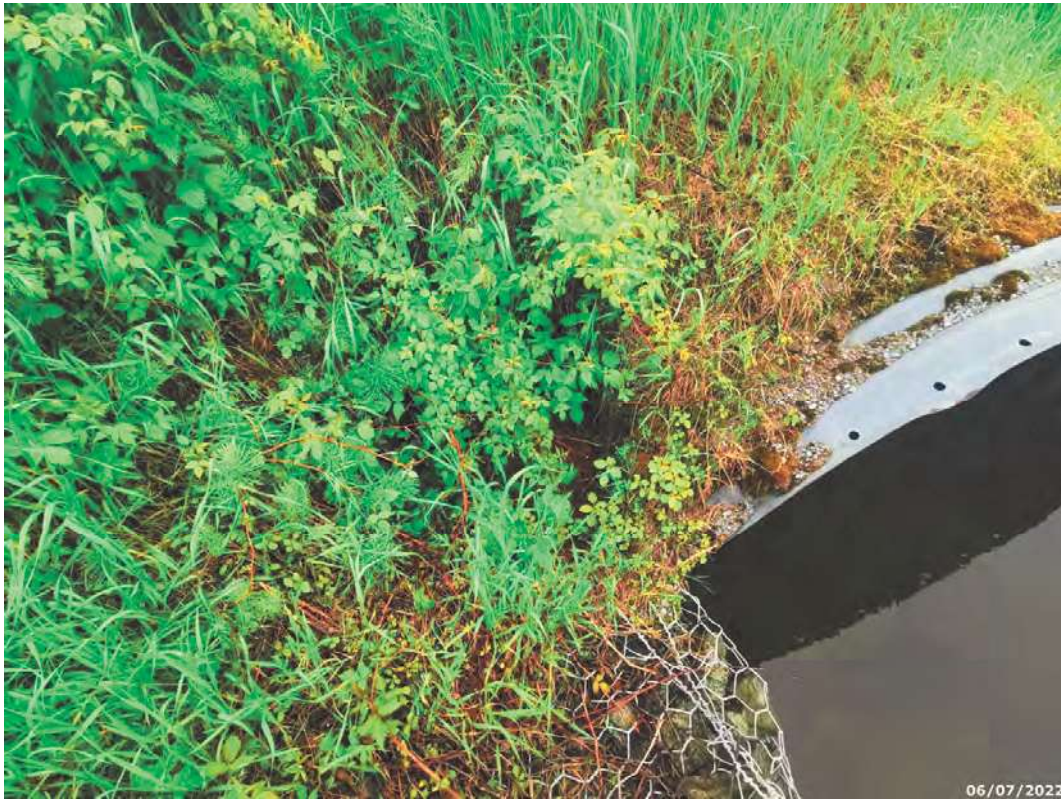
Erosion channel behind failed gabion basket

Washout in Northeast quadrant should be backfilled and packed to ensure no further damage to roadway. Monitor gabion baskets for further movement/restricting flow into culvert.

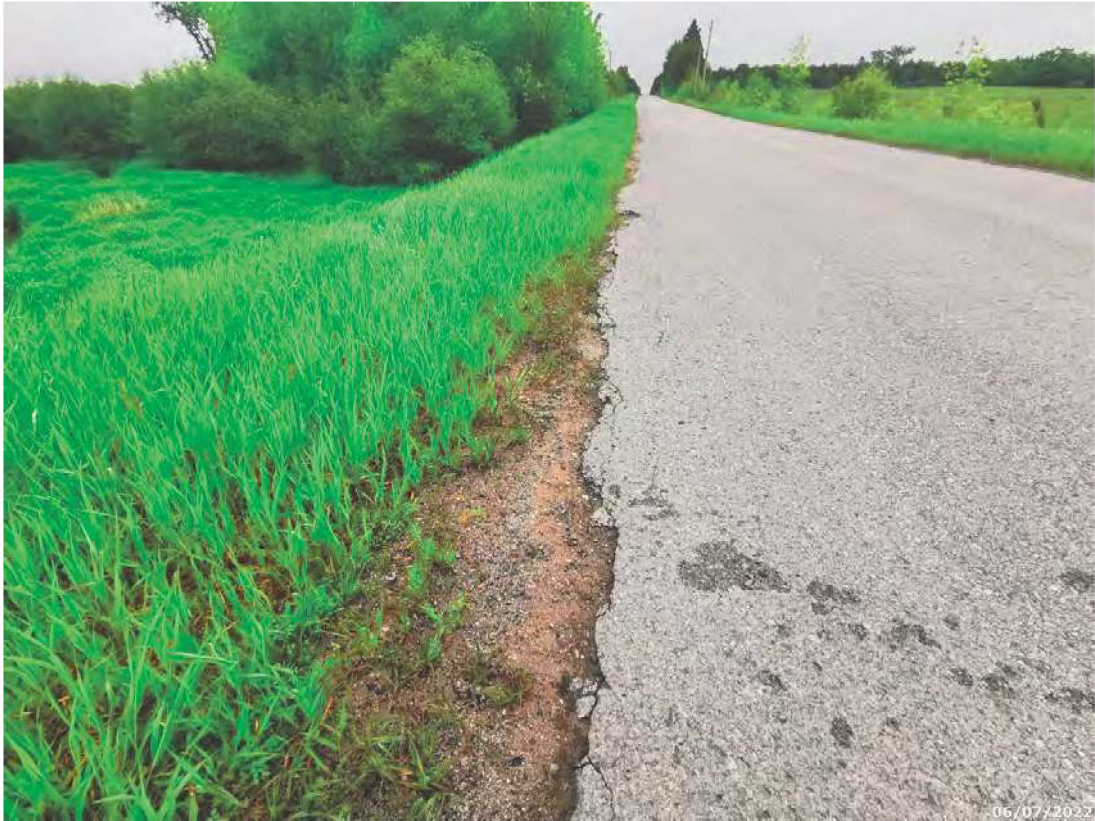
Potholes and broken shoulder edge of surface treatment

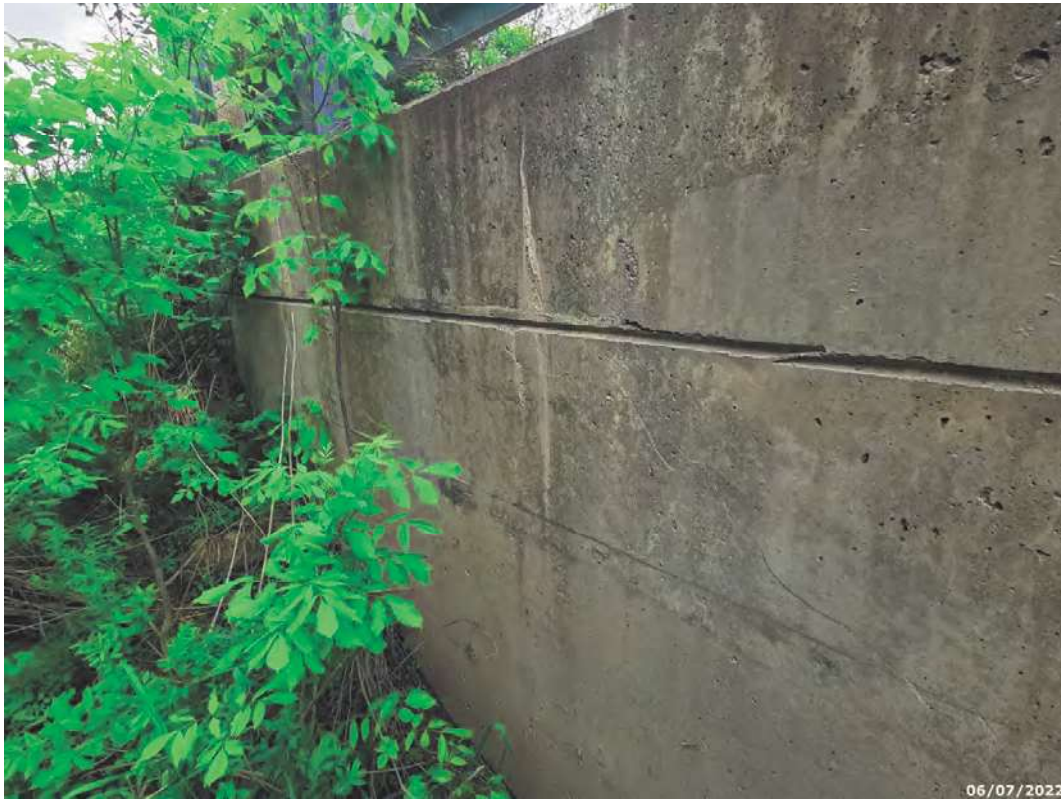
Localized stained medium crack at northwest wingwall

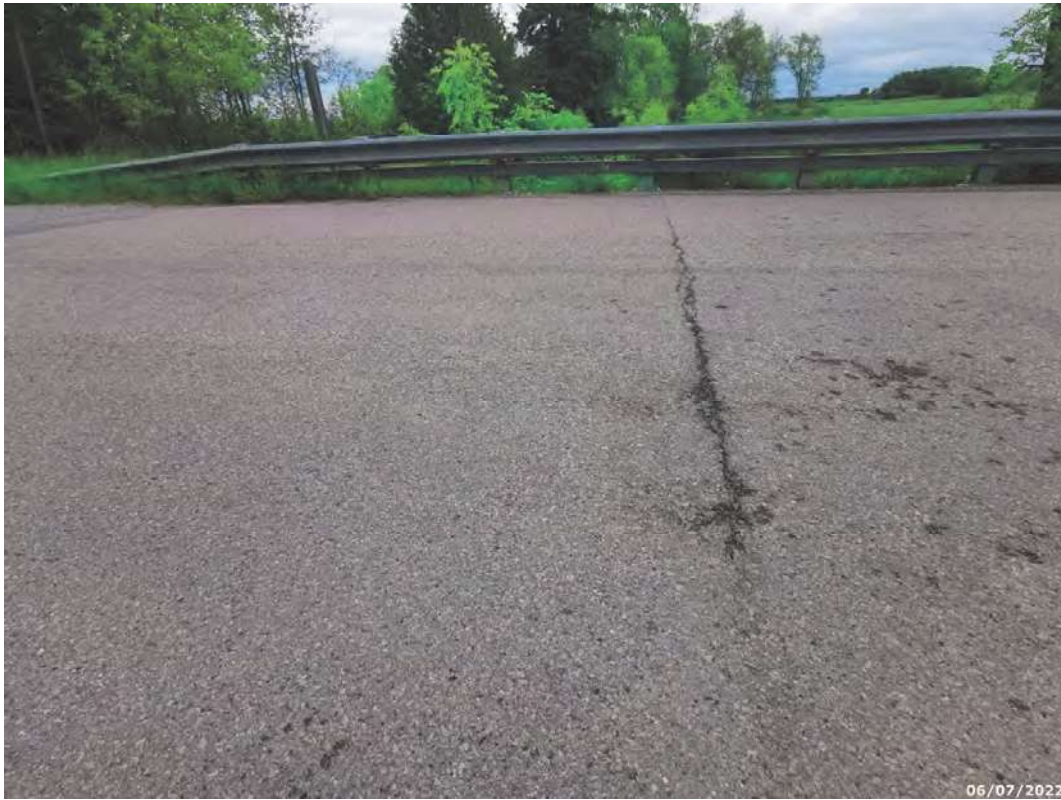
Medium to wide transverse crack in north approach
