THE MUNICIPALITY OF CENTRAL MANITOULIN

REQUEST FOR PROPOSALS 03-2026

FOR: Beaver Road East and West Bridges - Engineering Consulting Services for Design process.

Municipality of Central Manitoulin – 2022 OSIM Inspections

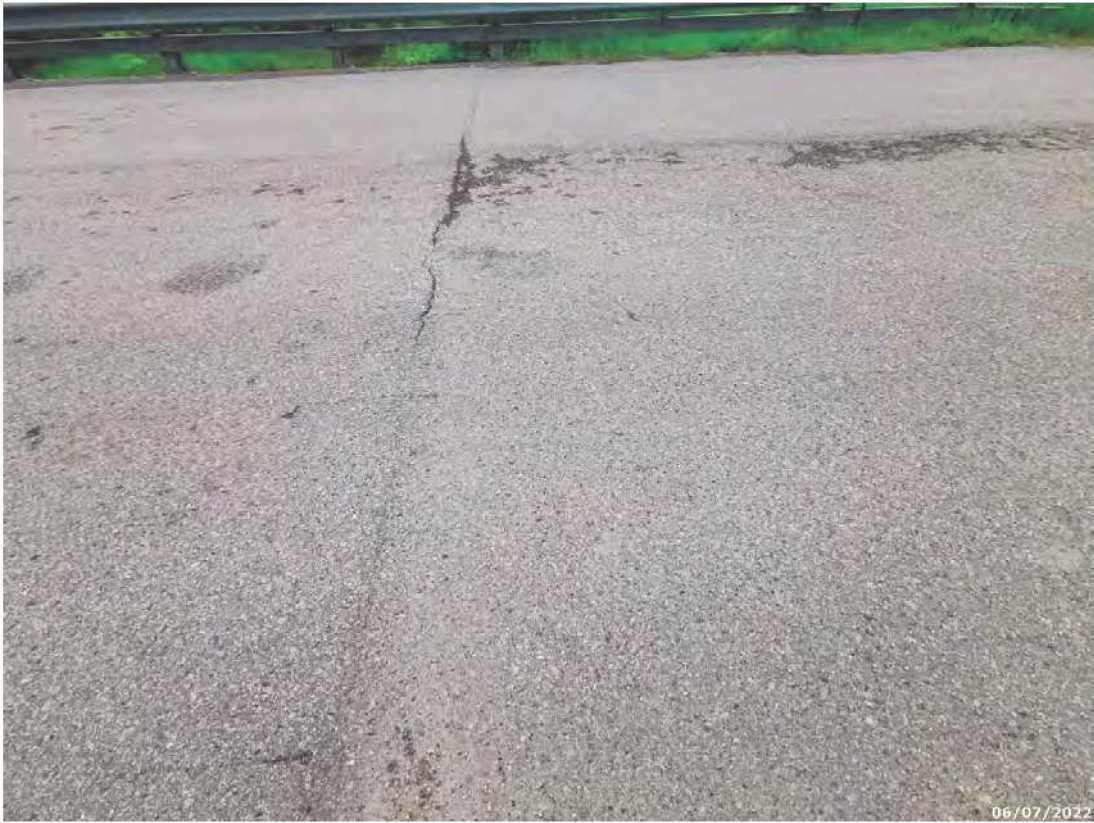
Light to medium transverse crack and settlement of south approach wearing surface

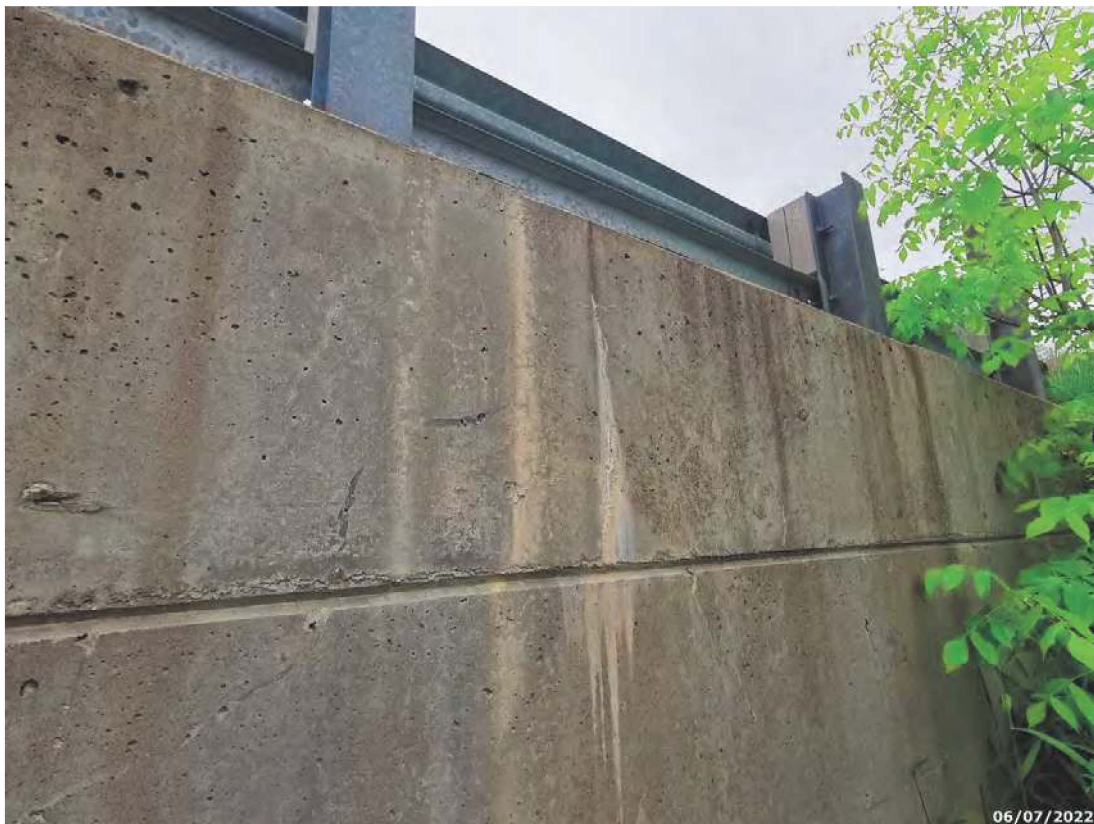
Localized stained vertical crack at northeast wingwall

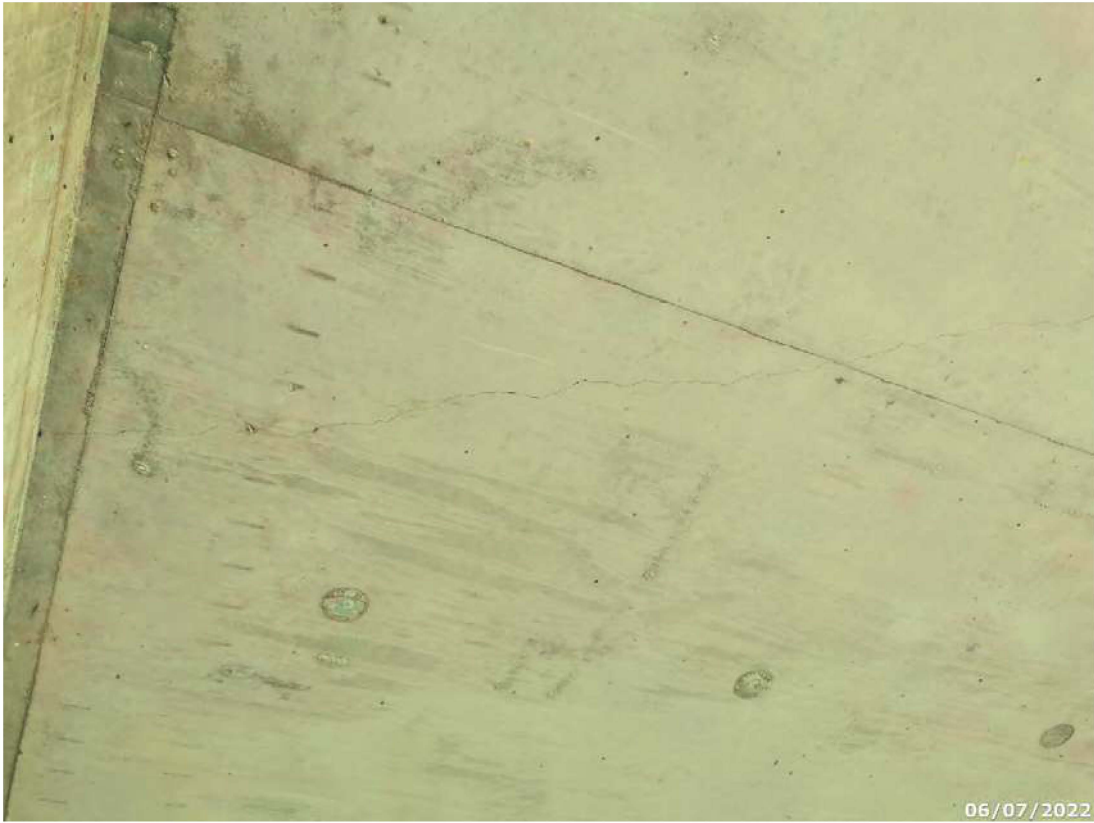
Medium crack in soffit in southeast quadrant

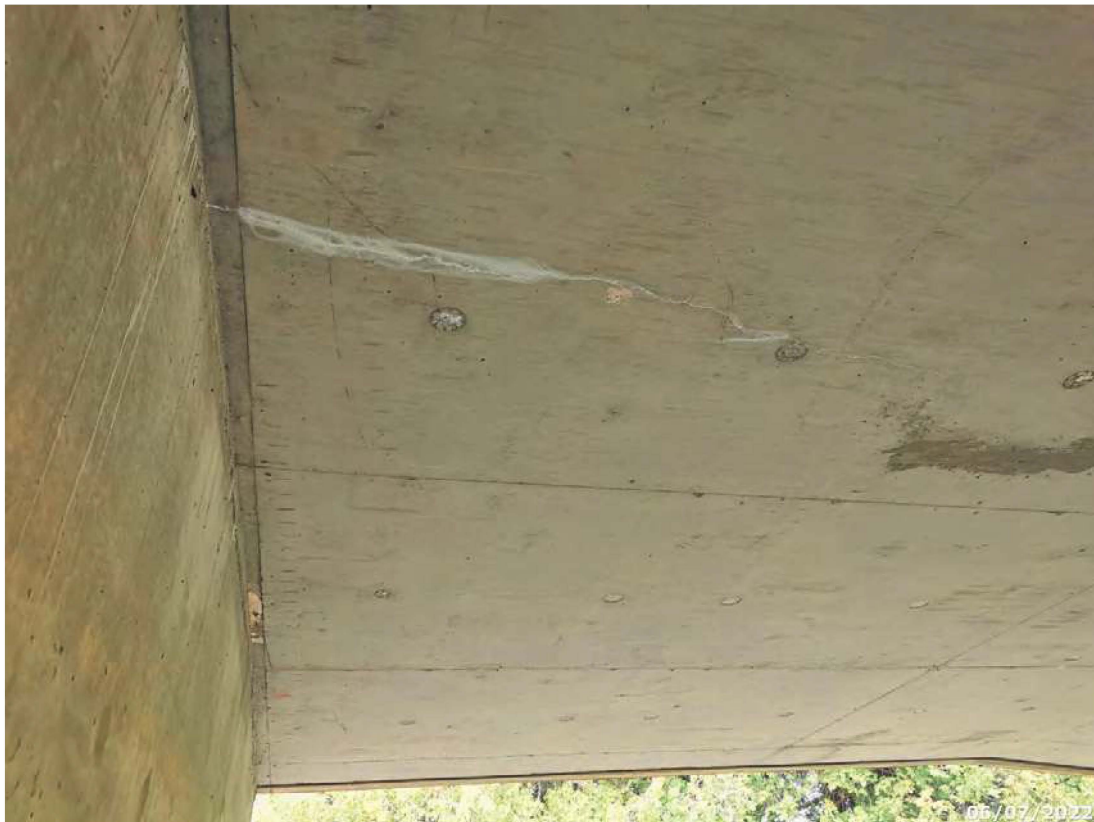
Medium to wide stained crack in soffit

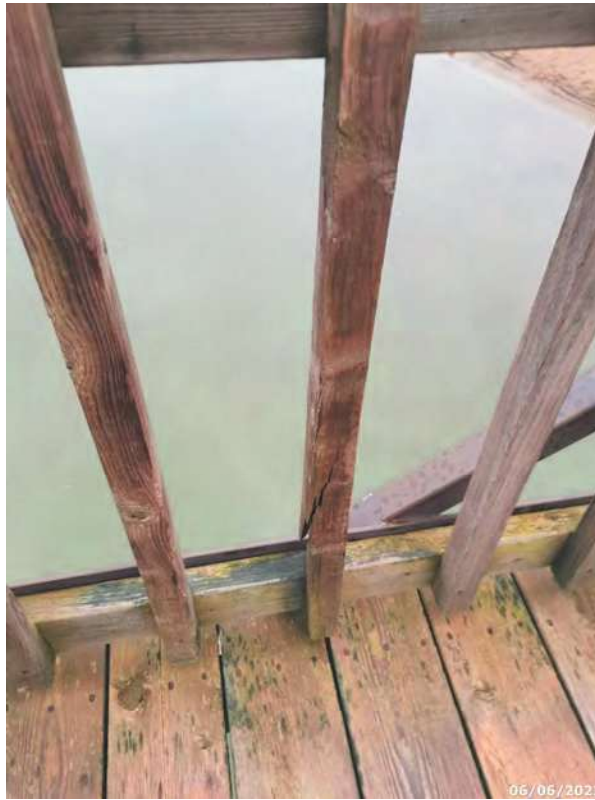
Broken picket

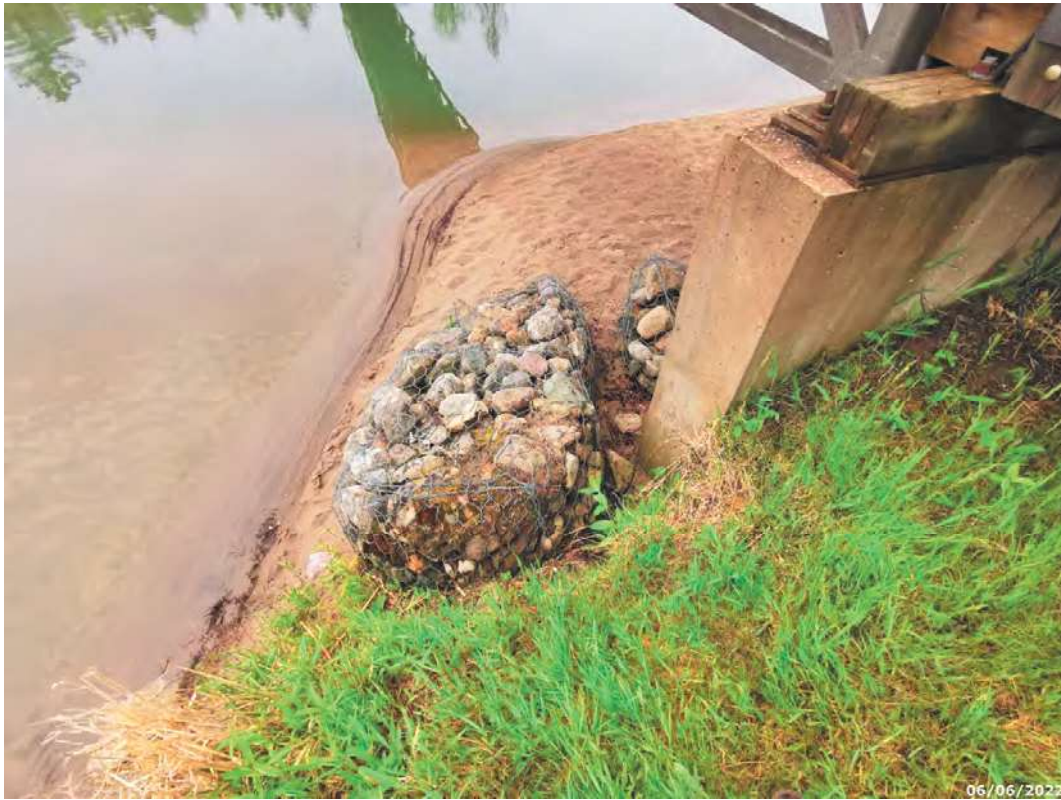
Failed and rotated gabien basket

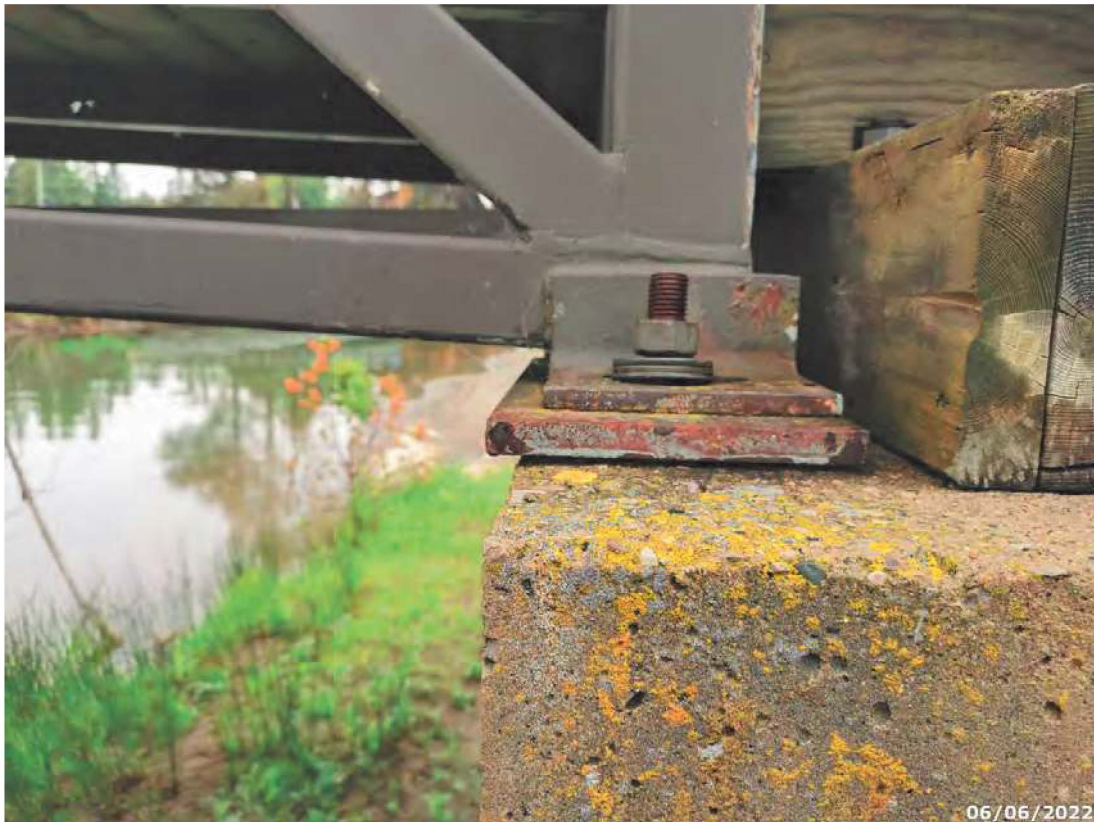
South bearing general arrangement, loose anchor nuts

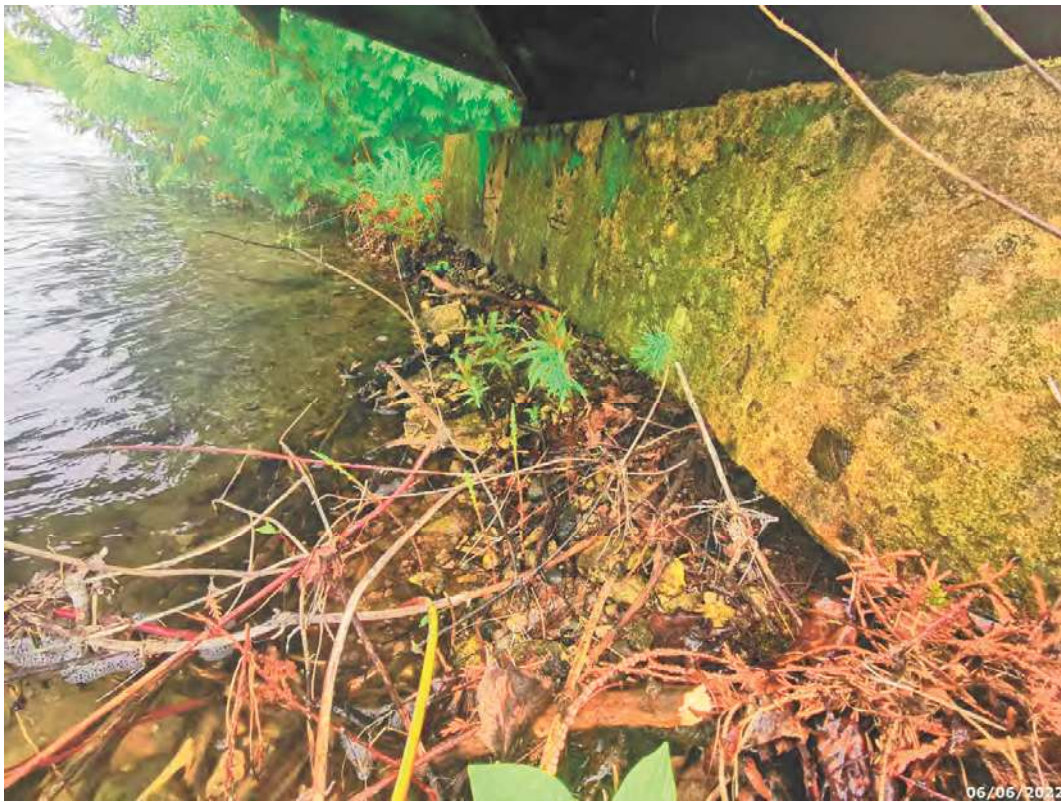
Moderate to severe undermining at south abutment

Bearing material under the abutments has eroded and should be replaced to stabilize abutments.

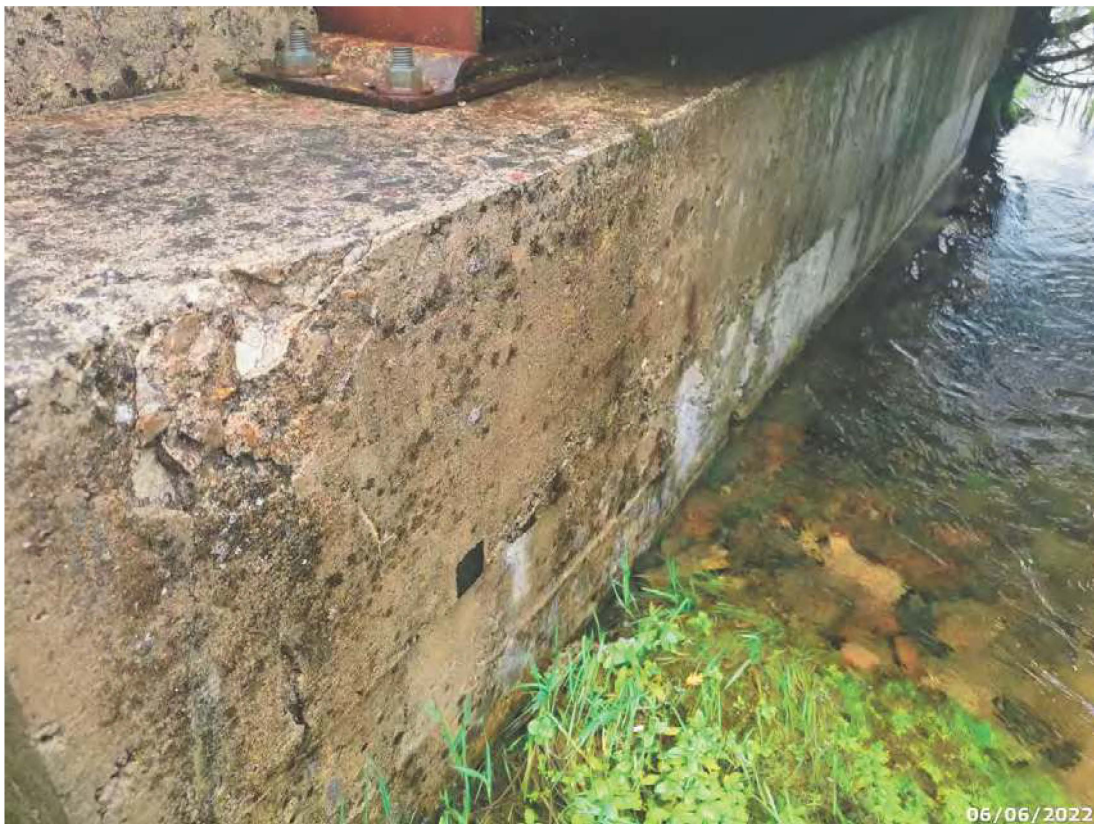
North abutment general arrangement, light spall and undermining at south edge

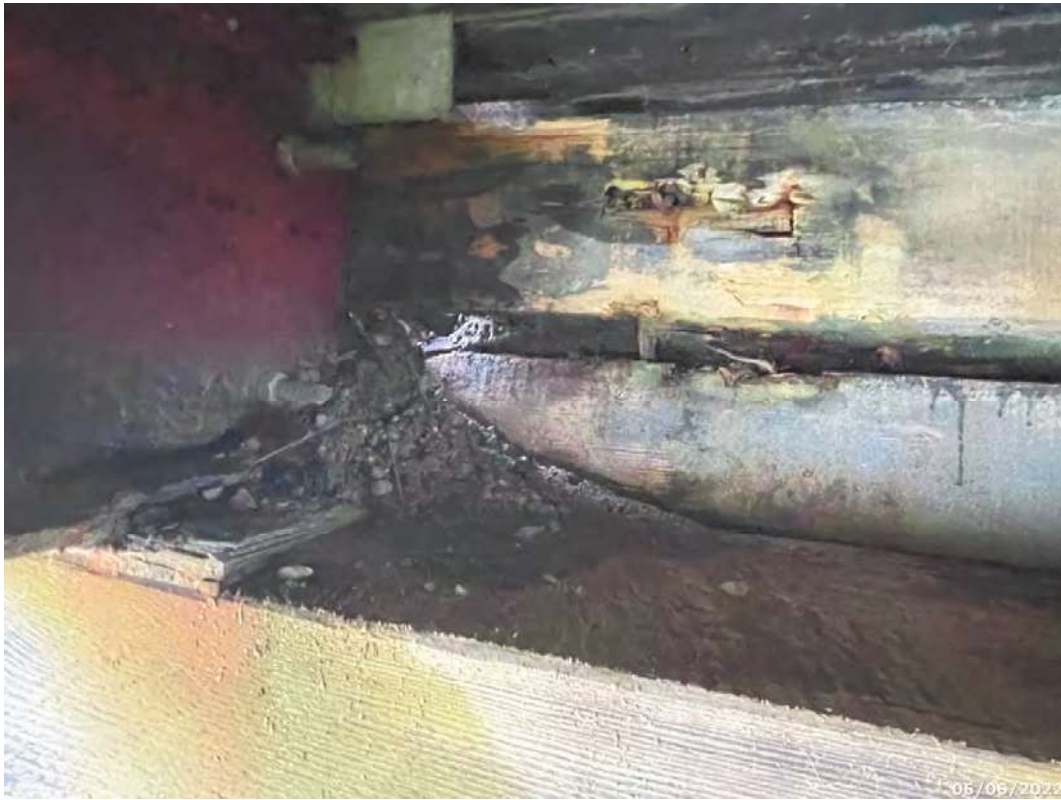
Severe Decay in Ballast Wall - Typical

Steel girders, bearings and ballast walls are in poor condition and should be replaced/repared within 1 year. If funding is not immediately available to replace the girders, the bearings should be cleaned and bearing stiffeners added to temporarily reinforce the bridge until the girders and bearings can be replaced. Annual cleaning of the bearings is required on all bridges.

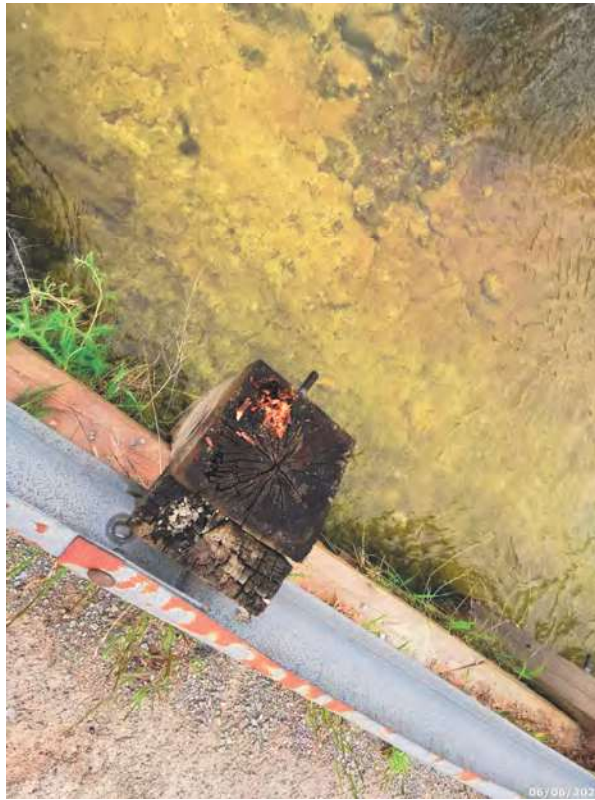
Typical decay of barrier posts

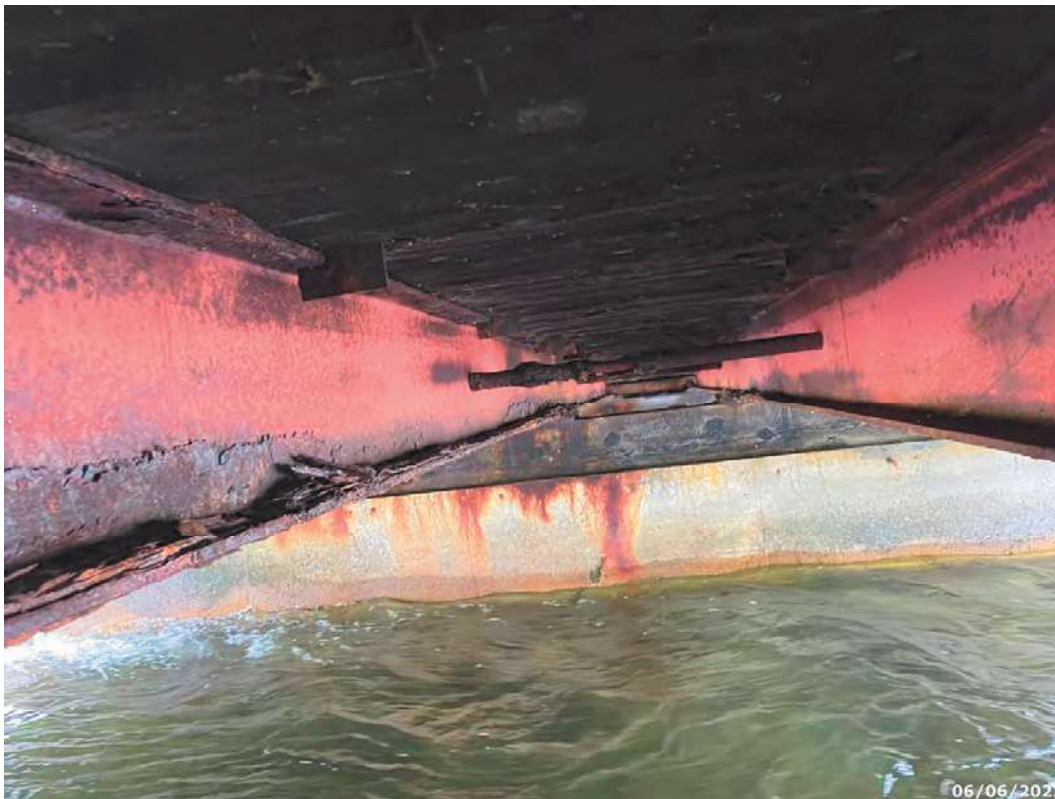
Severe corrosion in bottom flange, predominantly on centerline girder only

Steel girders to be replaced. Temporary stiffeners/repairs needed in the center girder, east span as soon as possible.				<input checked="" type="checkbox"/> Urgent <input type="checkbox"/> 1 year <input type="checkbox"/> 2 year

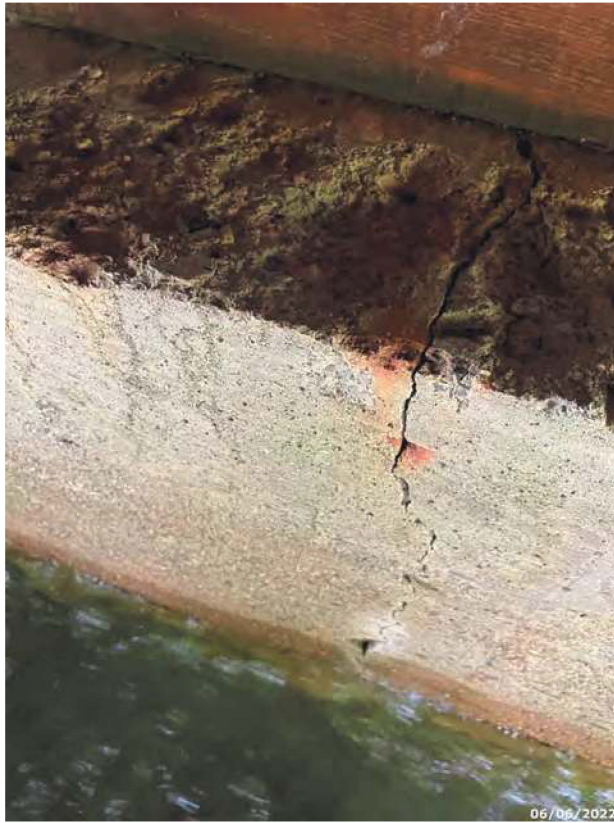
Wide crack in west abutment

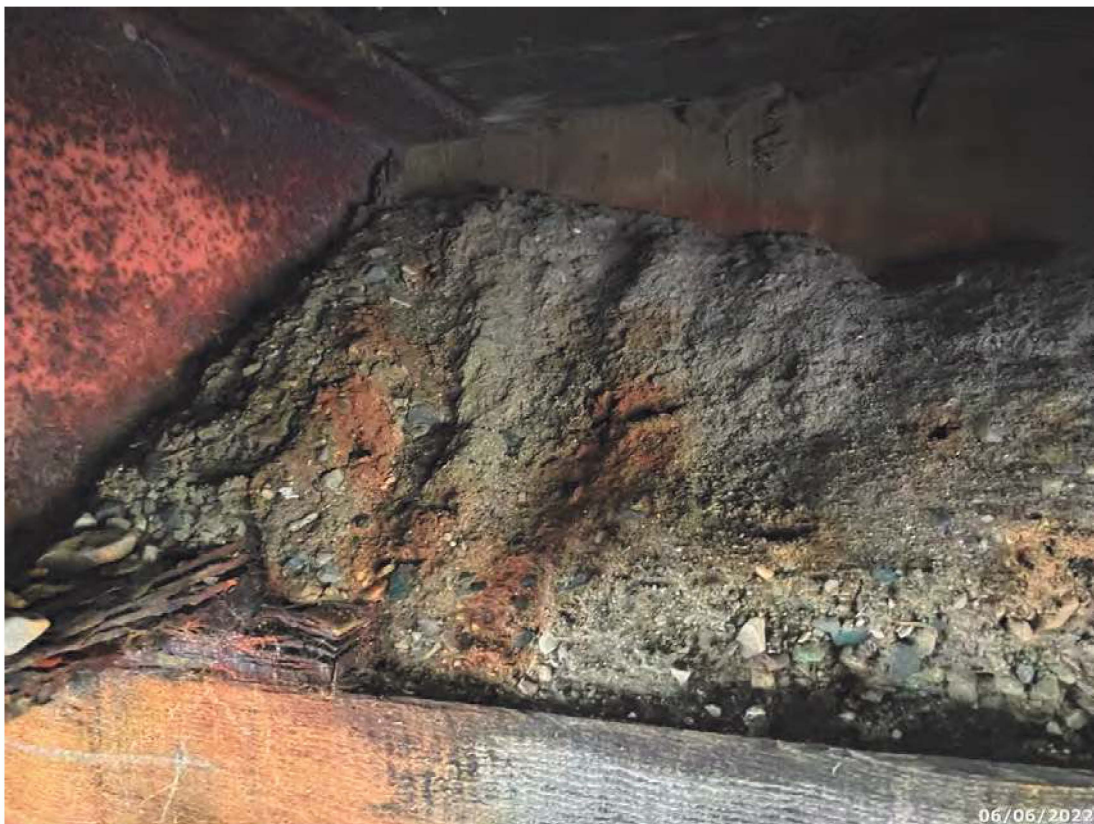
Severe debris build up at bearings

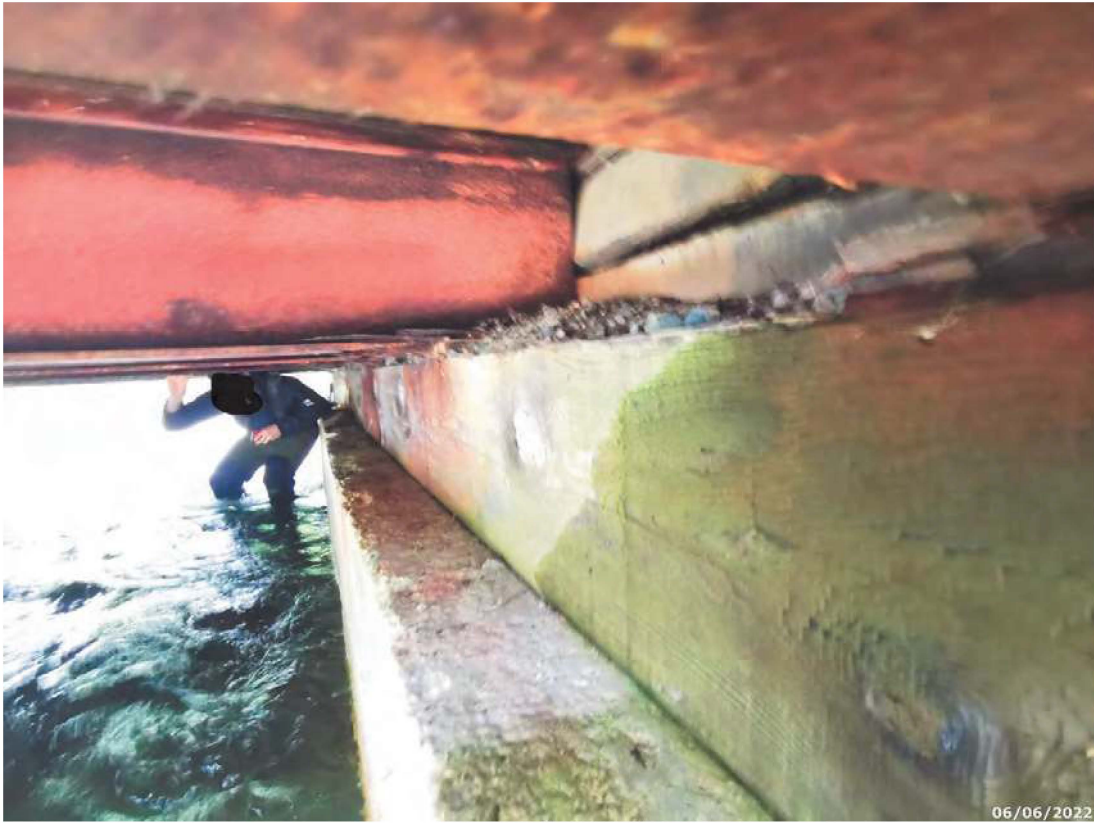
Severe corrosion of bottom flange and web at the west abutment.

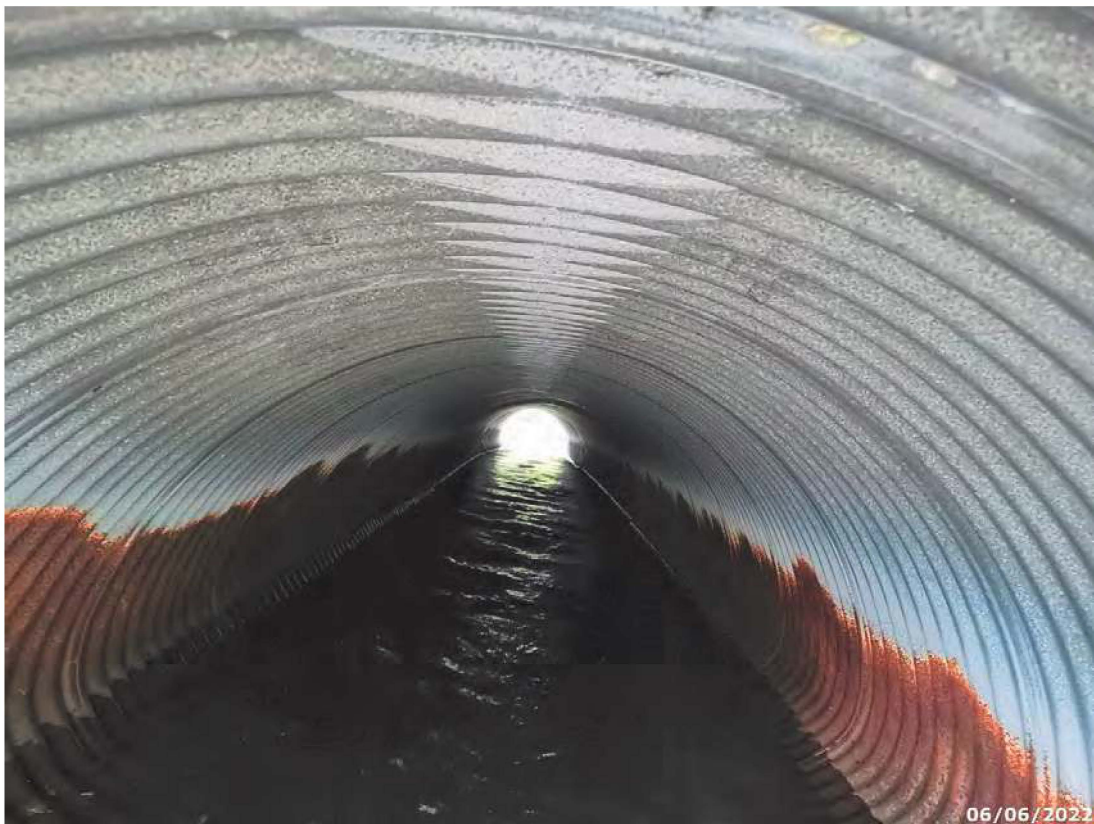
Sag in overflow pipe in obvert and dent at centerline
