THE MUNICIPALITY OF CENTRAL MANITOULIN

REQUEST FOR PROPOSALS 03-2026

FOR: Beaver Road East and West Bridges - Engineering Consulting Services for Design process.

Municipality of Central Manitoulin – 2022 OSIM Inspections

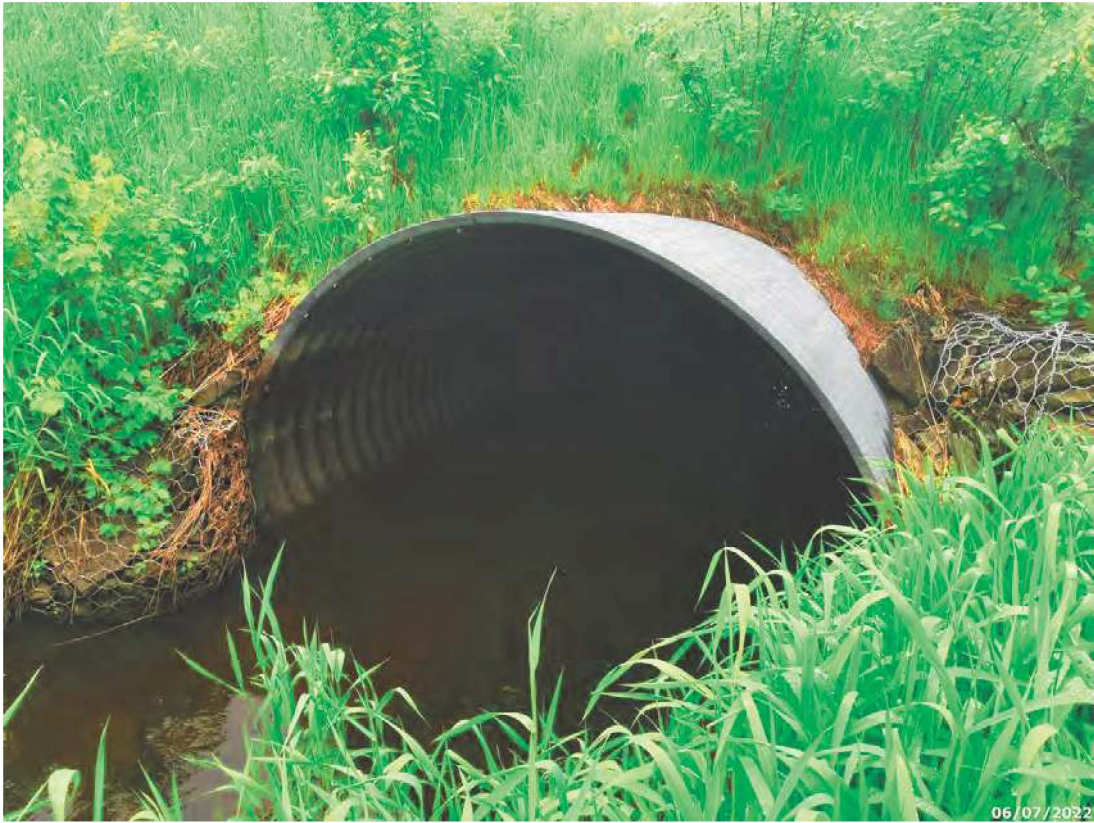
South elevation

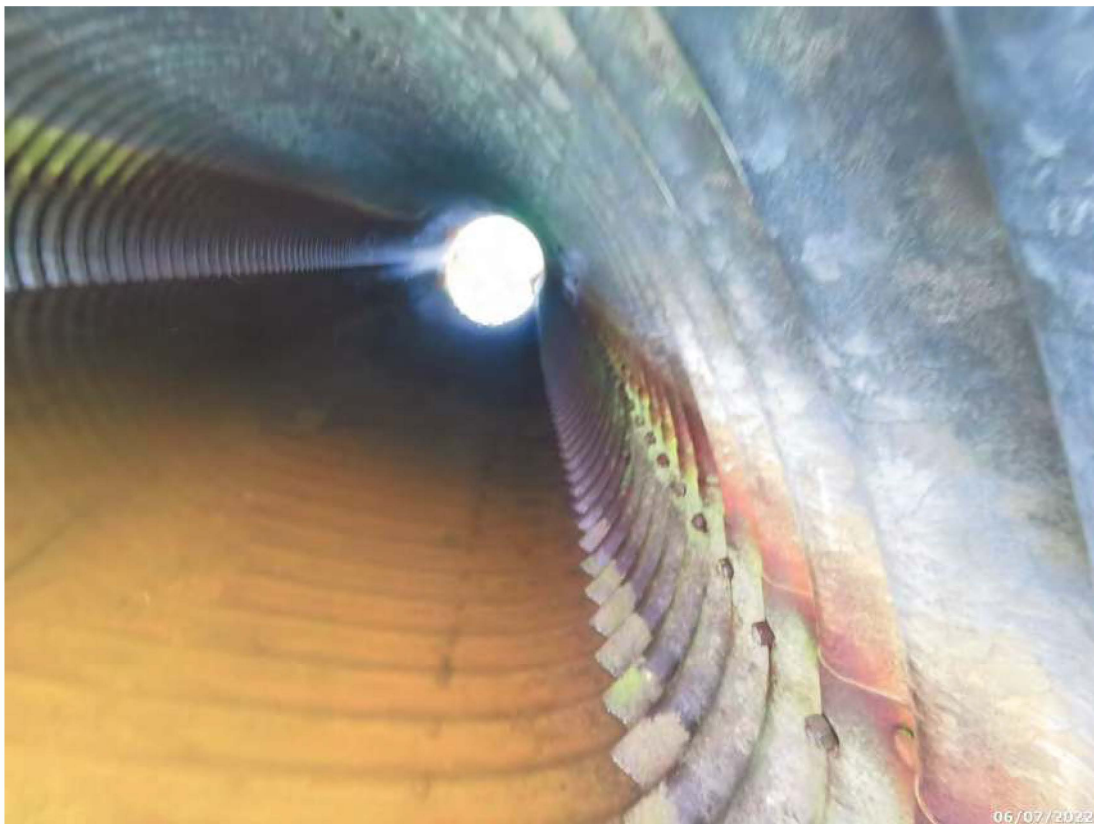
Looking South Along West Barrel Wall

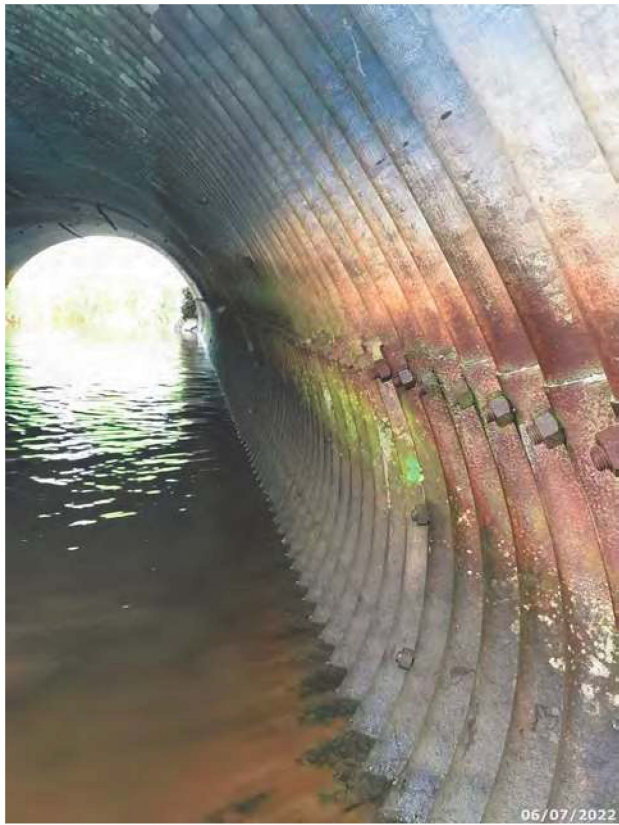
Looking North Along East Barrel Wall

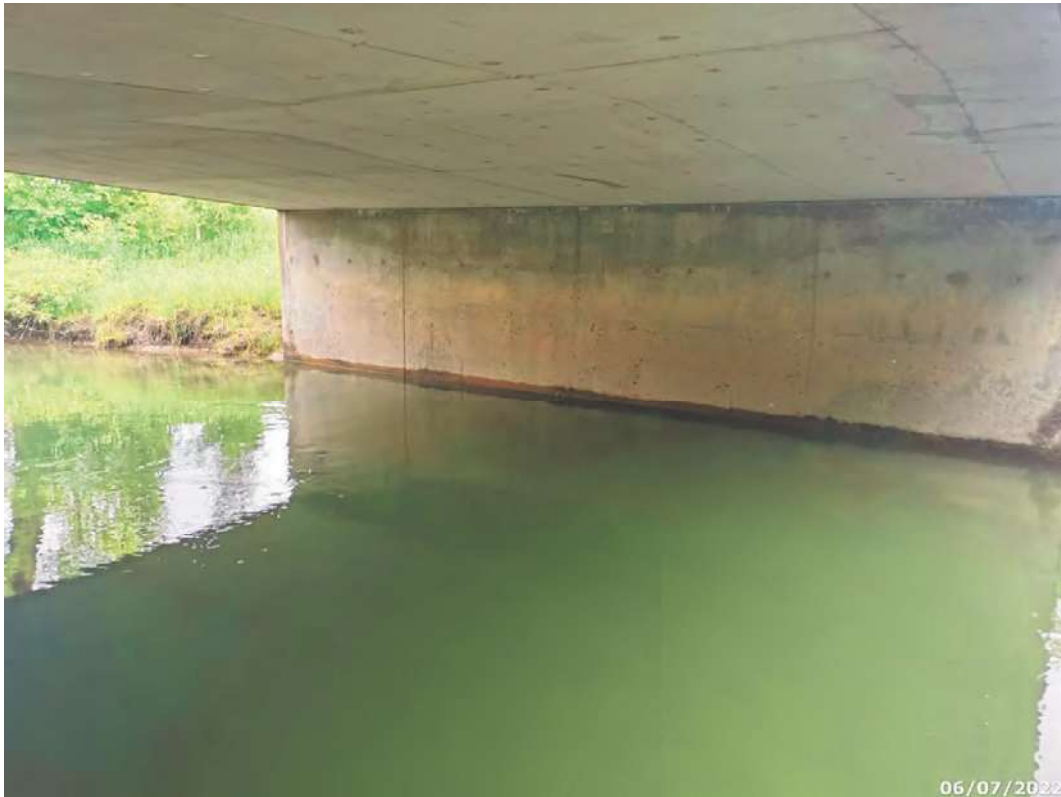
45.8	1.0	1.0		00. None
Comments:						
Medium vertical crack noted on south abutment at 2/3 height at mid-width. At one third from east end on south abutment there is a narrow to medium vertical crack spanning the full height and connects to crack in soffit.						
Recommended Work:			Maintenance Needs:			
<input type="checkbox"/> Rehab <input type="checkbox"/> Replace <input type="checkbox"/> 1-5 years <input type="checkbox"/> 6-10 years			<input type="checkbox"/> Urgent <input type="checkbox"/> 1 year <input type="checkbox"/> 2 year			
None			01. N/A

South abutment general arrangement

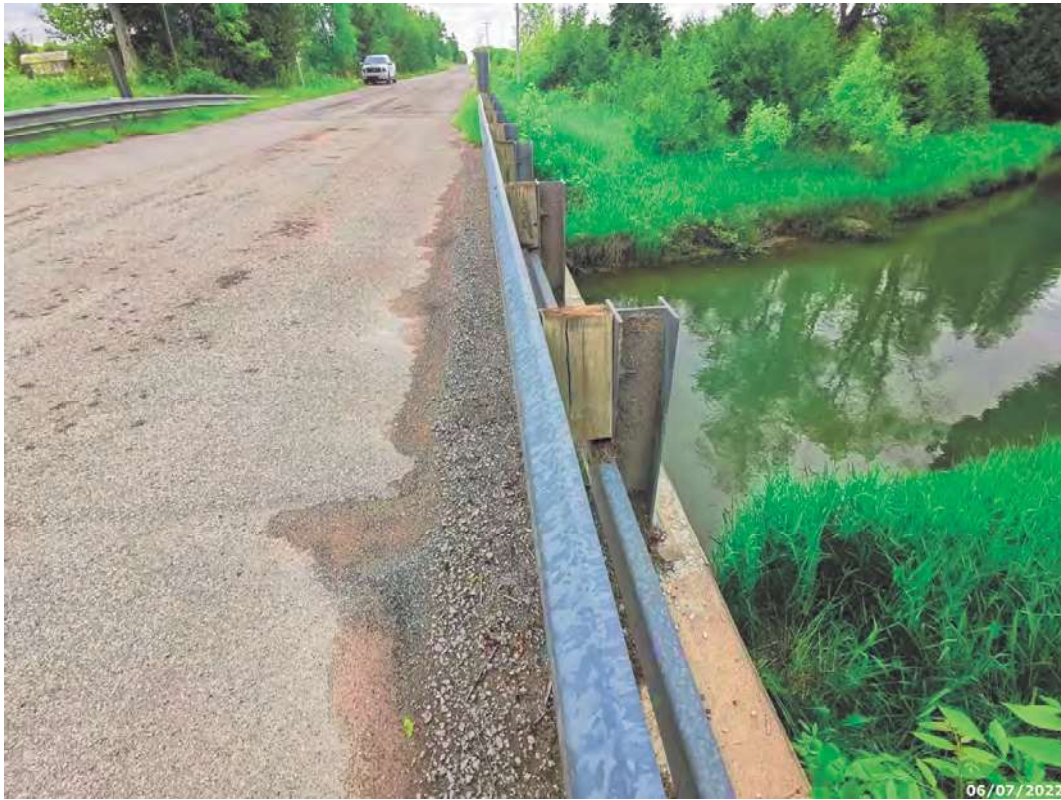
Typical barrier system, excess debris buildup

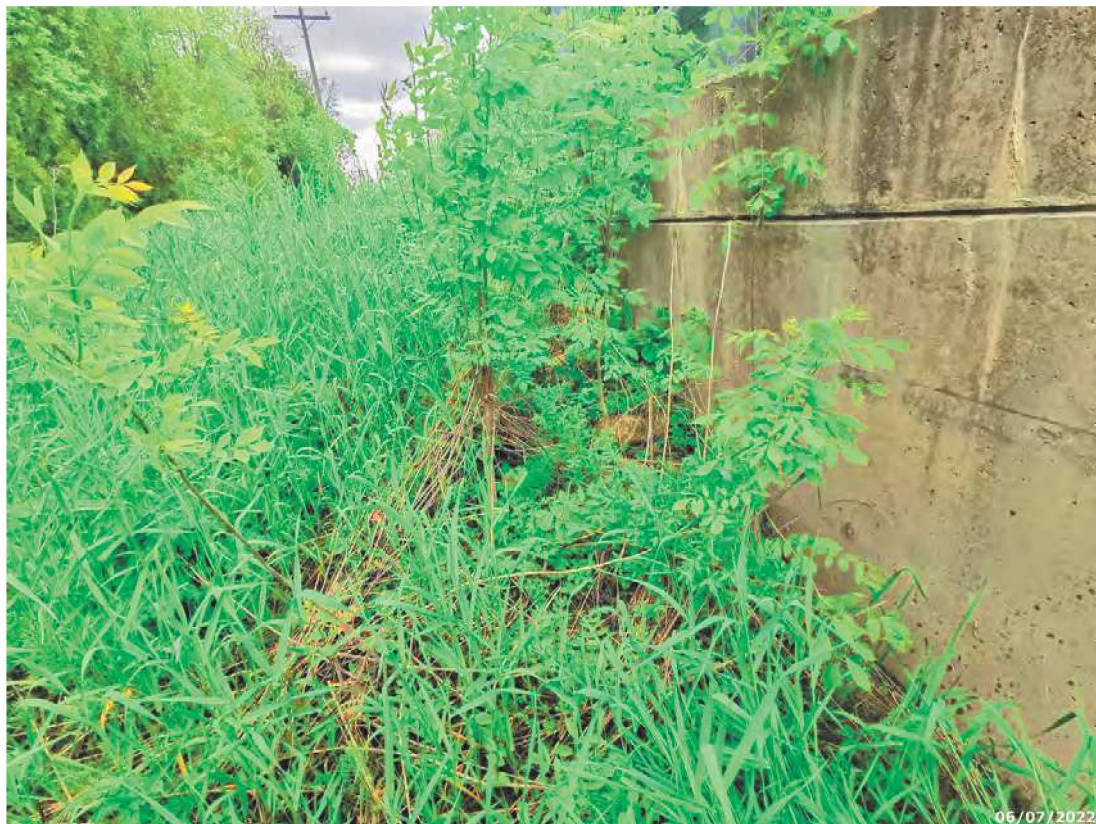
Tree growth adjacent to wingwall

Element Group:	Abutments	Length:	5.00 (m)			
Element Name:	Wingwalls	Width:	-			
Location:	Four Corners of Bridge	Height:	3.20 (m)			
Material:	Concrete	Count:	4			
Element Type:		Total Quantity:	64.0 (sq. m)			
Environment:	Benign Moderate Severe	Inspected:	Yes <input type="checkbox"/>	No <input type="checkbox"/>	Limited <input checked="" type="checkbox"/>	
Protection System:						Perform. Deficiencies
Condition Data:	Units m ² m / each / % / all	Exc.	Good	Fair	Poor*	
			54	10		00. None
Comments: Localized stained vertical crack at northeast wingwall. Tree growth adjacent to wingwall.						
Recommended Work:			<input type="checkbox"/> Rehab <input type="checkbox"/> Replace <input type="checkbox"/> 1-5 years <input type="checkbox"/> 6-10 years		Maintenance Needs: 02. Bridge Cleaning	
None					<input type="checkbox"/> Urgent <input checked="" type="checkbox"/> 1 year <input type="checkbox"/> 2 year Cut back vegetation growth adjacent to wingwalls.

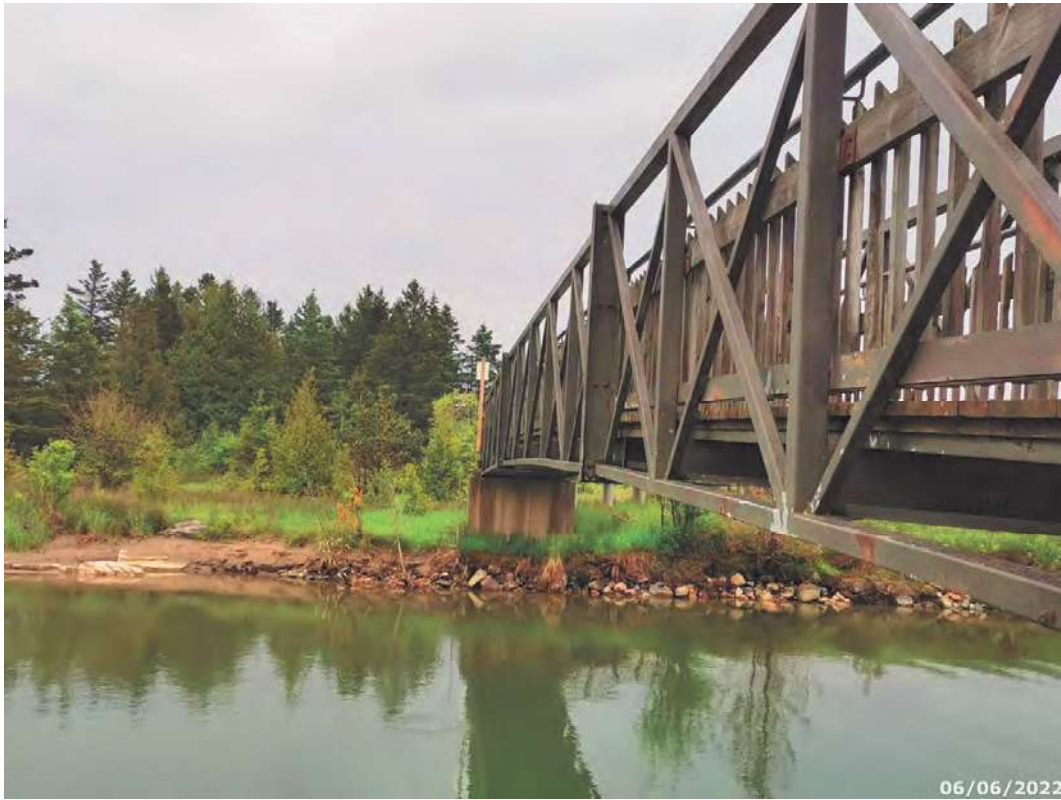
Moderate deflection of bottom chord at midspan

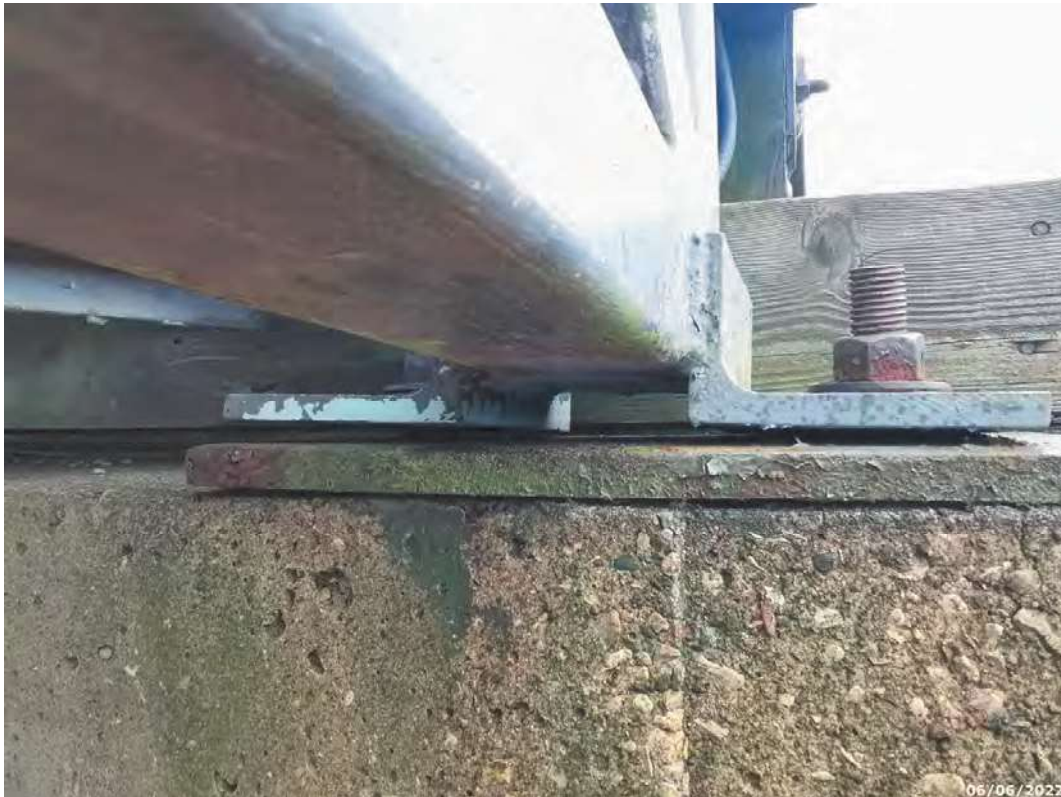
Minimal contact at northwest bearing

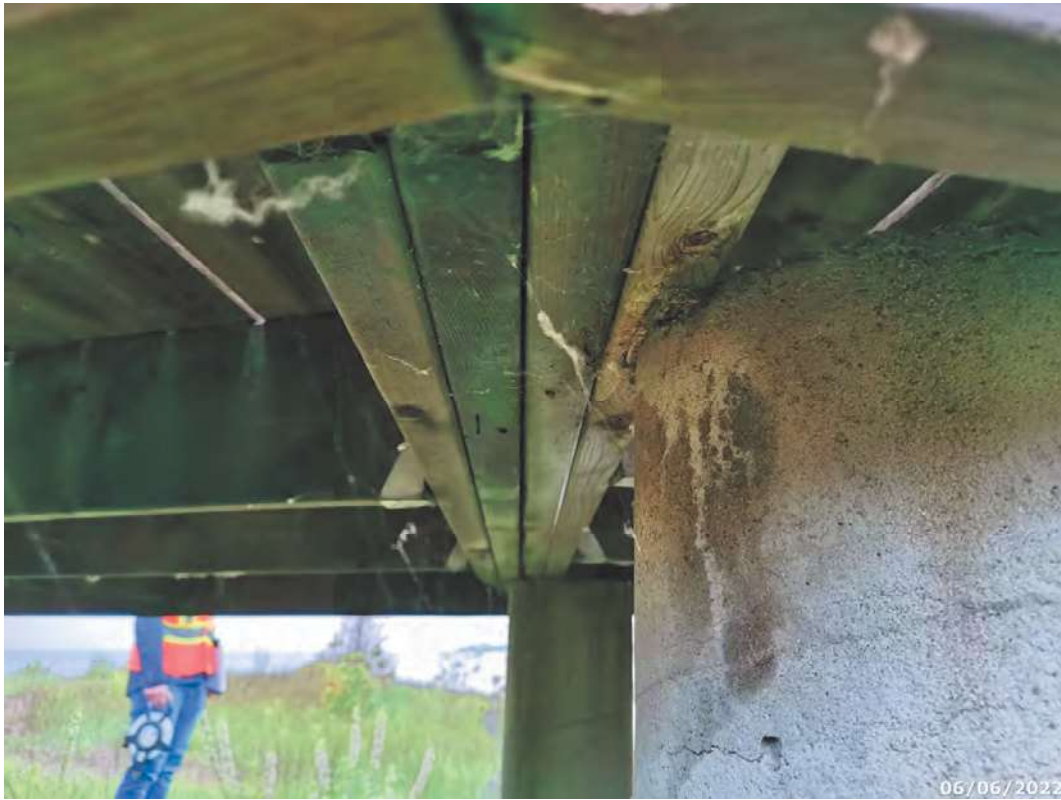
Minimal approach sidewalk bearing

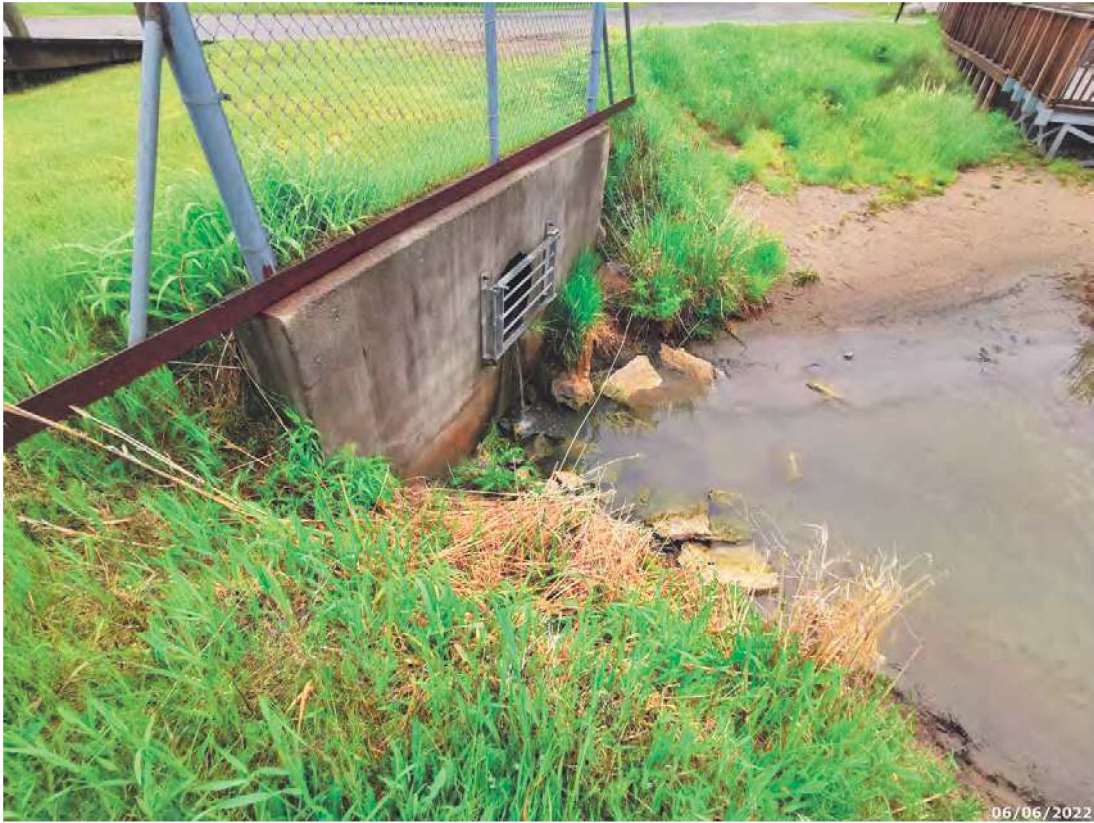
Storm sewer outlet, northeast of bridge

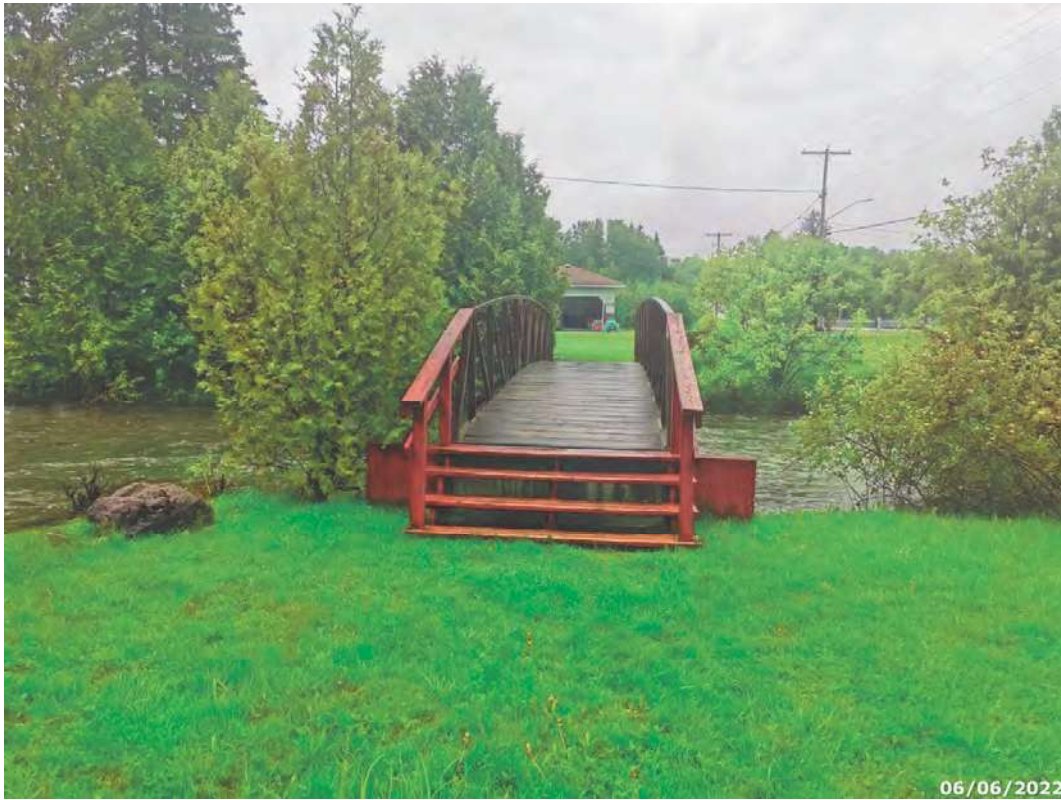
Typical north approach

Repair and Rehabilitation Required:		Priority				Estimated Construction Cost
Element	Repair and Rehabilitation Required	6 to 10 years	1 to 5 years	Within 1 year	Urgent	
Abutments	Clear bearings of debris			X		Maintenance
Abutments	Restore lost bearing material and stabilize		X			\$7,500
Total Cost						\$7,500

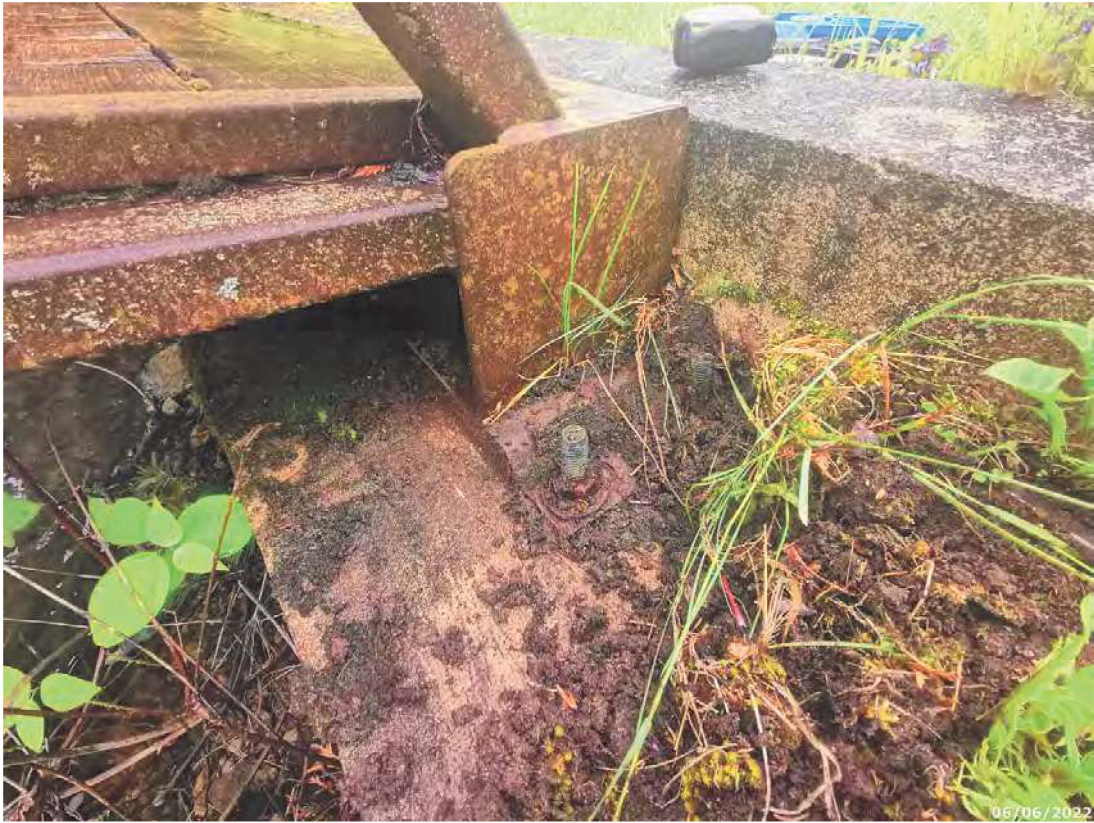
Severe debris buildup, south bearing

Bearing material under the abutments has eroded and should be replaced to stabilize abutments.

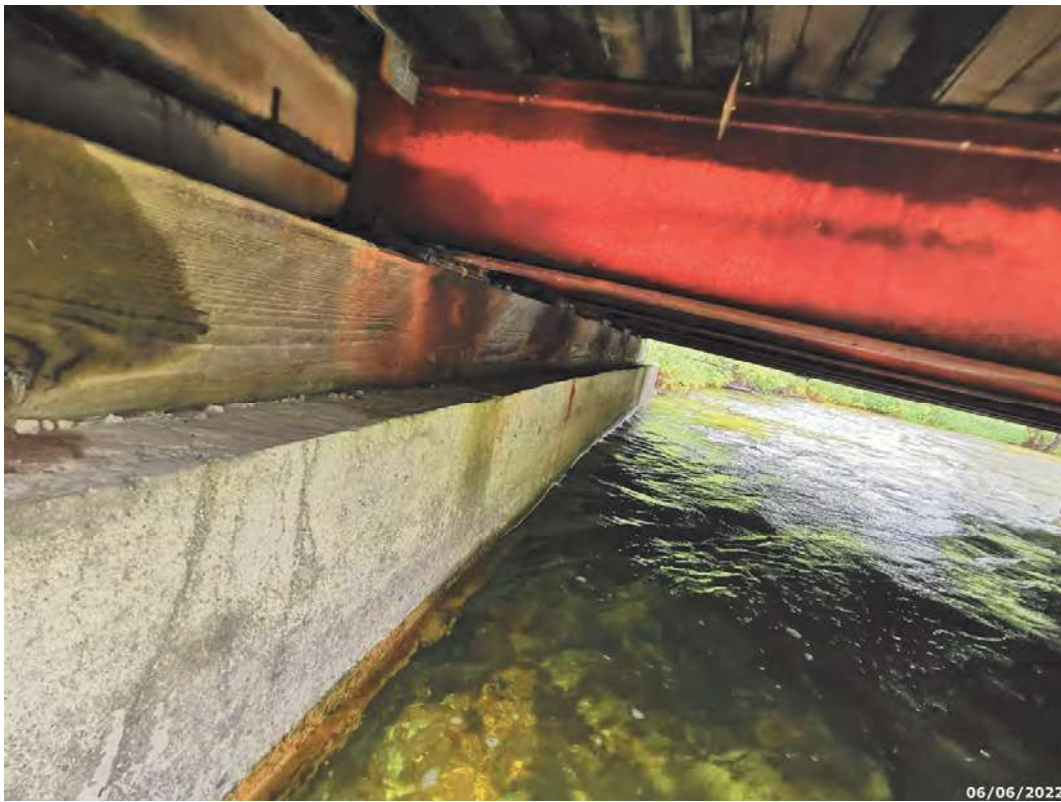
East Abutment General Arrangement

Element Group:	Abutments	Length:	
Element Name:	Ballast Walls	Width:	6.0 (m)
Location:	E/W	Height:	0.51 (m)
Material:	Wood	Count:	2
Element Type:		Total Quantity:	6.12 (sq.m)
Environment:	Benign <u>Moderate</u> Severe	Inspected:	Yes <input type="checkbox"/> No <input type="checkbox"/> Limited <input checked="" type="checkbox"/>
Protection System:	Creosote		Perform. Deficiencies
Condition Data:	<u>m²</u> m / each / % / all	Exc.	Good
			Fair
			Poor*
			Continuing Settlement
Comments:	Severe decay throughout, alarming loss of fill onto bearing, delamination between planks.		
Recommended Work:	<input type="checkbox"/> Rehab <input checked="" type="checkbox"/> Replace <input checked="" type="checkbox"/> 1-5 years <input type="checkbox"/> 6-10 years		Maintenance Needs: 01. N/A
Replace ballast walls.			<input type="checkbox"/> Urgent <input type="checkbox"/> 1 year <input type="checkbox"/> 2 year

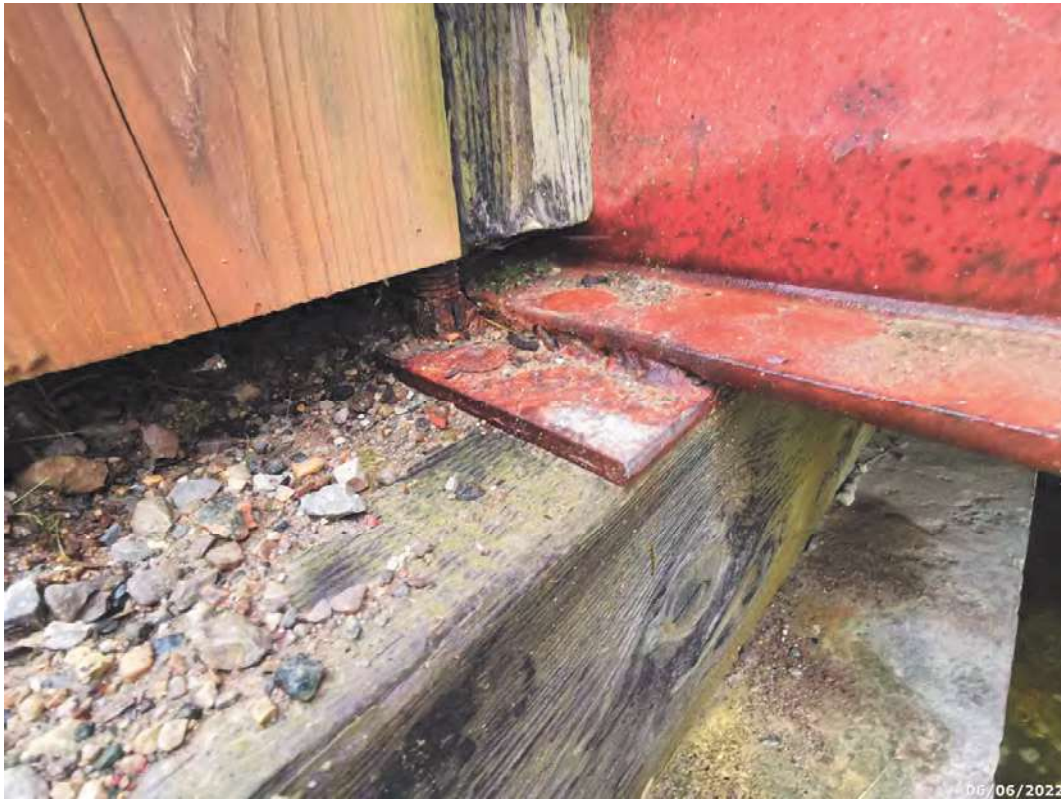
Typical bearing plate at east abutment (exterior beams only)

Element Group:	Abutments	Length:	
Element Name:	Bearings	Width:	
Location:	Abutment Piers	Height:	
Material:	Steel	Count:	21
Element Type:	Plate	Total Quantity:	21 (Each)
Environment:	Benign / Moderate / Severe	Inspected:	Yes <input type="checkbox"/> No <input type="checkbox"/> Limited <input checked="" type="checkbox"/>
Protection System:			Perform. Deficiencies
Condition Data:	Units m ² / m (each) % / all	Exc.	Good
			Fair
			Poor*
			21

01.
Comments: Severe corrosion throughout, steel is seperating, some bolts are corroded through. Nuts on anchor bolts are severely corroded and broken in half by hand. Creasote leaking through west abutment cribbing.			
Recommended Work:		Maintenance Needs:	
<input type="checkbox"/> Rehab <input checked="" type="checkbox"/> Replace <input checked="" type="checkbox"/> 1-5 years <input type="checkbox"/> 6-10 years Replace all bearings and repair webs and flanges of beams.		01. N/A <input type="checkbox"/> Urgent <input type="checkbox"/> 1 year <input type="checkbox"/> 2 year

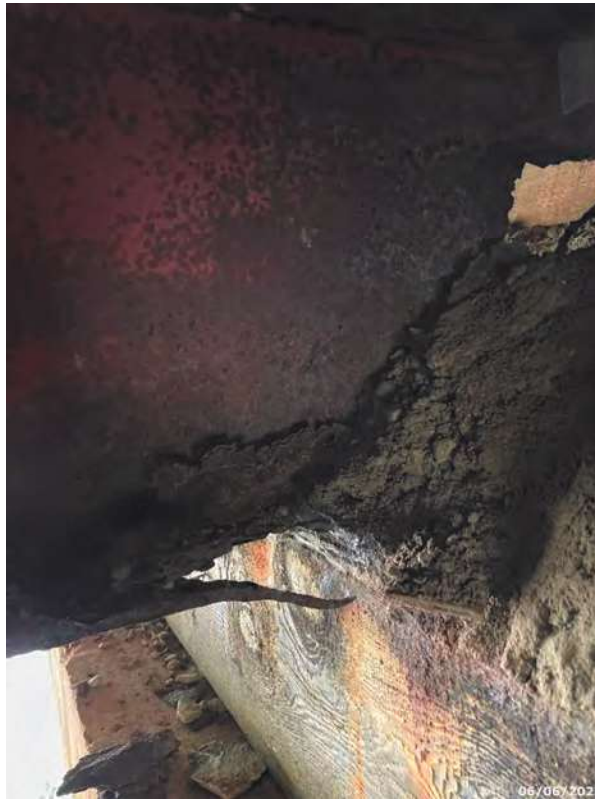
Severe Section Loss at Bearing

Steel girders, bearings and ballast walls are in poor condition and should be replaced/repared within 1 year. If funding is not immediately available to replace the girders, the bearings should be cleaned and bearing stiffeners added to temporarily reinforce the bridge until the girders and bearings can be replaced. Annual cleaning of the bearings is required on all bridges.

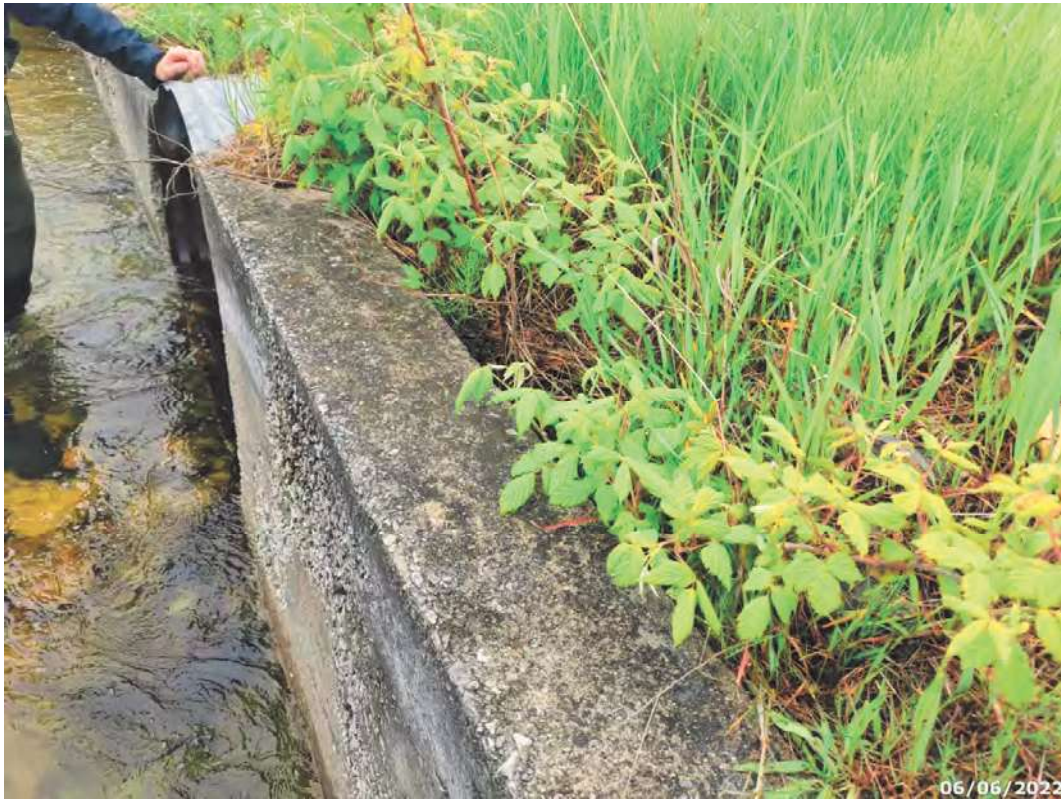
10.72	2	14.
Comments: NW wingwall separating from west abutment, moderate spalls throughout, some undermining present, wingwall acts as headwall around 2 overflow pipes and light popouts.						
Recommended Work:			Maintenance Needs:			
<input type="checkbox"/> Rehab <input type="checkbox"/> Replace <input type="checkbox"/> 1-5 years <input type="checkbox"/> 6-10 years			01. N/A <input type="checkbox"/> Urgent <input type="checkbox"/> 1 year <input type="checkbox"/> 2 year

Light pop outs and erosion behind concrete headwall. (NW quadrant of bridge)
